PUERTO RICO SCHOOL FACILITIES ASSESSMENT

COUNCIL OF THE GREAT CITY SCHOOLS

NOVEMBER 11, 2017

Hurricane Maria Damage Assessment of School Facilities in Puerto Rico

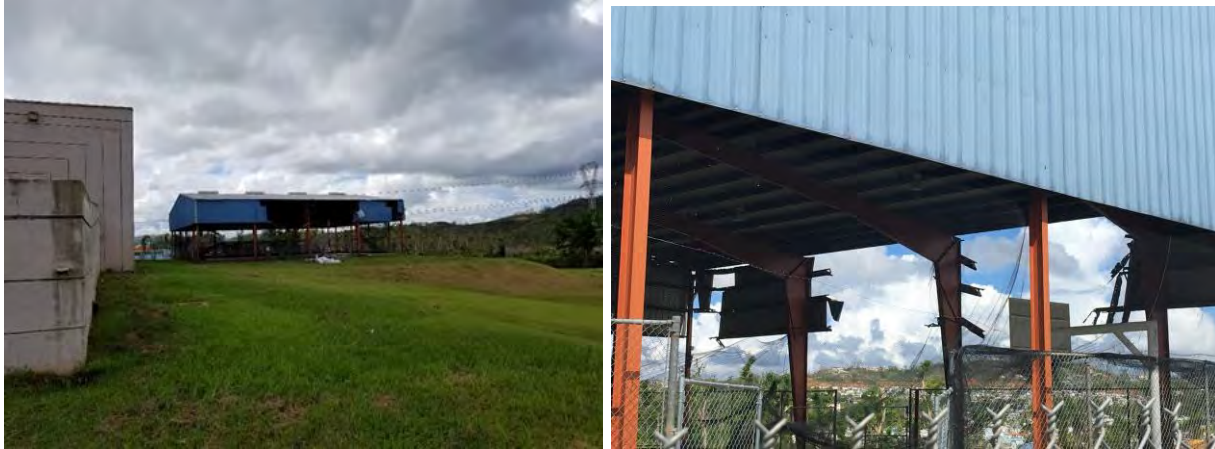
Damaged Gym Area

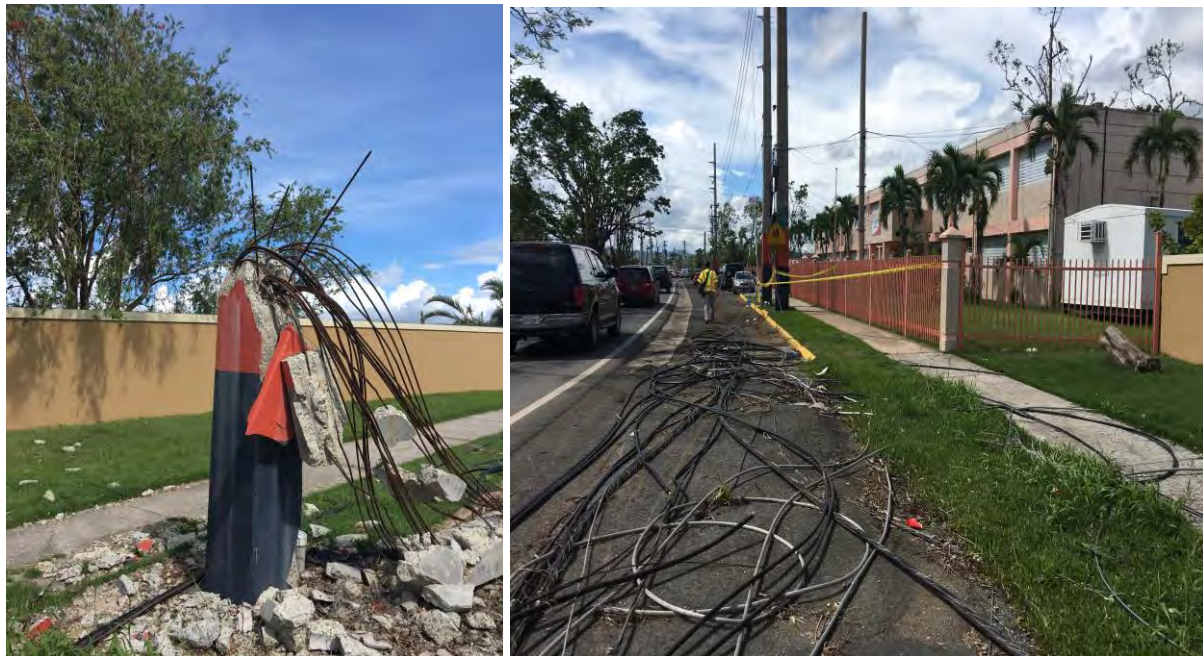
Downed power line in front of campus

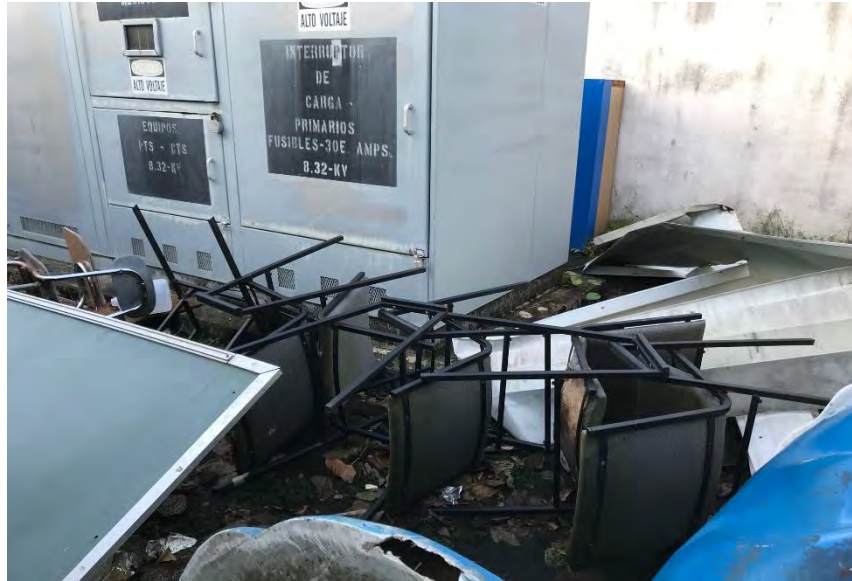
Miscellaneous equipment around generators

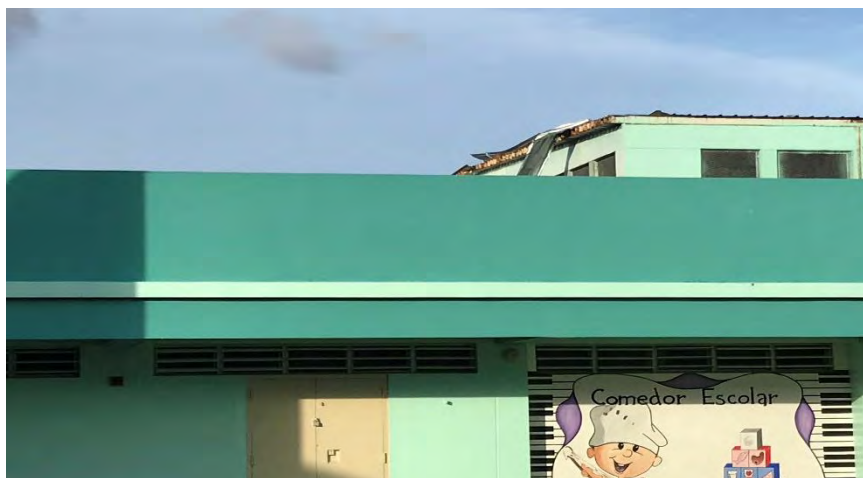
Damaged gym roof

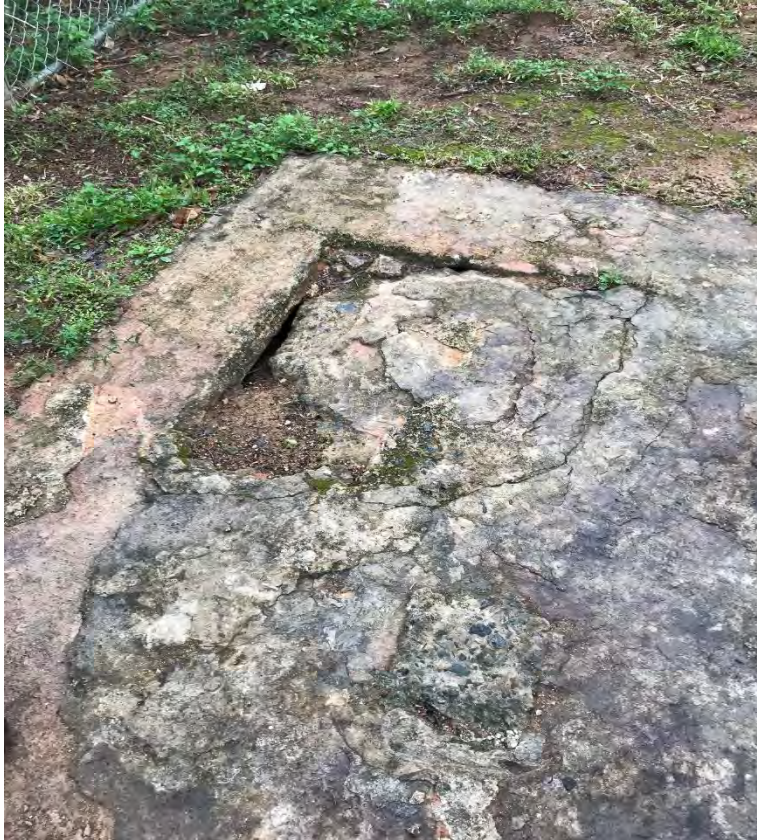
Opening to septic tank needs patching

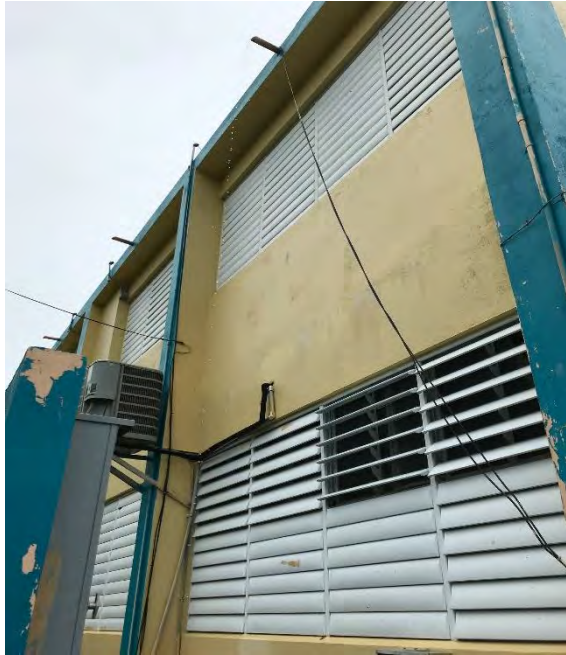
Downed electrical wires

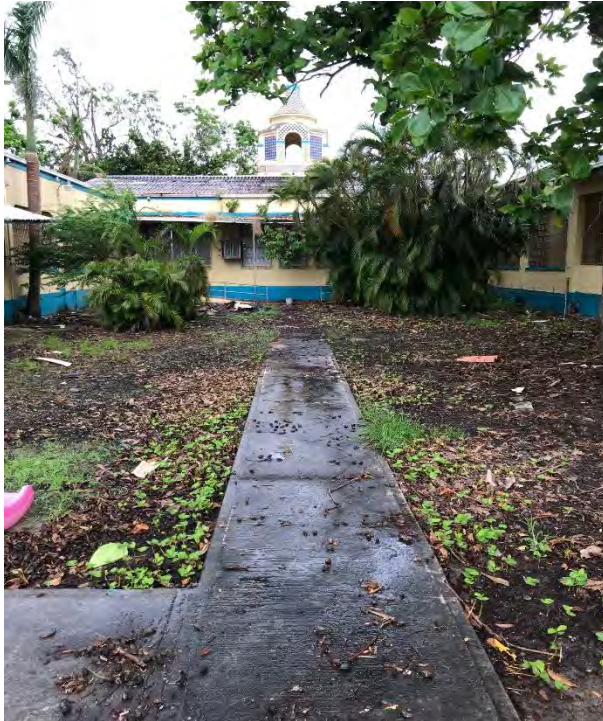
Courtyard that had been flooded with sewage

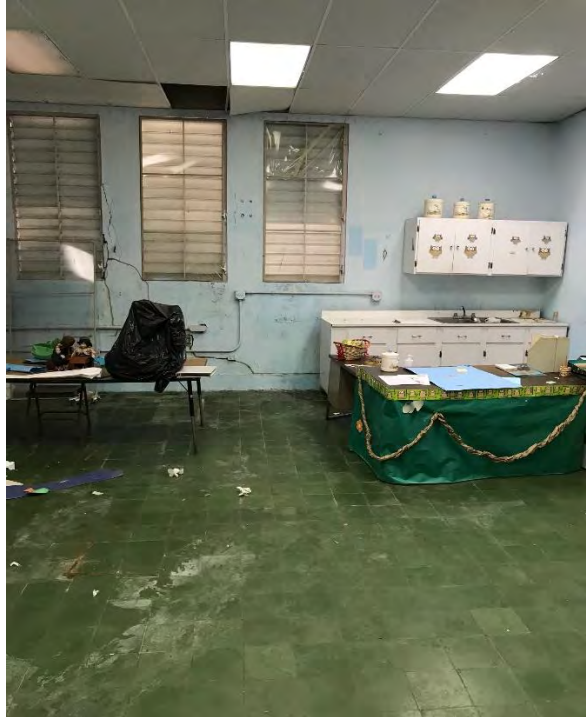
Damaged classroom

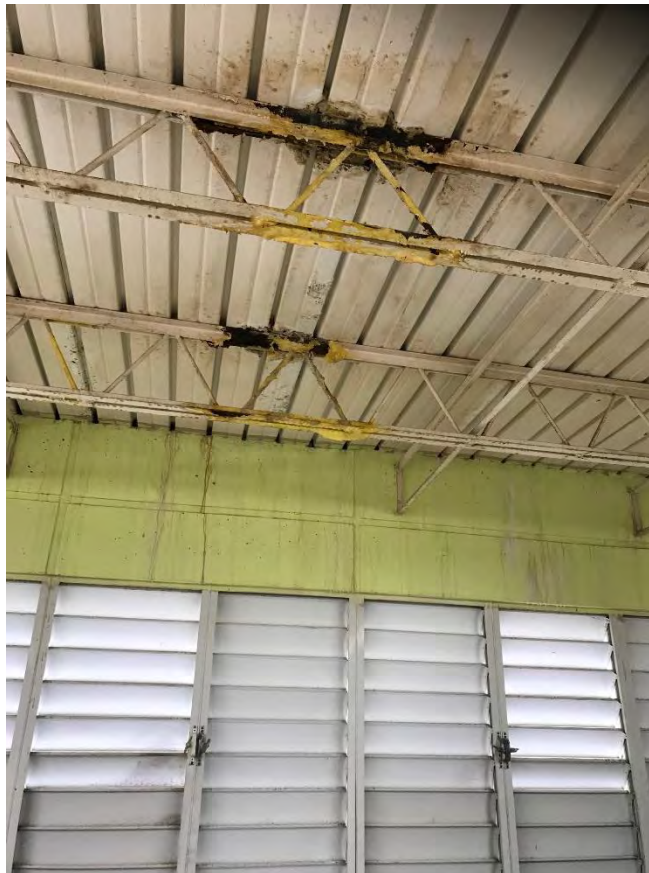
Ceiling damage from moisture

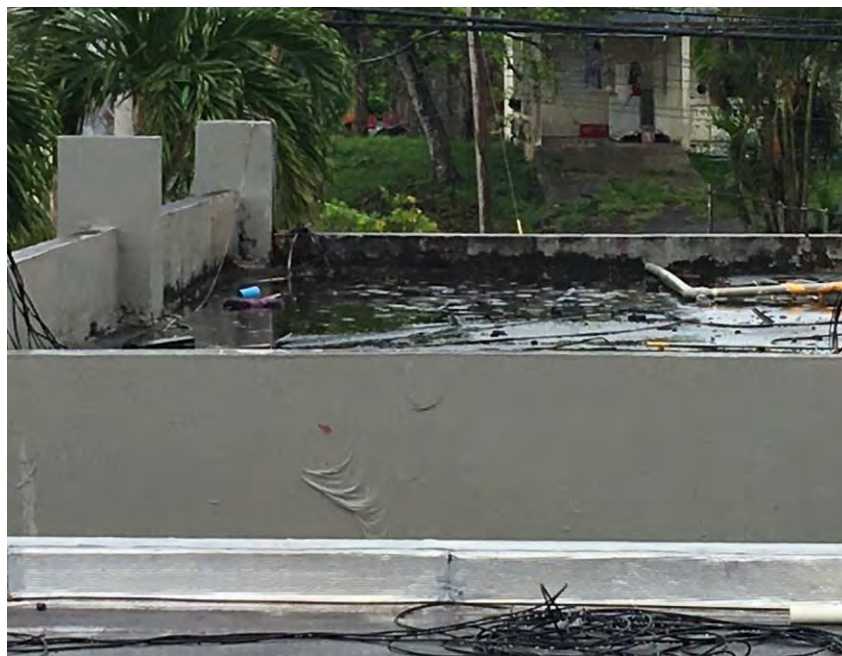
Standing water and roof debris

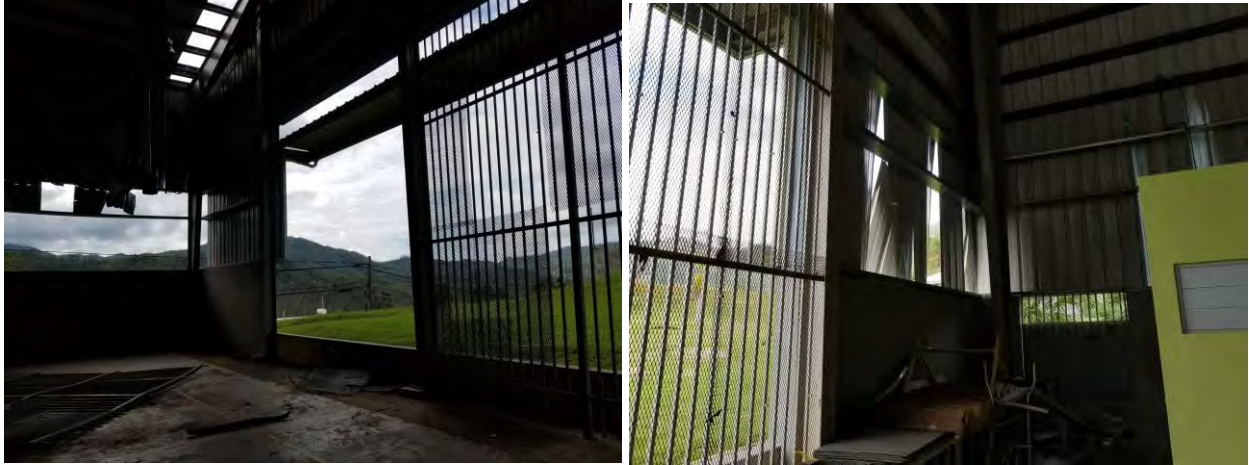
PE Shelter damaged

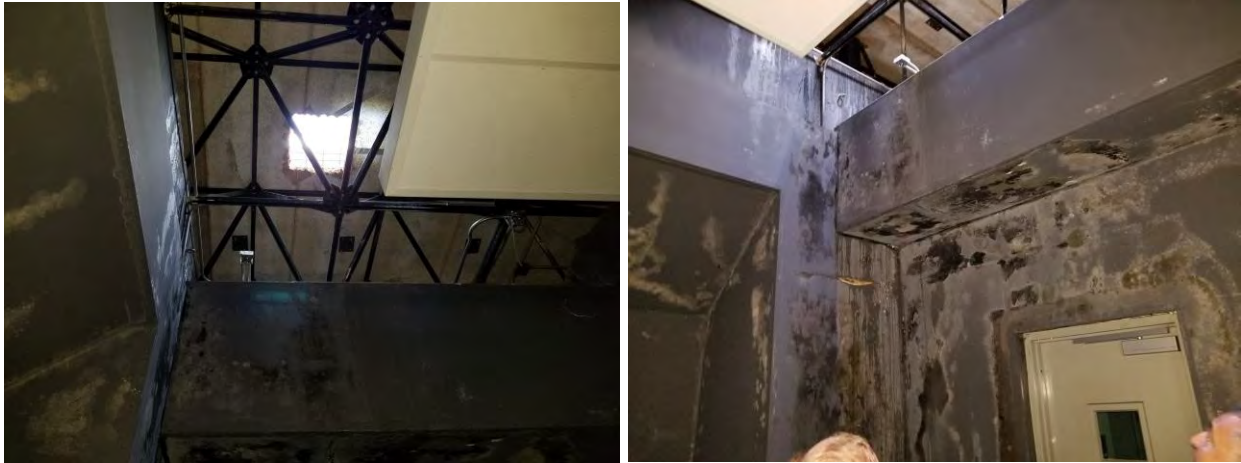
Theater roof damage and mold on stage

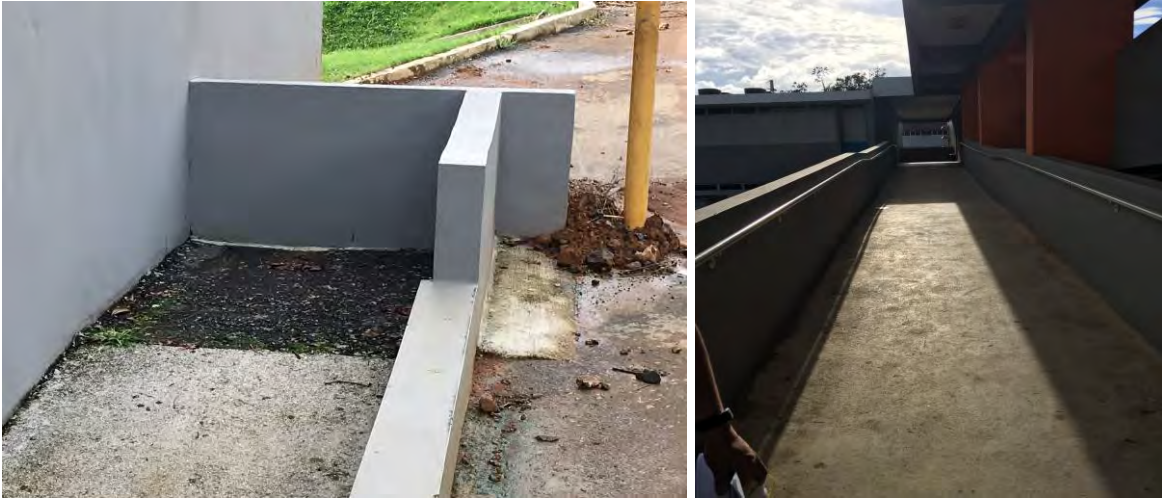
Building foundation and architectural design flaw - major drainage issues
Water flows into building due to inadequate drainage

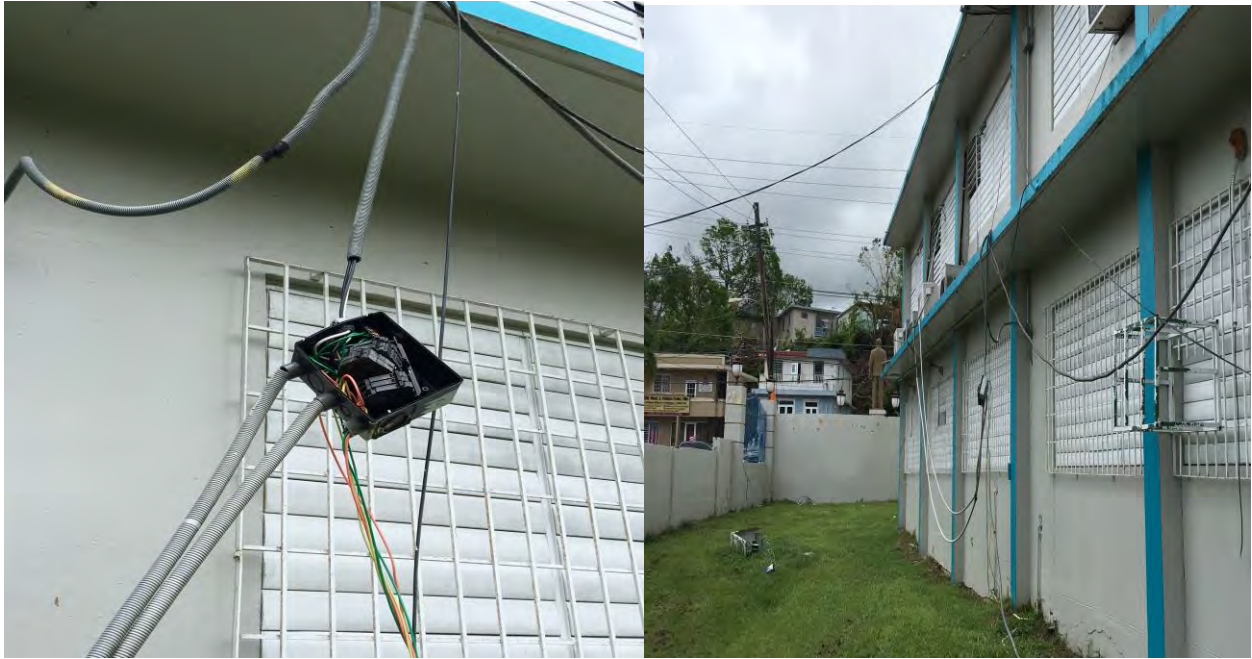
Downed power lines - safety issue

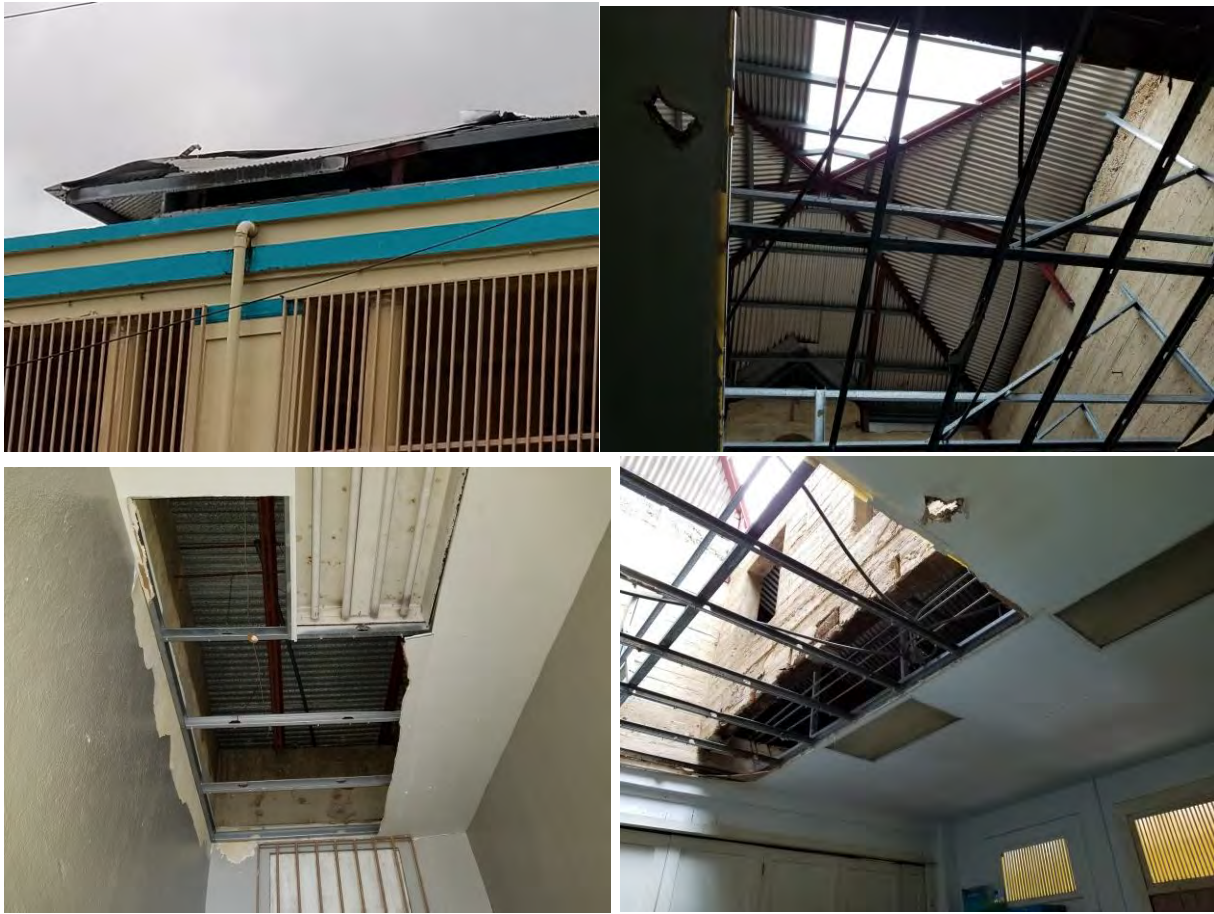
Severe roof damage. Several classrooms affected.

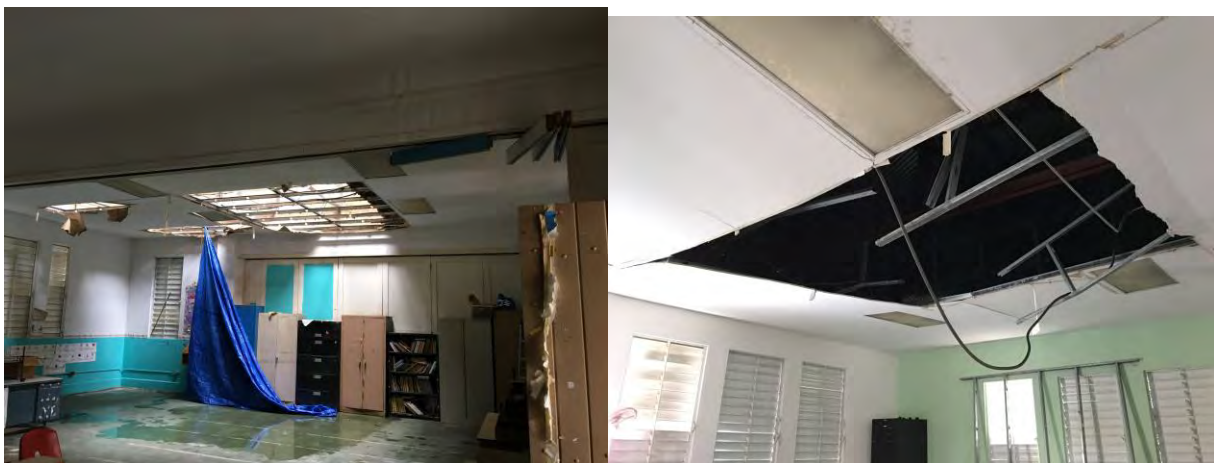
Roof and classroom damage

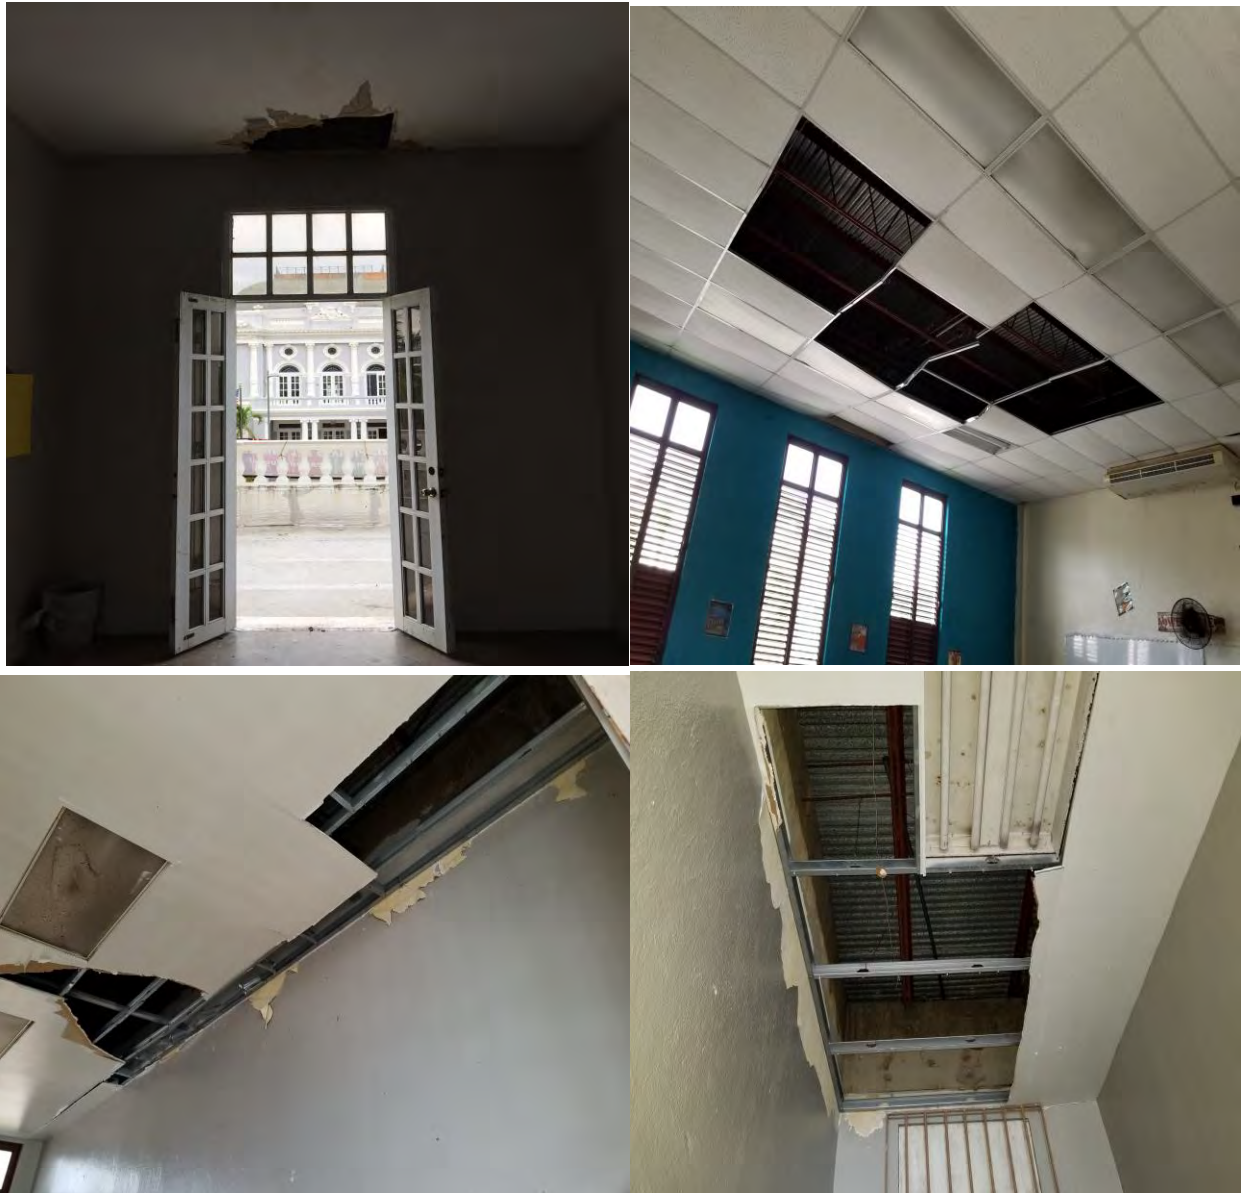
Roof, hallway and classroom damage in several areas.

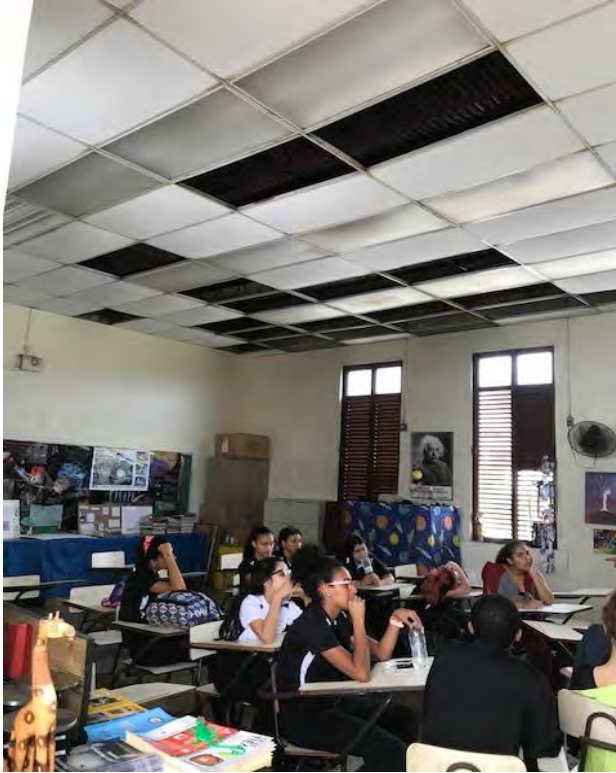
Ceiling damage in working classroom

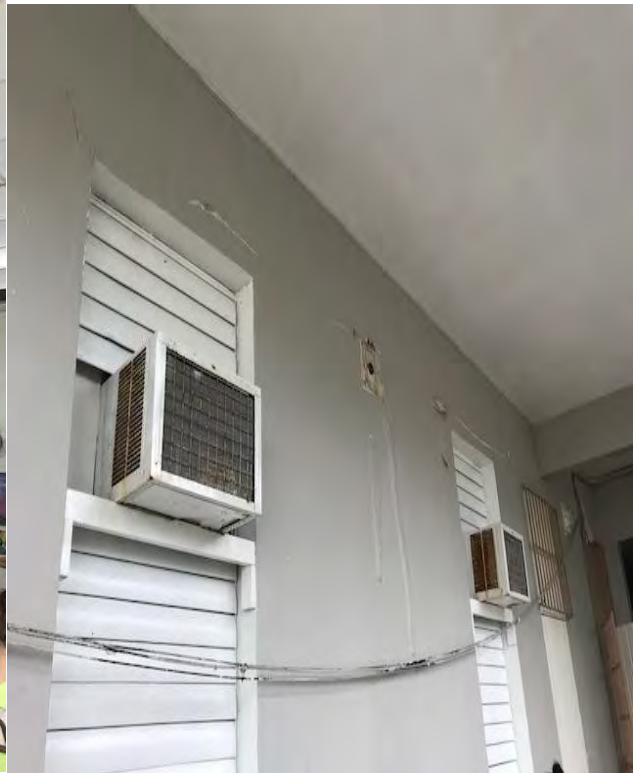
Downed wiring along corridor

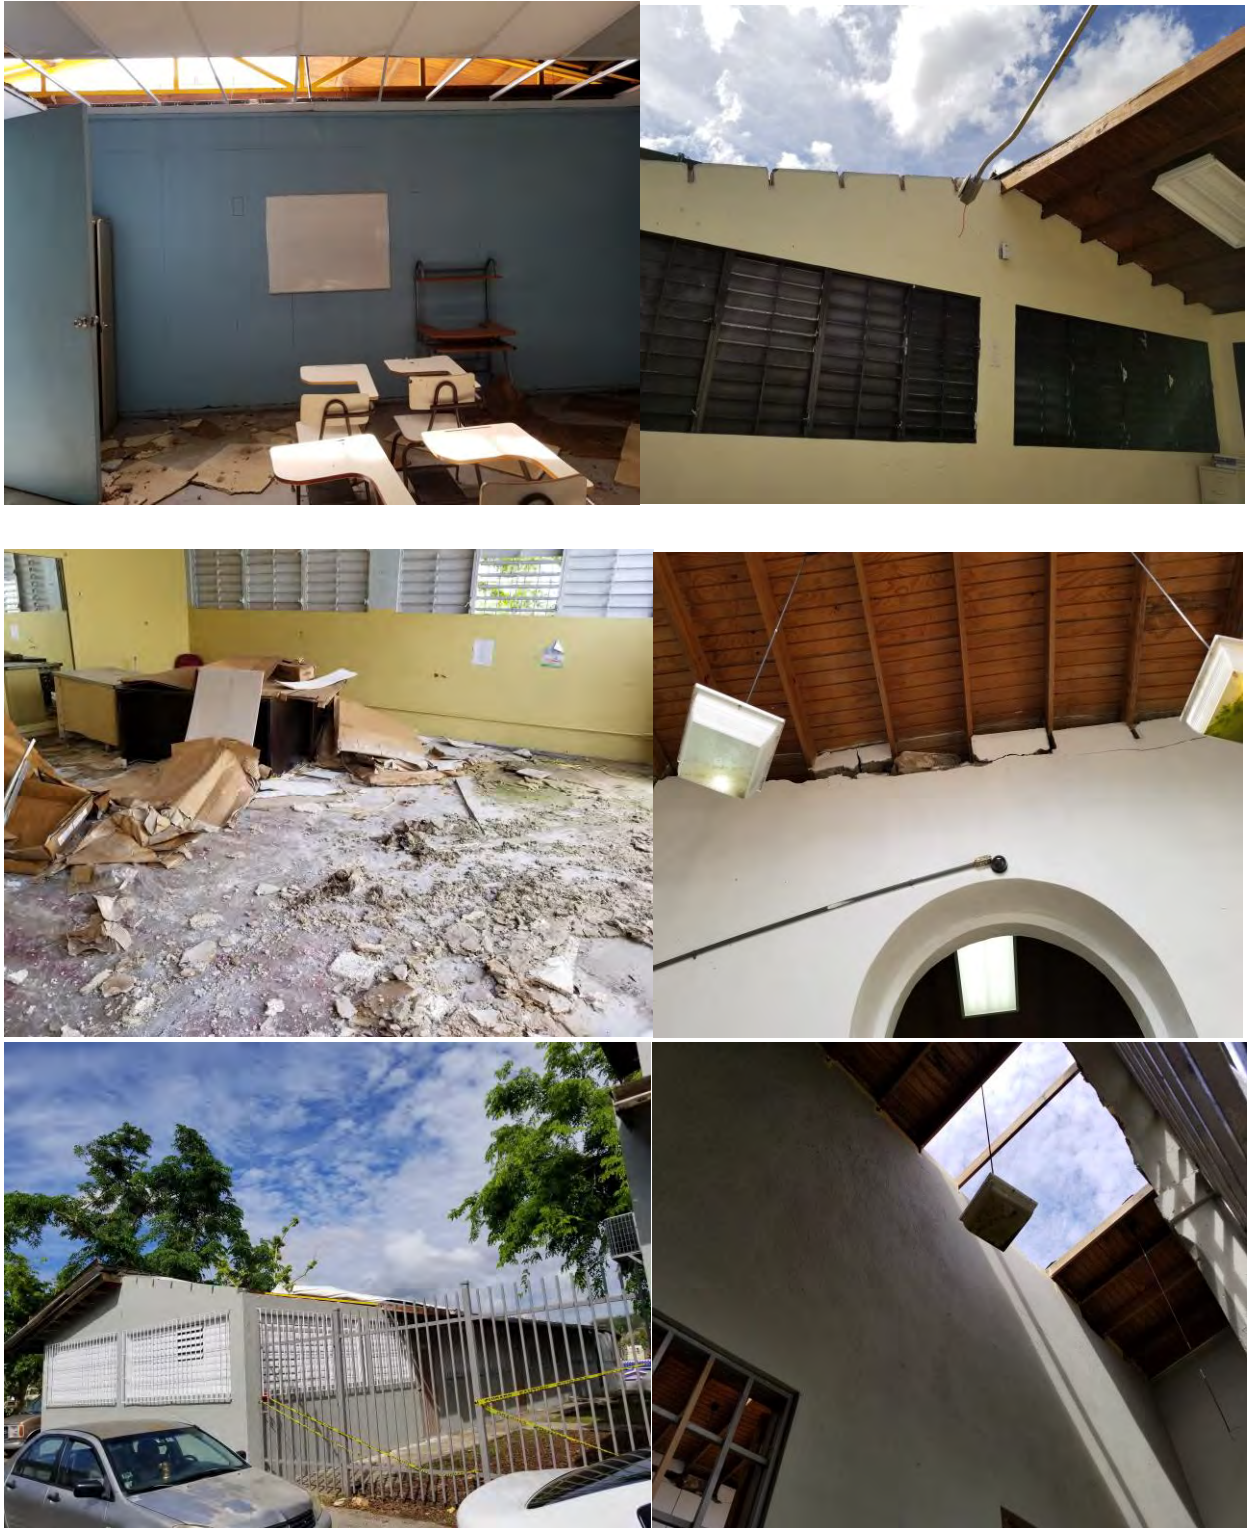
Two buildings with severe roof damage

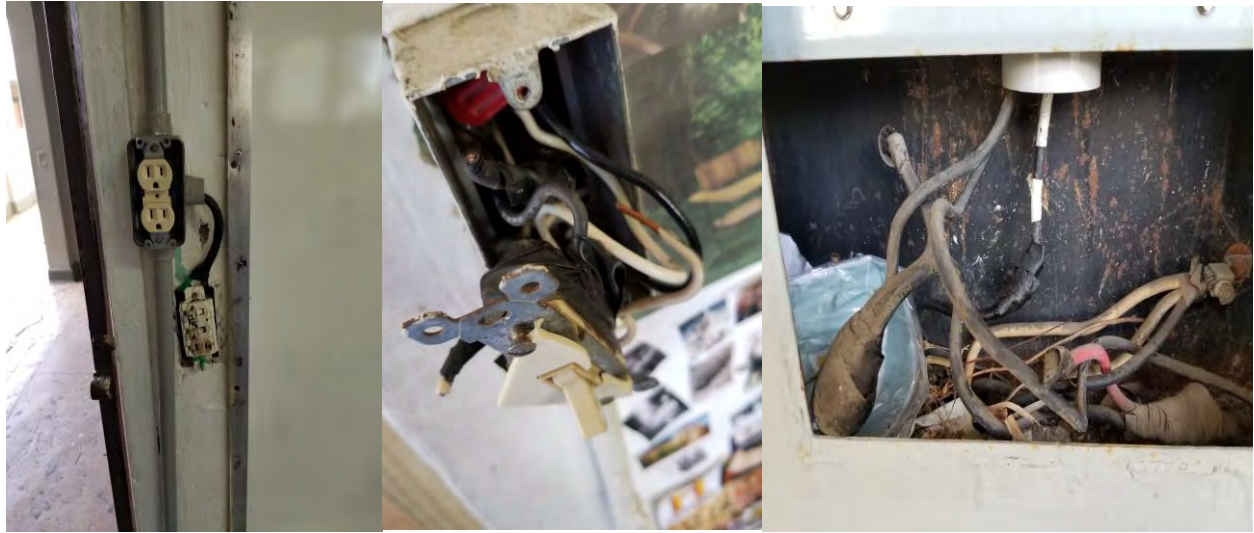
Electrical safety hazards all over building

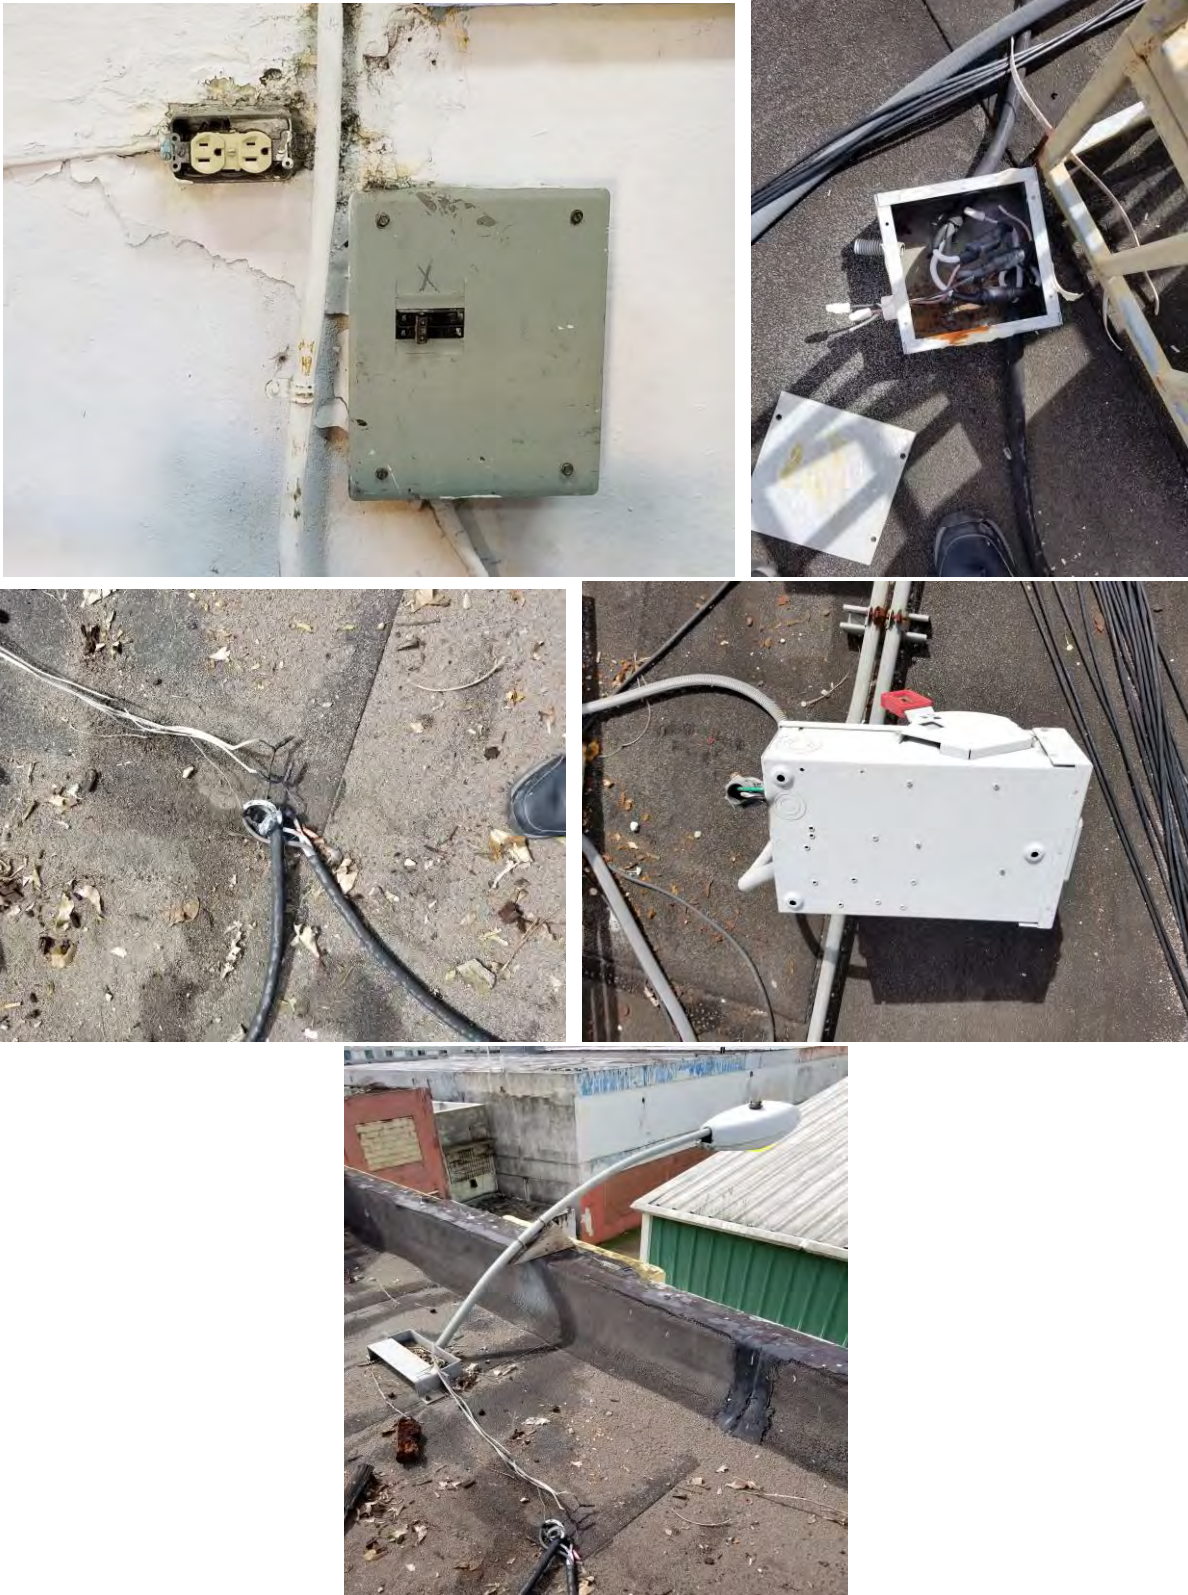
- Electrical panel on the roof exposed and electrical tape was used instead of wire nut connectors. The wiring inside the box was routed incorrectly and one 60 amp split 30 breaker was not fully attached.

Electrical safety hazards in classrooms and on roof.

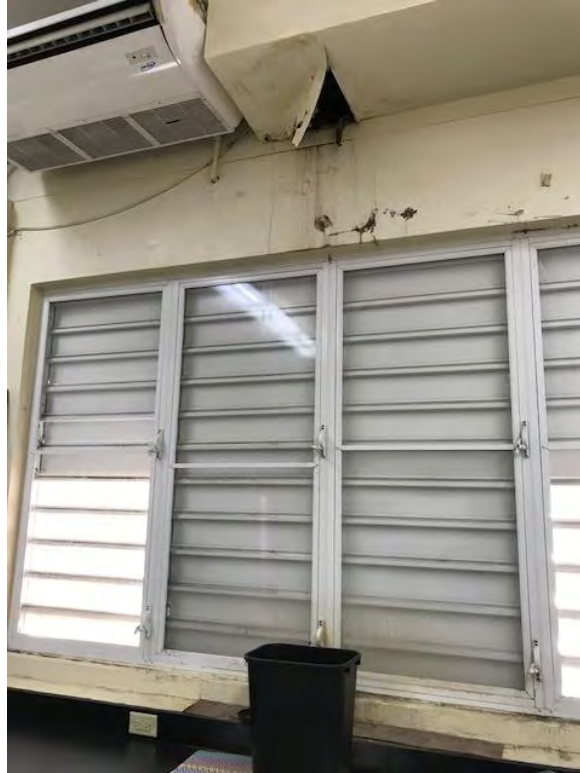
Water coming into classroom from roof

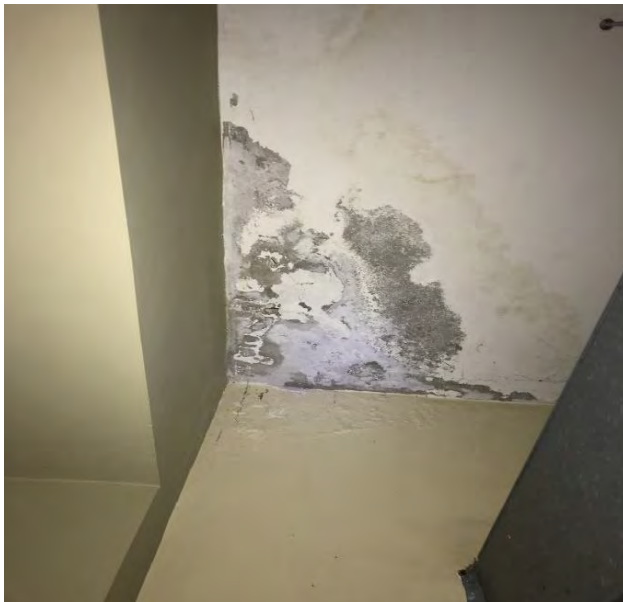
Active water leaks from ceiling

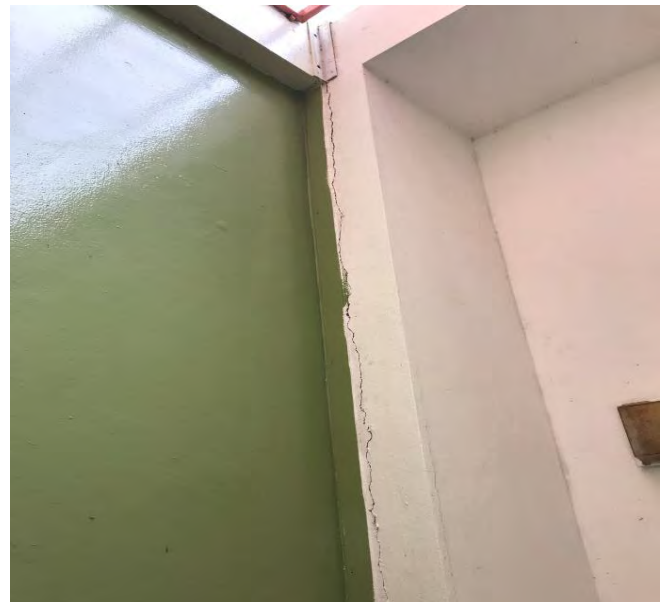
Vertical cracks along column

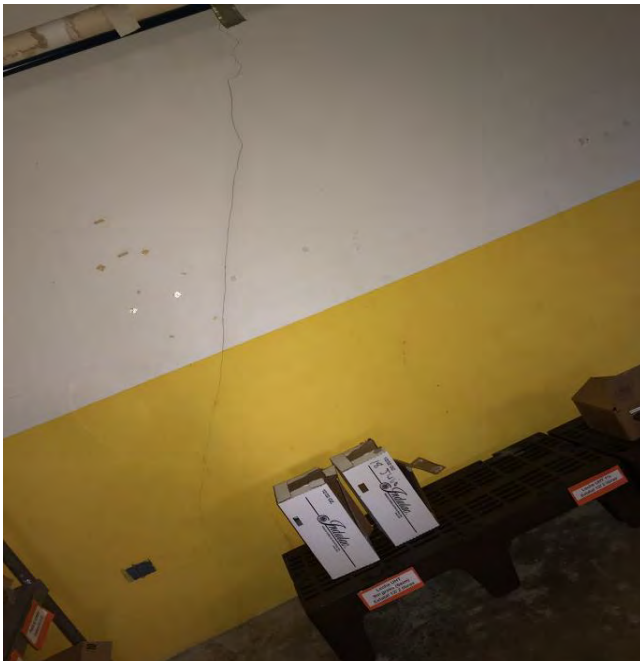
Wall crack in kitchen dry storage

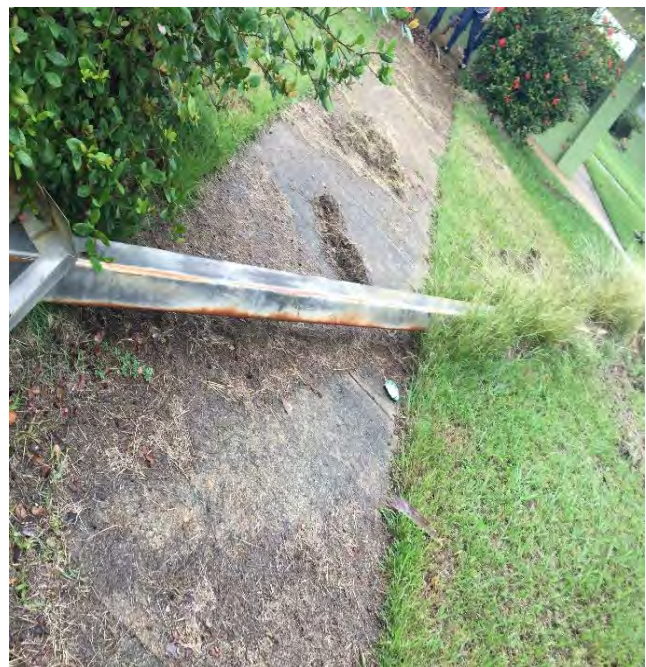
Fallen exterior site lighting

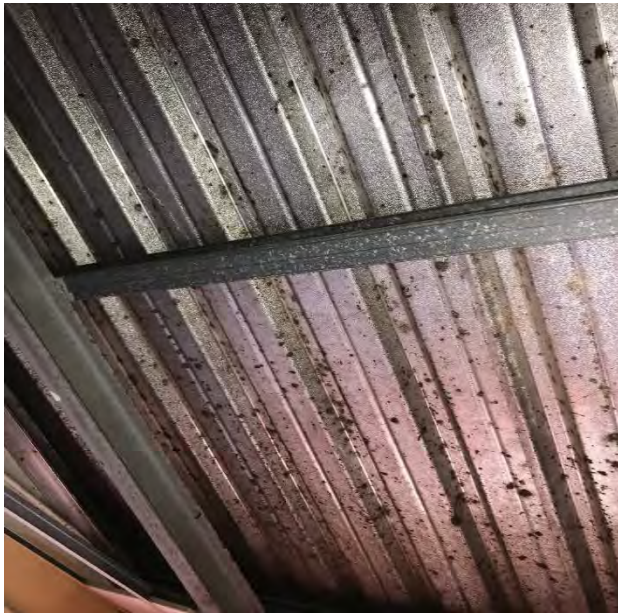
Mold visible on underside of roofing

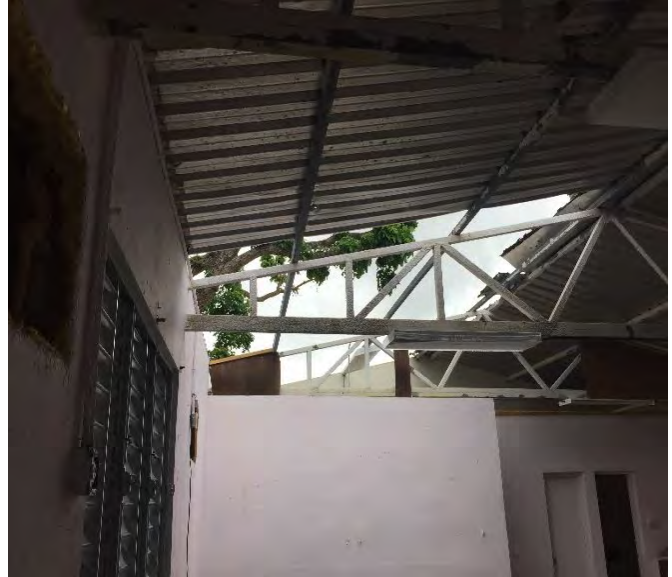
Part of classroom building roof blown off

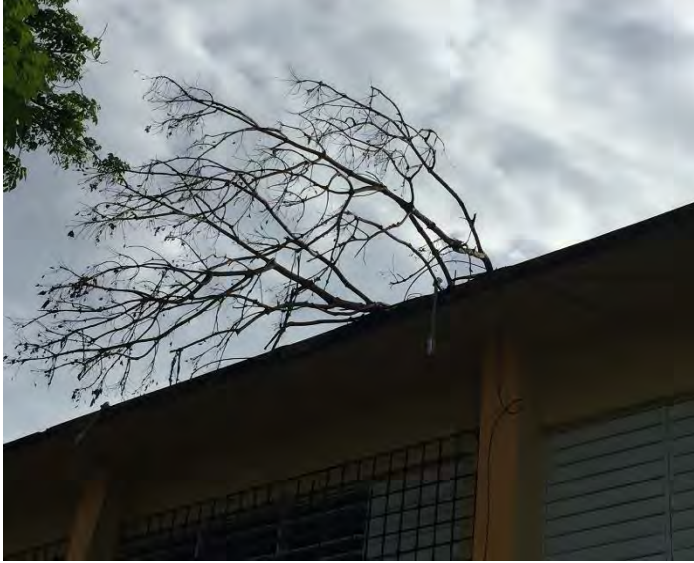
Debris on roof

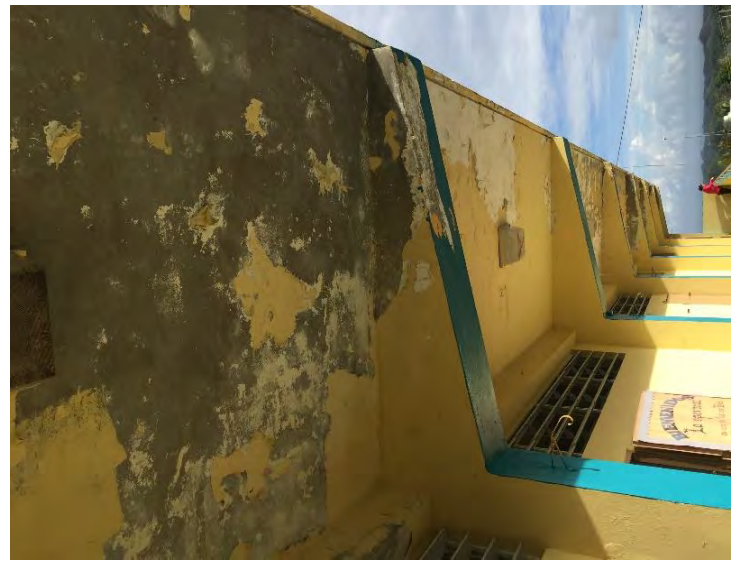
Paint flaking off from excessive moisture

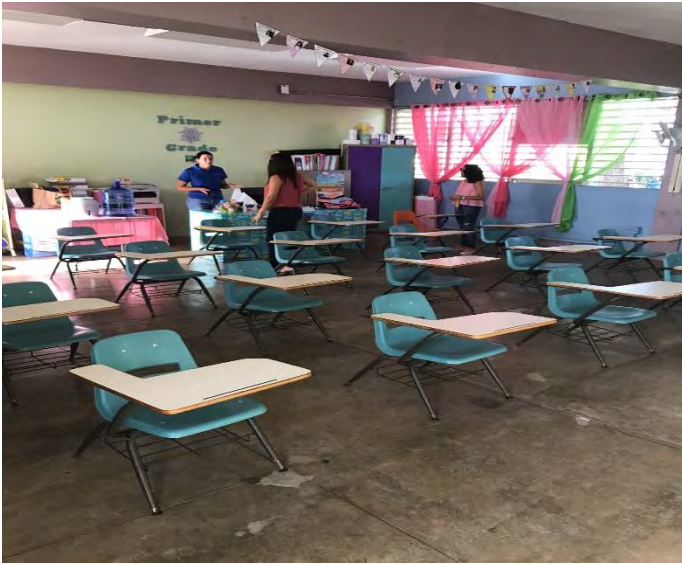
Paint peeling and ceiling cracking

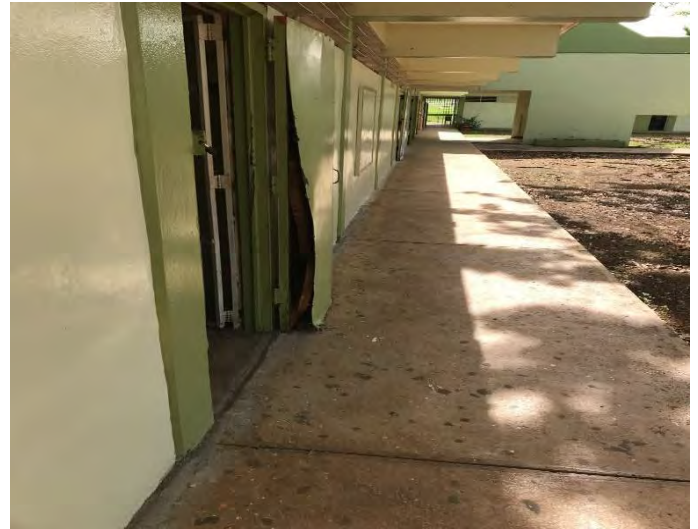
Damage to exterior door to classroom

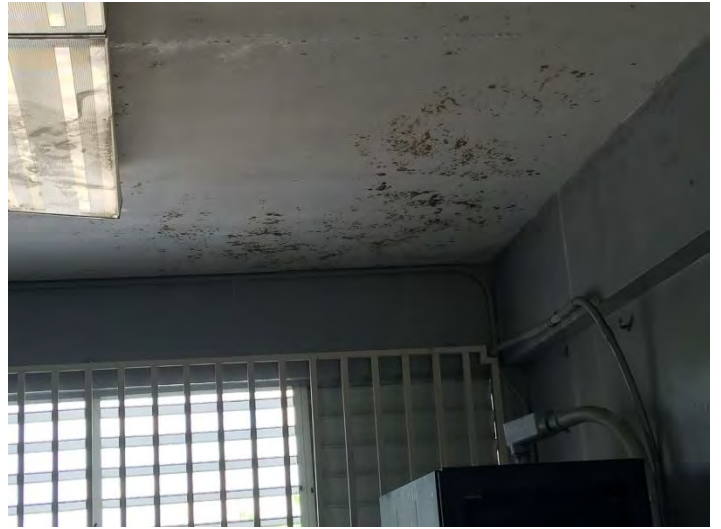
Cracks and mold on ceiling

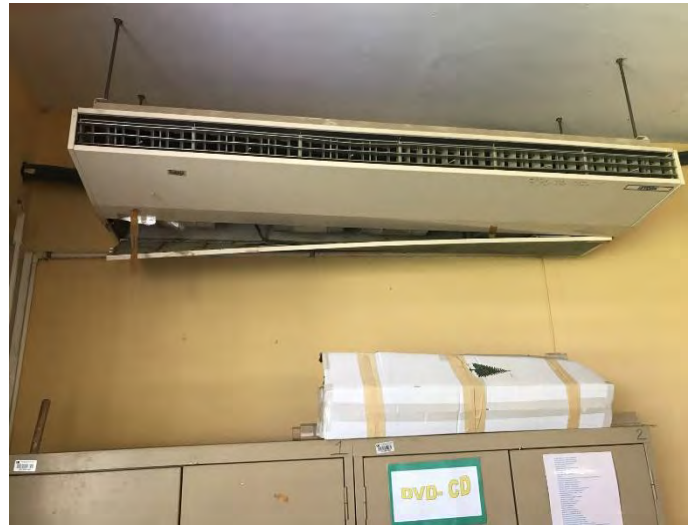
Damaged ventilator

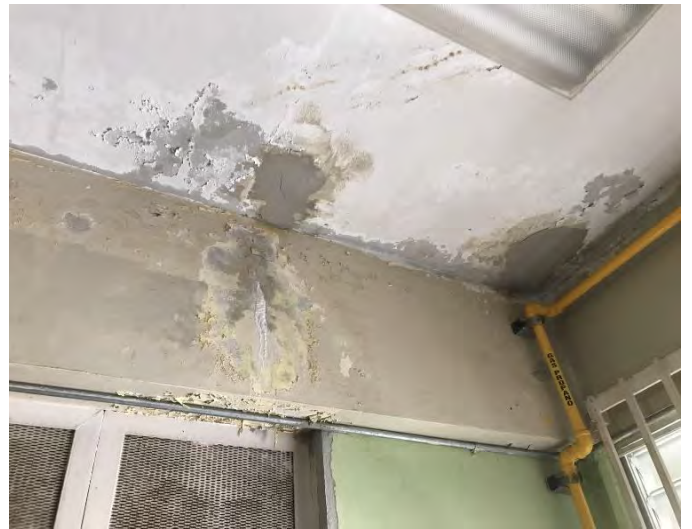
Ceiling in kitchen area damaged

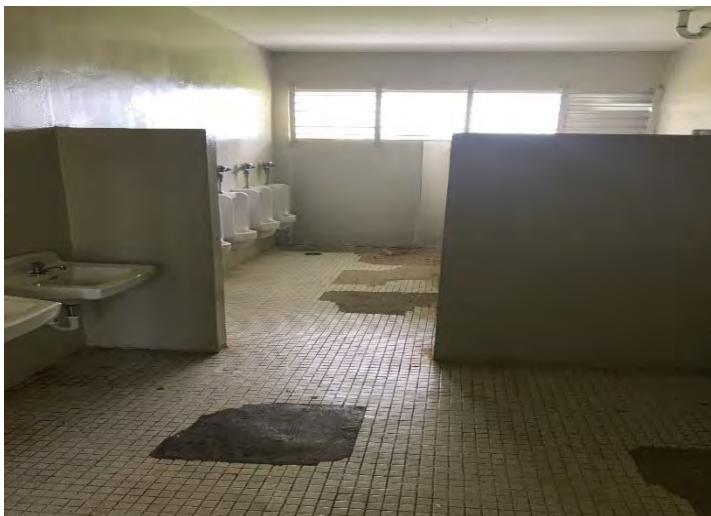
Broken bathroom floor tile
