PUERTO RICO SCHOOL FACILITIES ASSESSMENT

COUNCIL OF THE GREAT CITY SCHOOLS

NOVEMBER 11, 2017

Hurricane Maria Damage Assessment of School Facilities in Puerto Rico

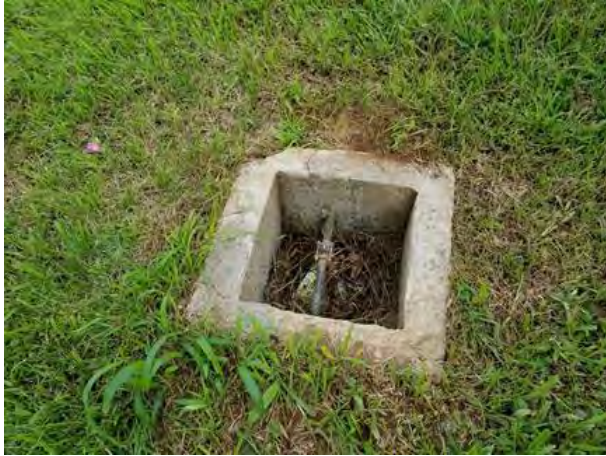
Exposed Gas Line

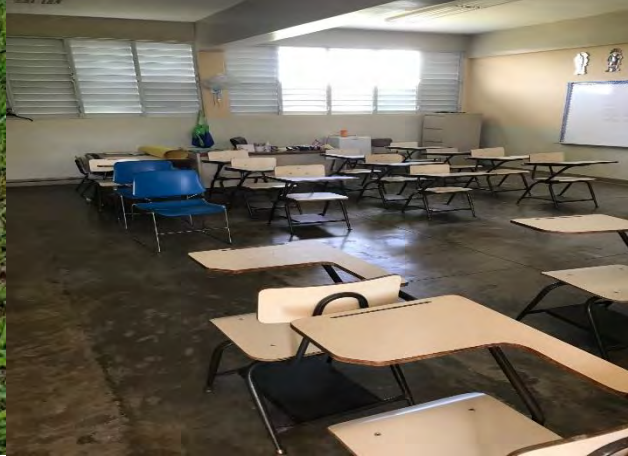
Classrooms clean and ready for instruction

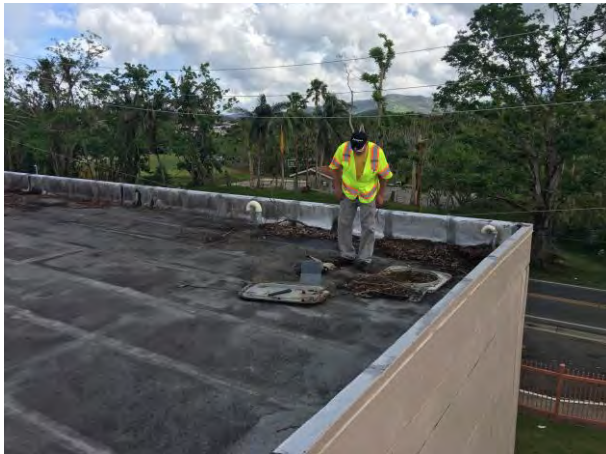
Roof Debris

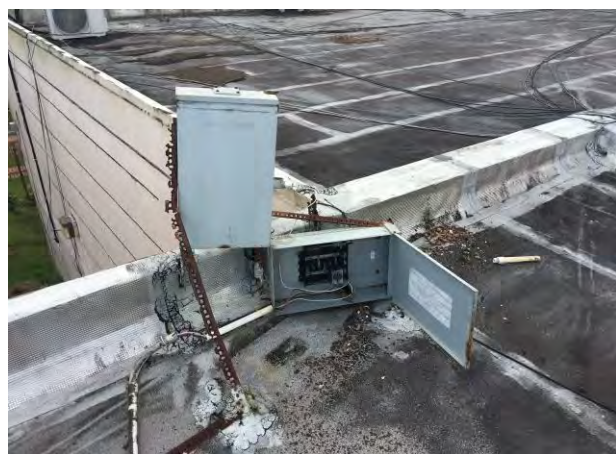
Clogged roof drains

AC equipment not secured to building								
Recommendations (Notes)								
Test water before using it to cook, prepare food and/or offer as drinking water								
Remove hanging debris from gym area and adjacent playfield. Have contractor secure all loose ends								
Have electrician disconnect and safe-off electrical panel on roof								
Specific Findings								
Storm Damage								
Structure	Elements	Specifics	None	Minimal	Moderate	Severe	Replace	Comments
	Foundation			x				
	Walls, exterior			x				
	Roof					x		Remove debris from rain downspouts
		Membrane						
		Flashing					x	GYM
		Penetration				x		Patch
		Gutters				x		Clean debris and snake downspouts
		Fascia			x			
	Windows, exterior			x				Screens with Storm Louvers
		Treatments		x

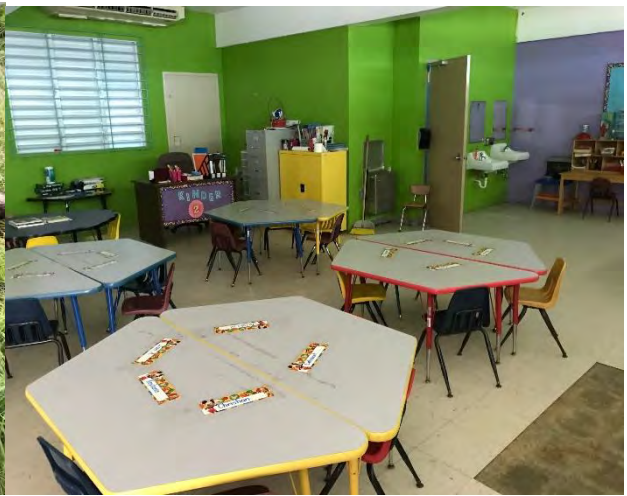
Classrooms prepped for instruction

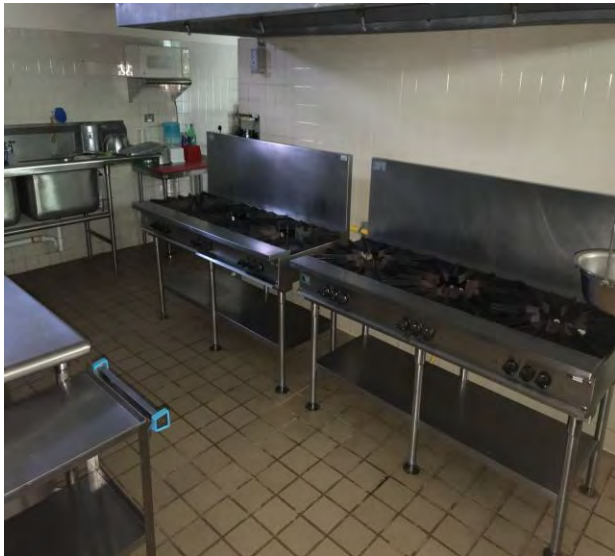
Kitchen clean & ready for food prep

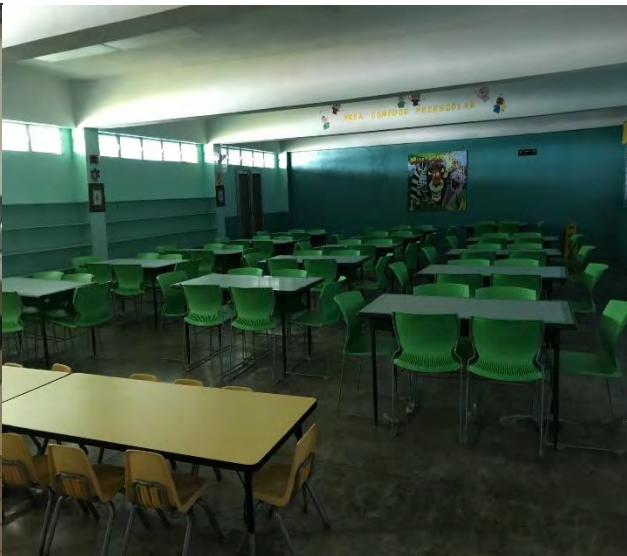
Dining area clean & ready for use

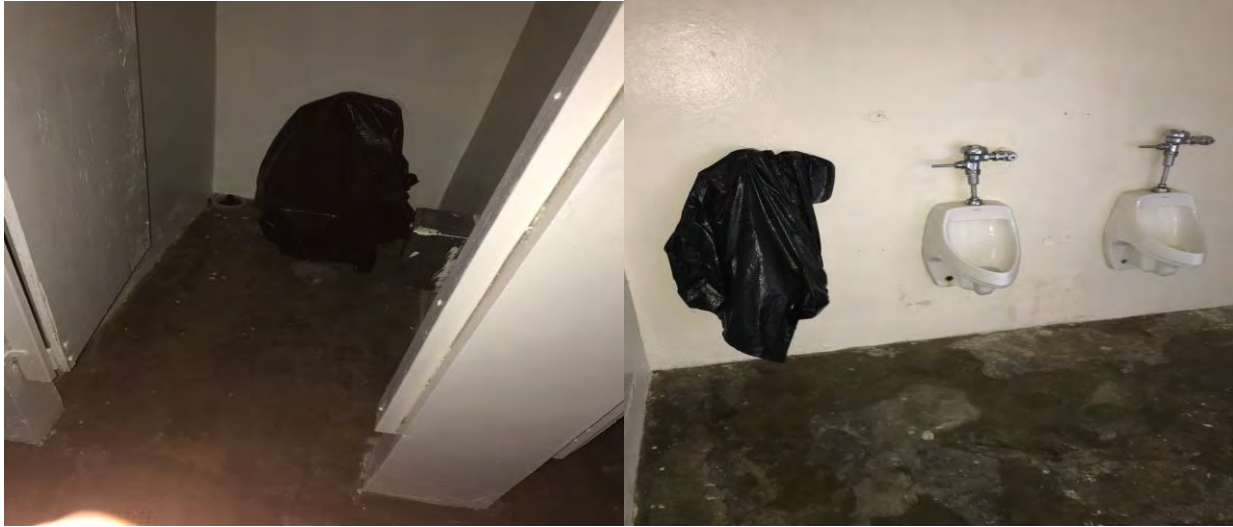
- Water coming through light fixtures on second floor
- Generally poor general maintenance
- Many water fountains do not work
- Most bathroom fixtures on both floors do not function.
- Fire alarms smashed or missing
- Corridor light fixtures rusted out
- Fire hoses missing
- Gym roof damaged

Repair/replace 1st floor toilet in girl's restroom & urinal in 1st floor boy's restroom

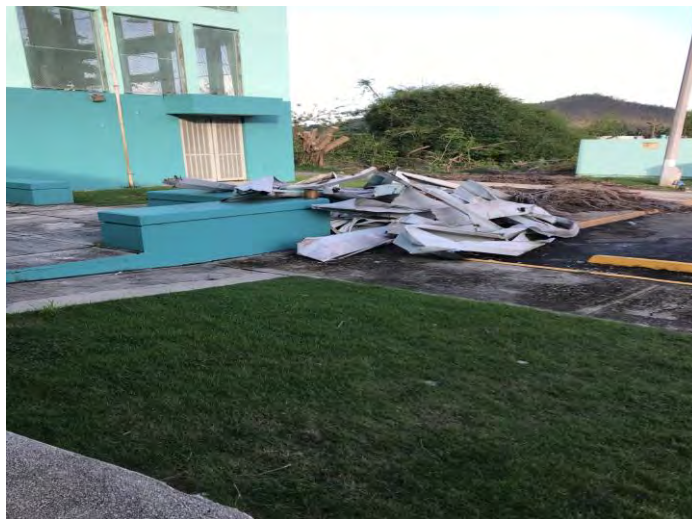
Debris in parking area outside of gym

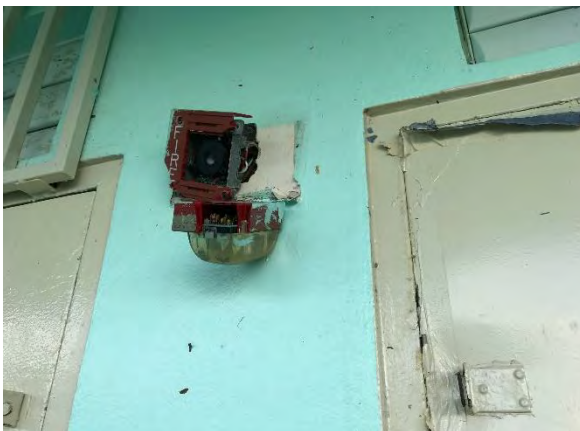
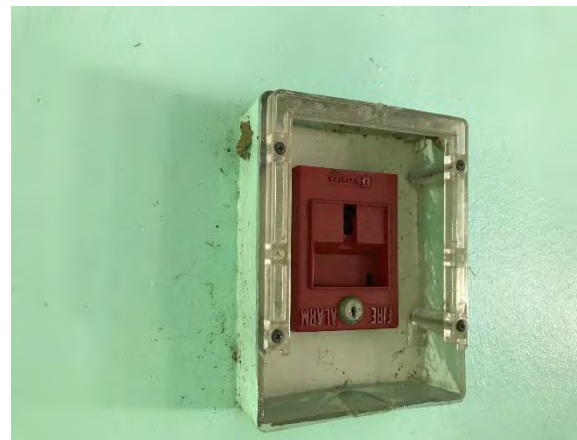
Damaged or missing fire alarms

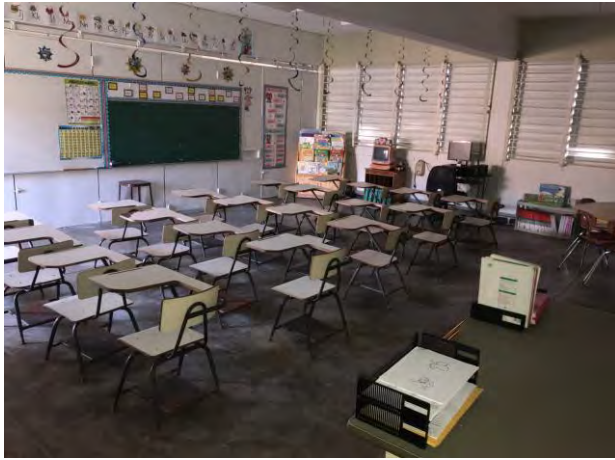
Classrooms setup & prepped for instruction

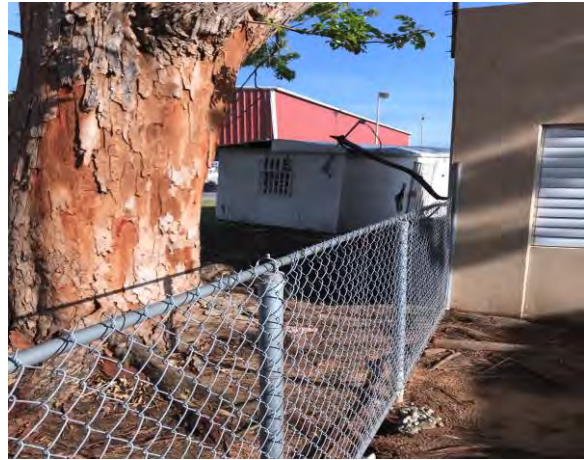
- Moderate issues with roof membrane
- 1 room (home economics) with black glue. Caution when addressing this area. (Do not grind out)
- Remove temporary building that was flooded.
- No power.
- Has water
- Classrooms are clean and ready to receive students
- School had 5 feet of water in certain areas. All have been cleaned.
- Playground and baseball diamond badly flooded but adequately fenced off
- One-bathroom door has been removed
- Water in corridor lights
- Toilets and sinks in first floor bathrooms work; some on second floor do not
- Needs new roof but currently functional
- General debris on the grounds

Remove damaged mobile unit from site

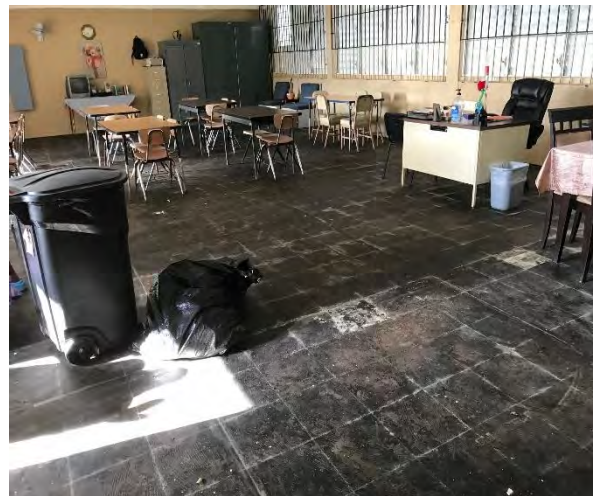
Flooring in home economics room

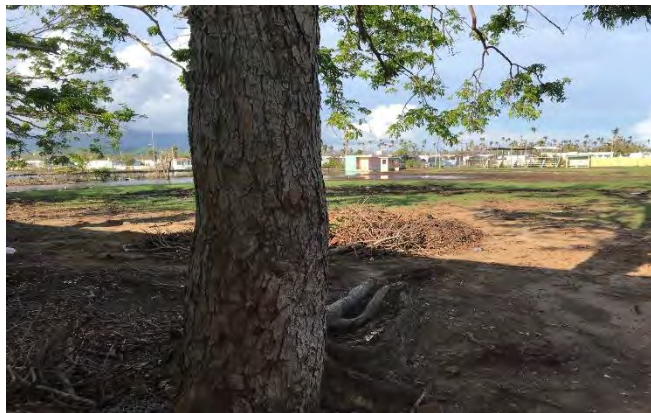
Flooded but fenced off ball park

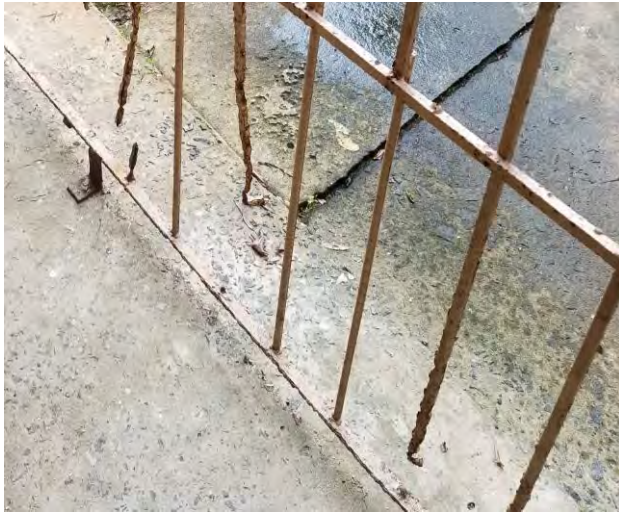
- Complaint about a structural issue. Investigated area in question and no immediate threat, only surface cracks
- Roof has debris
- Cover resell with concrete hole over septic tank (minor hole)
- Back of perimeter fence fallen over to street side. Needs to be replaced.
- Security gate in the main hallway has been rusted through and presents a safety issue (2 different areas)
- Water fountain on first floor corridor does not work
- Computer lab has not been cleaned and checked for damage due to evidence of ceiling leakage
- Classrooms generally clean and ready to receive students
- Kitchen is not usable, but school is bringing in meals
- Air-conditioning duct blown off roof; back fencing down
- No commercial power
- Dangling security cameras
- Minor debris on playground
- Downed security fence
- Vegetation growing on roof

Security Gate should be repaired for safety

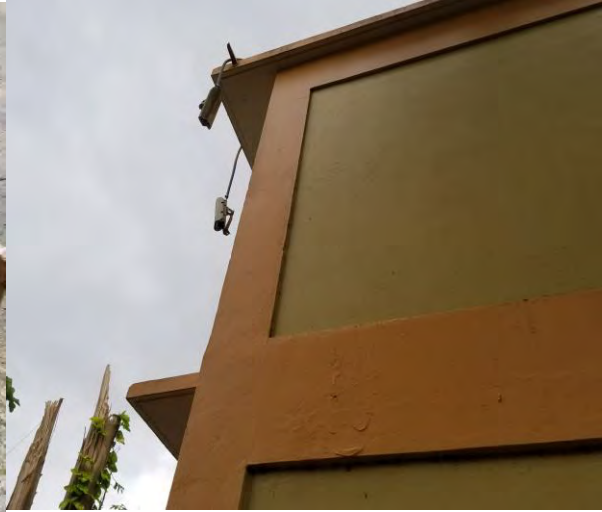
Security cameras hanging

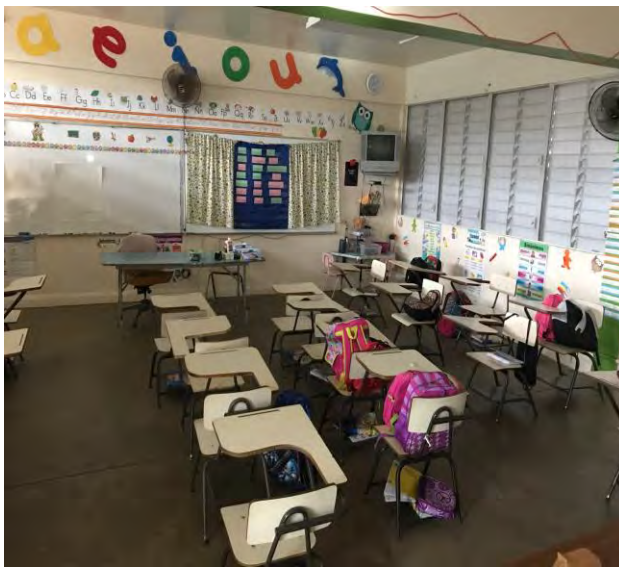
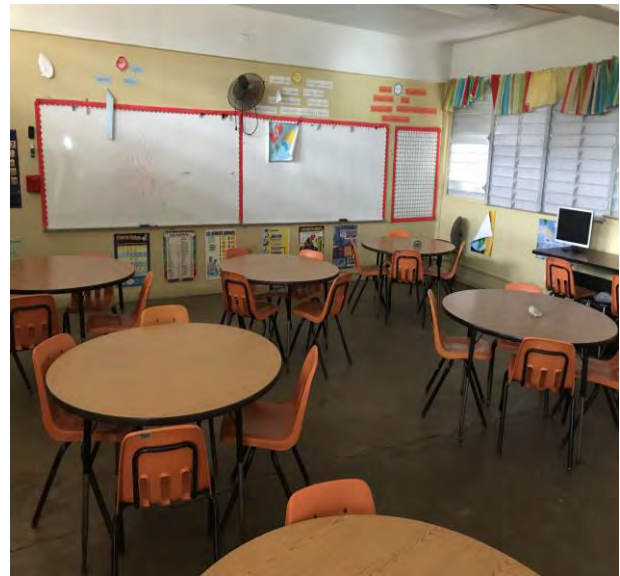
Classrooms setup & prepped for instruction

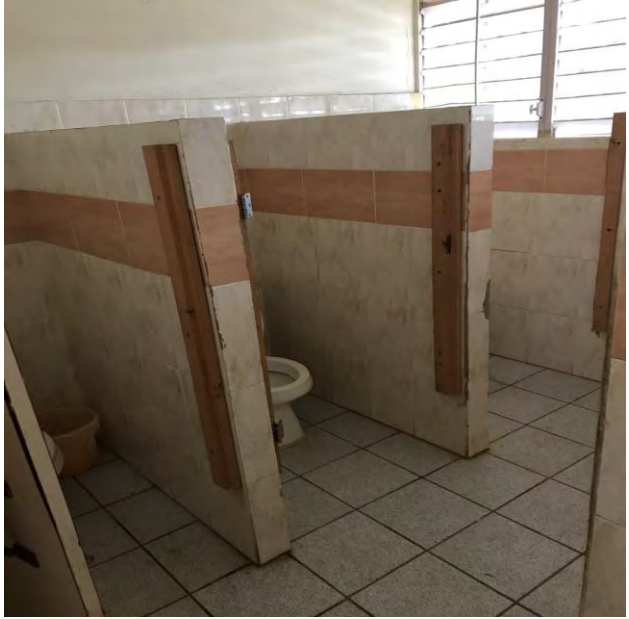
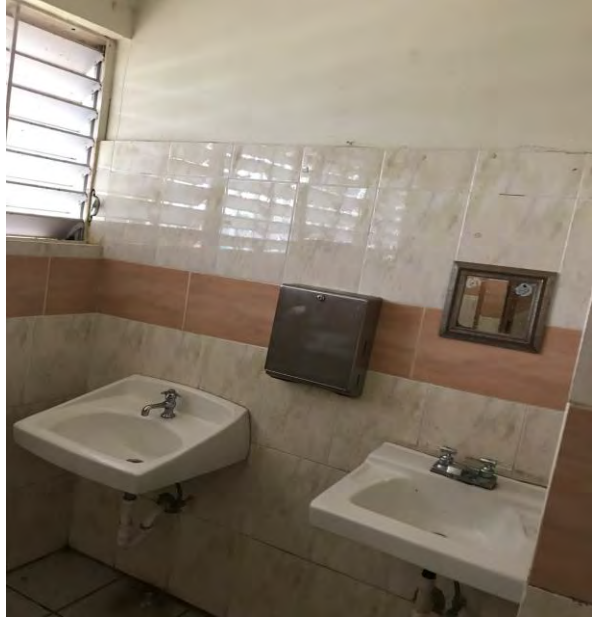
Bathrooms are operable, but need repairs to finishes

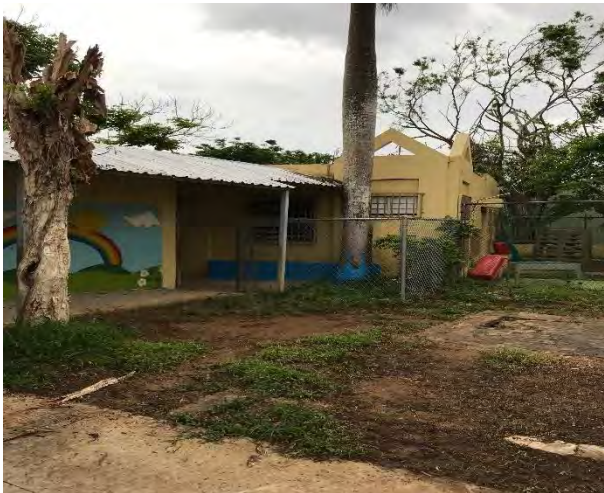
Debris on roof

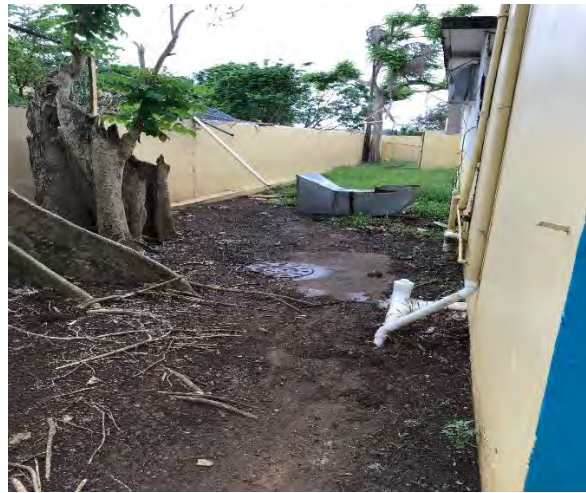
Duct blown off roof

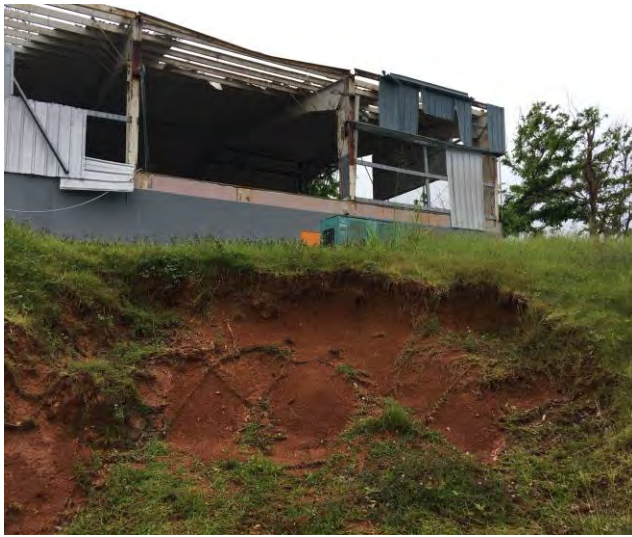
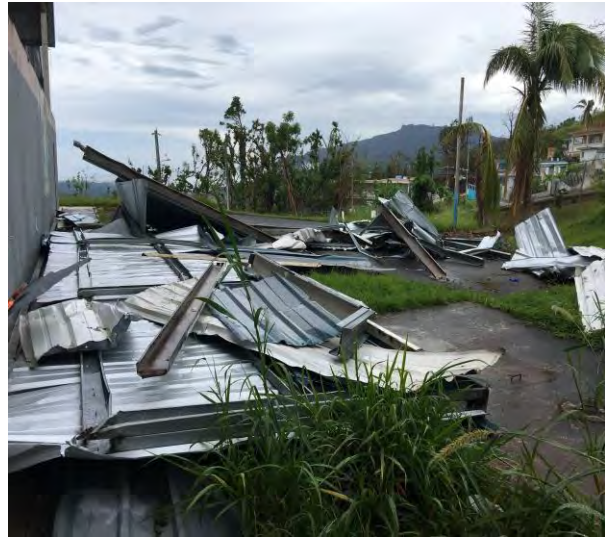
- Substantial roof leaks / wet ceiling tile
- Musty smell / high potential for mold on wet ceiling tiles
- Kitchen in very good shape
- No commercial power
- Plumbing works
- Exterior walls neglected / paint peeling
- Gym roof and sides destroyed. Floor still in remarkably good shape.
- Spalling exterior plaster at various locations.
- Loose wires throughout
- No power but water in school
- Water pouring off roof onto electrical panel
- Water fountain at entrance out of order
- Play-ground is functional
- Bathroom in pre-K room works
- Roof needs to be recoated
- Cistern on roof is uncovered
- Structural cracks in some classroom ceilings
- Hole in library ceiling and black mold in library
- Lawn uncut
- Couldn't get into many classrooms
- Bathrooms were generally functional

Damaged gym

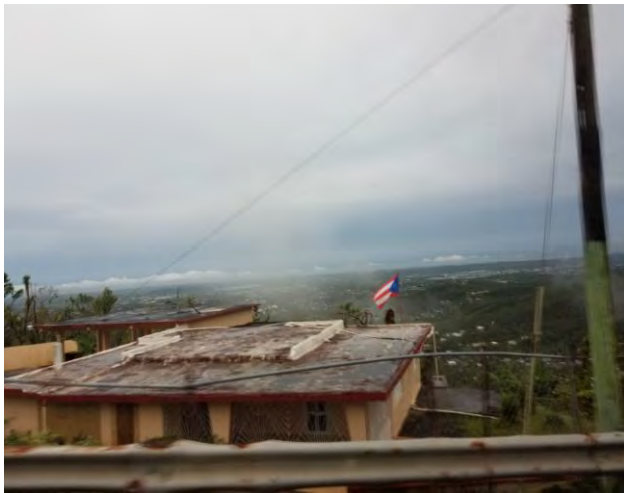
Damaged roof and exterior

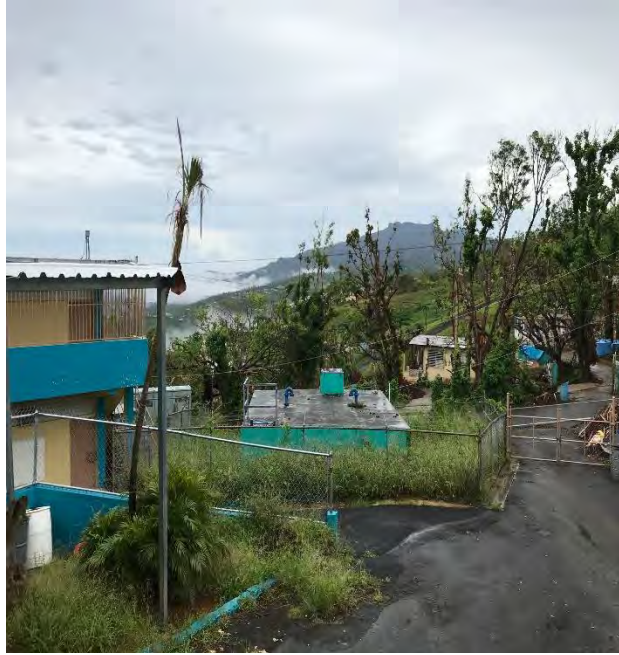
Unkempt grounds

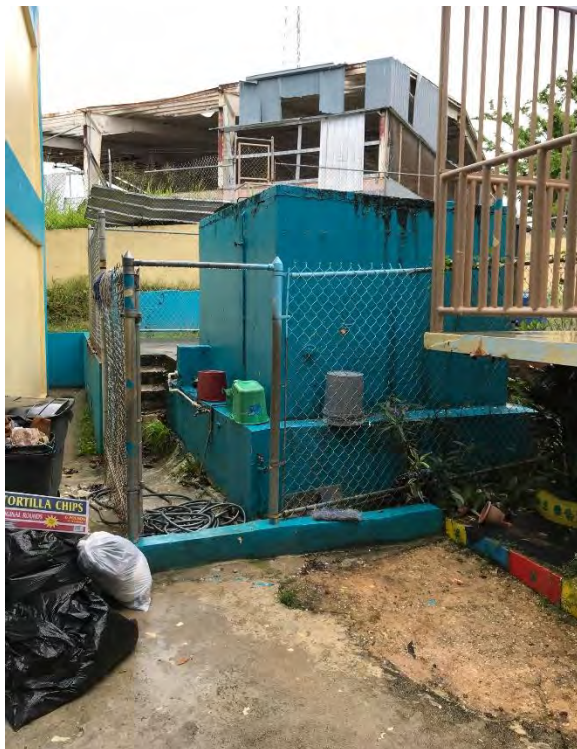
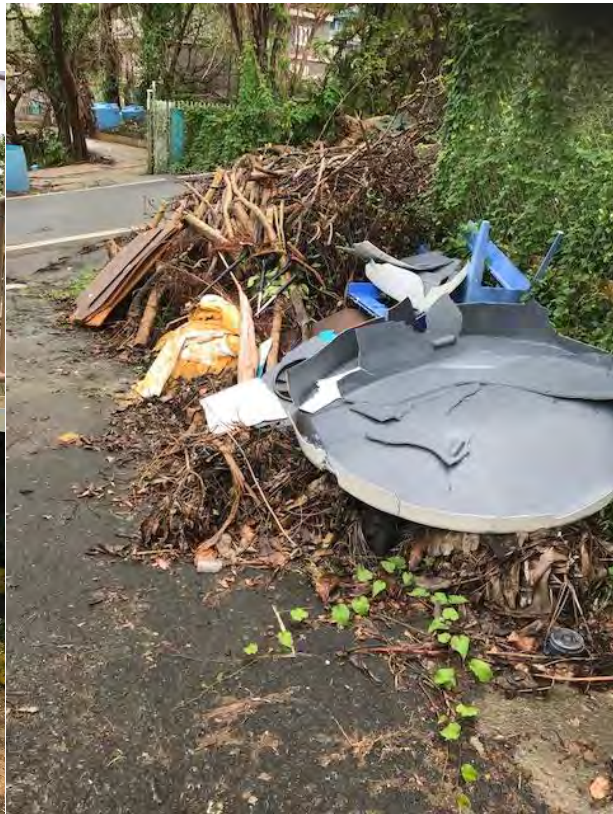
Debris in front of building

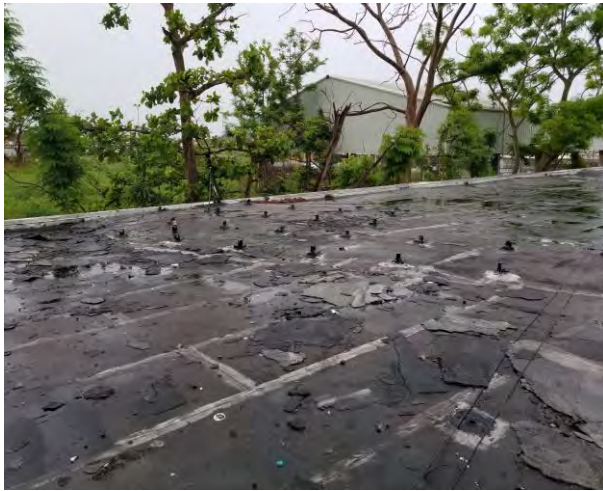
- Standing water in courtyard
- Part of second floor roof missing

Roof materials blown from 2nd floor roofs

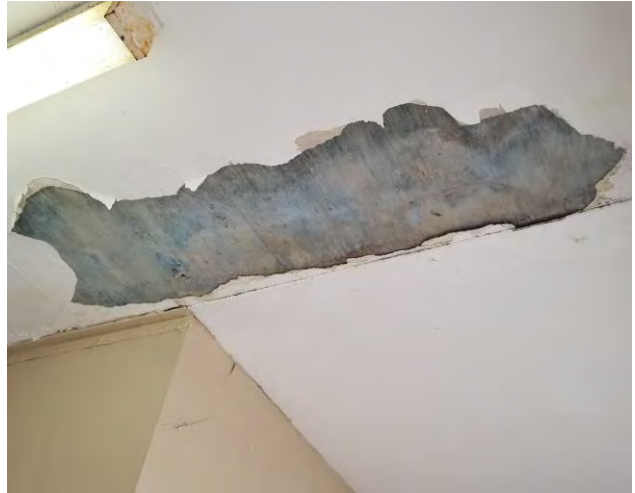
Plaster ceilings falling from hallways

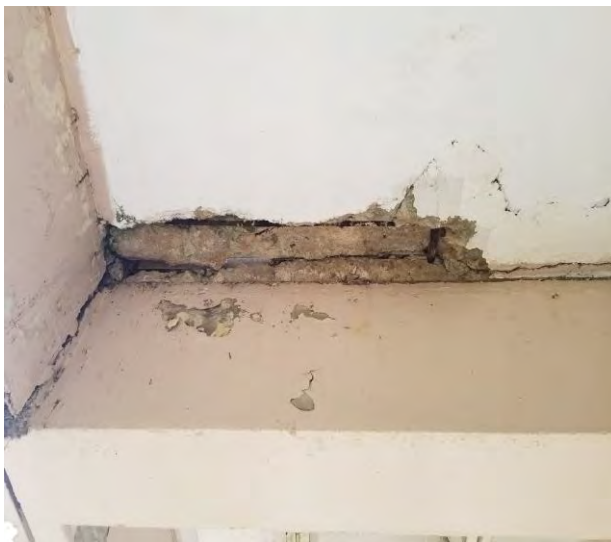
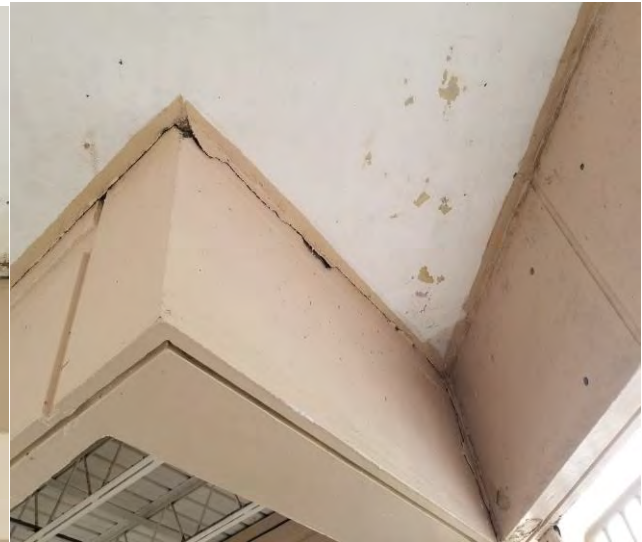
Structural erosion issues

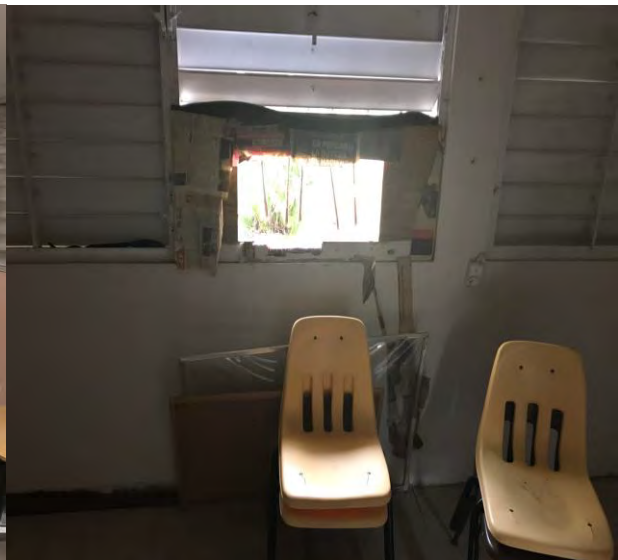
Repair damaged window in 2nd floor classroom

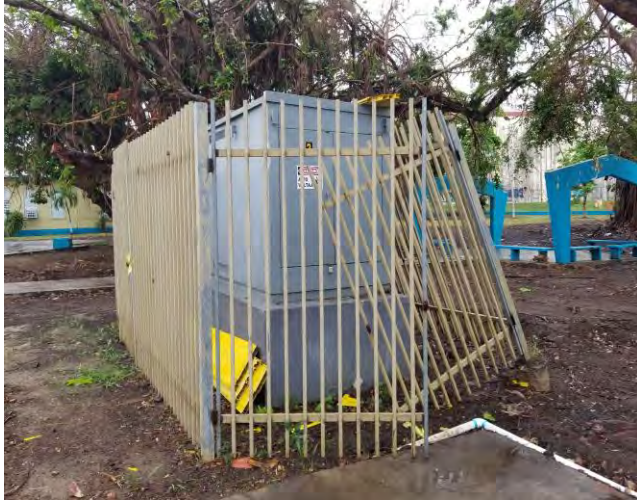
Transformer sub-unit (power)

Replace main service electrical switchgear

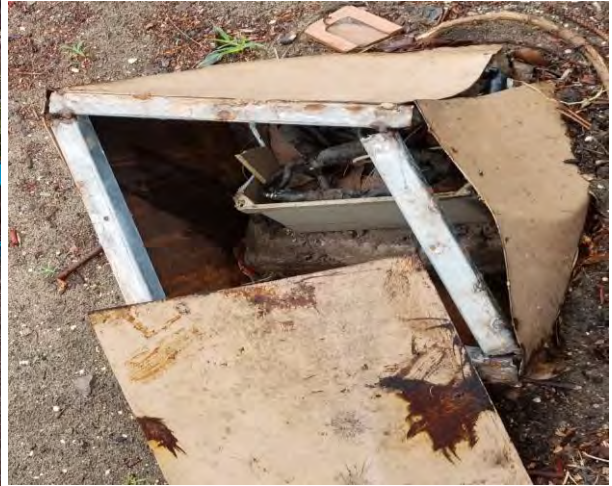
Live wires exposed on grounds

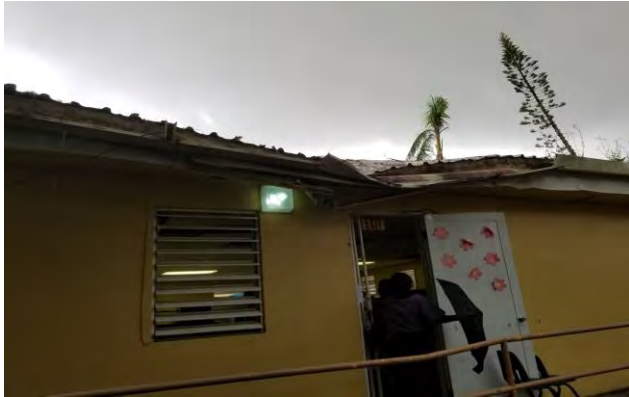
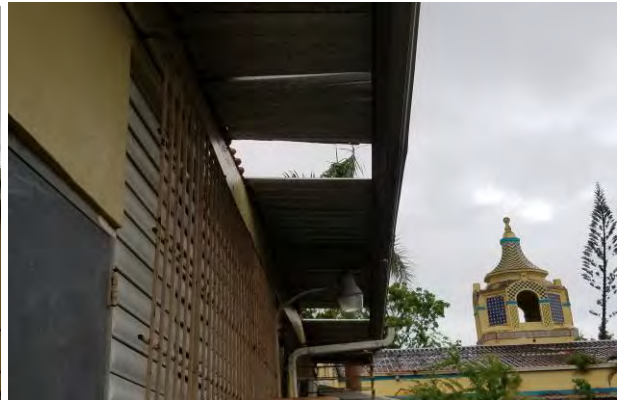
Several buildings with roof damage

Replace roofs on all buildings

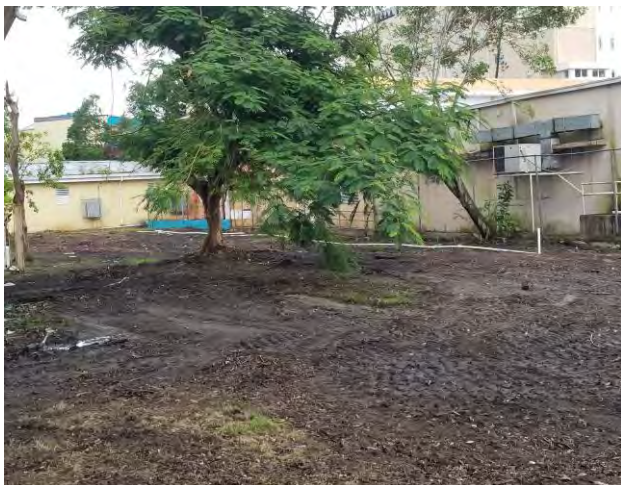
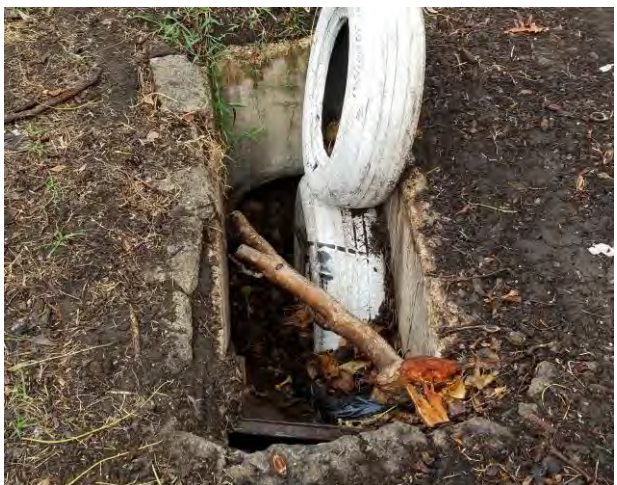
Major plumbing and drainage issue—exposed septic tank with tires

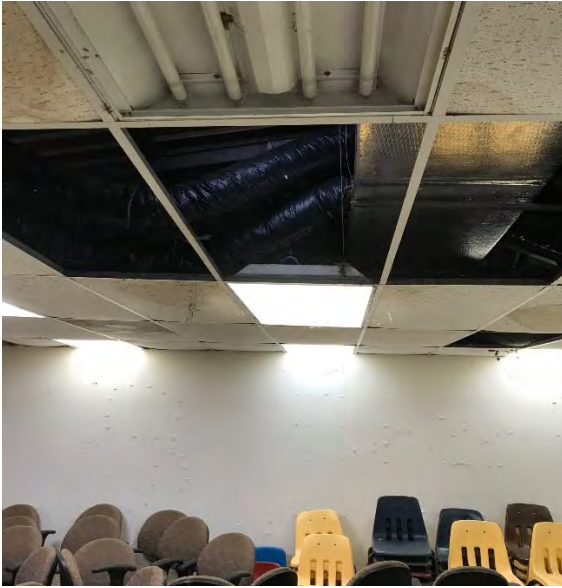
Damaged ceilings

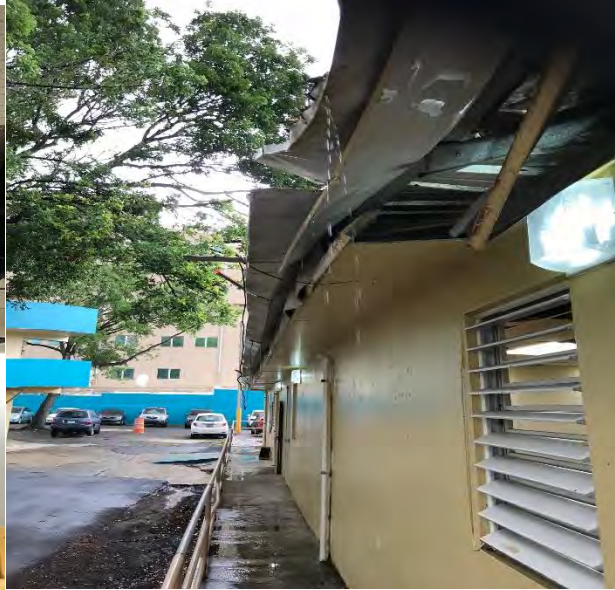
Damaged gutters

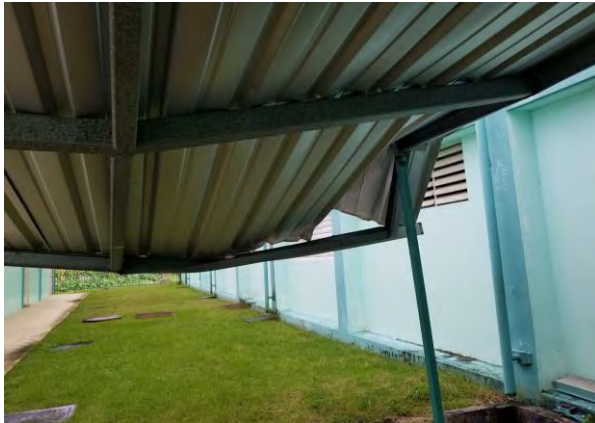
- Canopy damage – Outdoor back corridor
- T-Building – 10” gap from concrete ramp
- Minor corrosion / algae growth in the back-downstairs hallway corridor

Metal canopy damaged

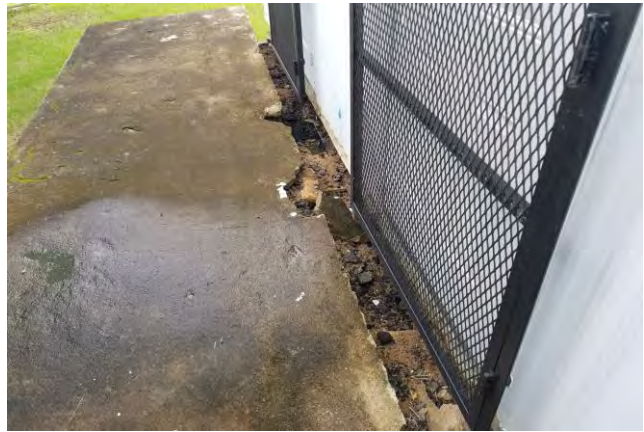
Temporary SPED building separation from ramp

Replace special education unit onto platform

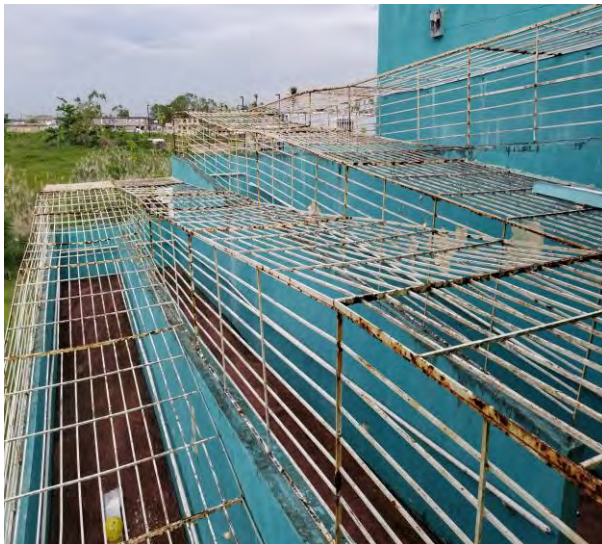
- Fence enclosing kindergarten playground has bent and missing sections
- ADA ramp is in poor condition, and the cage enclosing it is rusted and misshapen.

Caged walkway

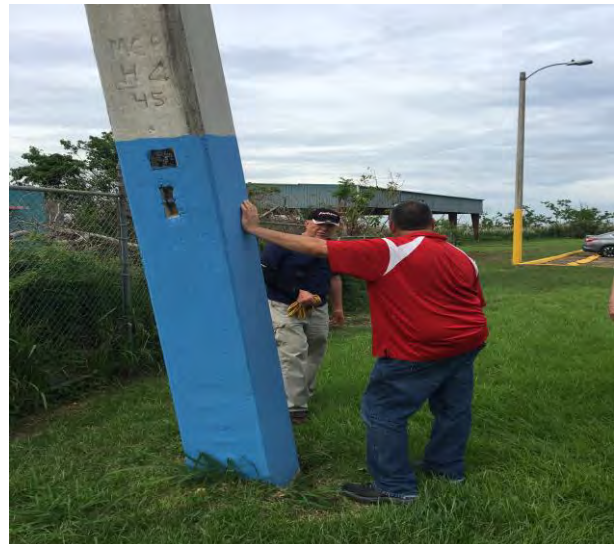
Leaning tsunami warning tower

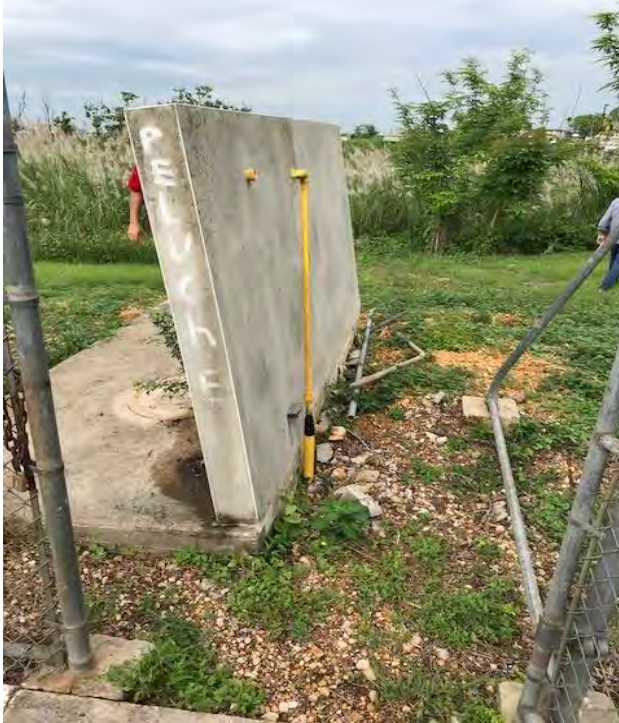
- Propane tanks removed and pad needs rehab work
- Bleachers need to repair safety rails and backboards need rims.
- Some paint peeling
- No power but the school has water

Propane tank gone

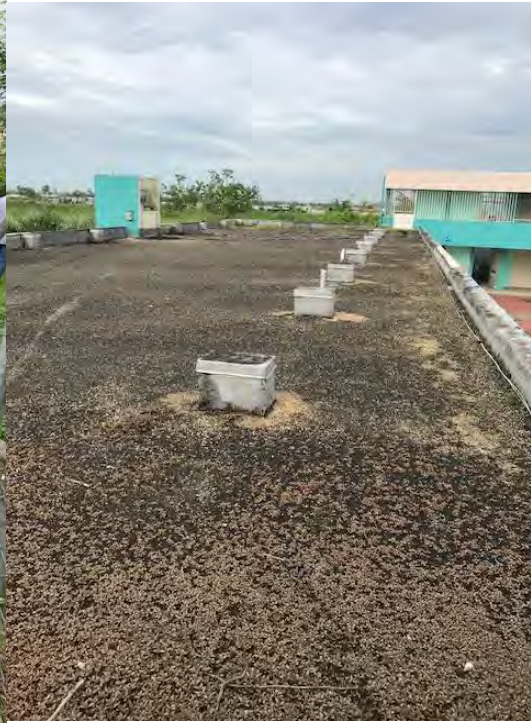
Functional roof

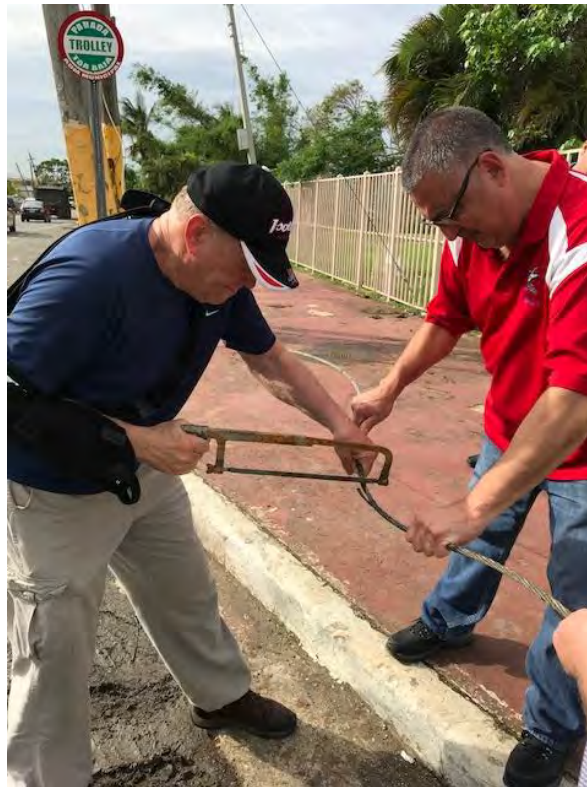
Cutting ground wire at entrance

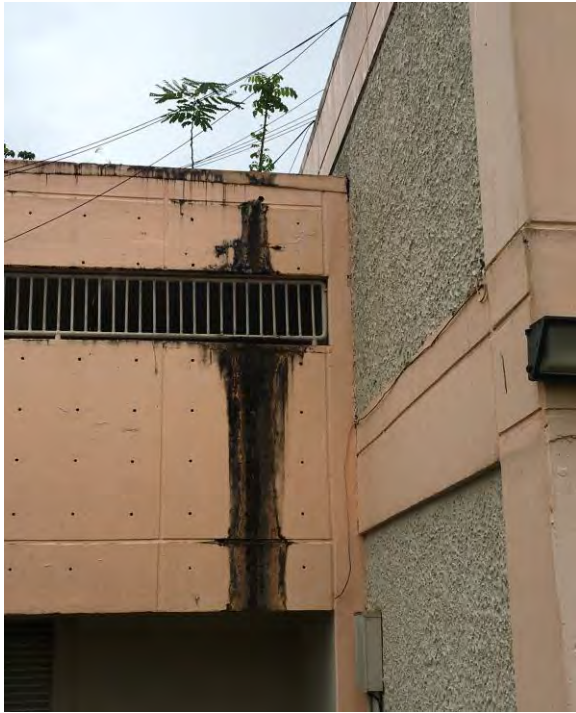
Clear roof of dangling wires

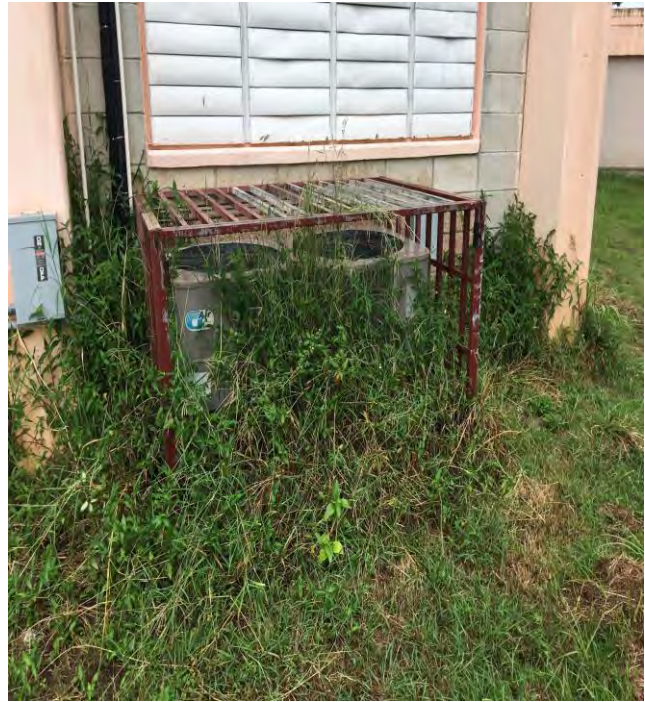
Landscaping required

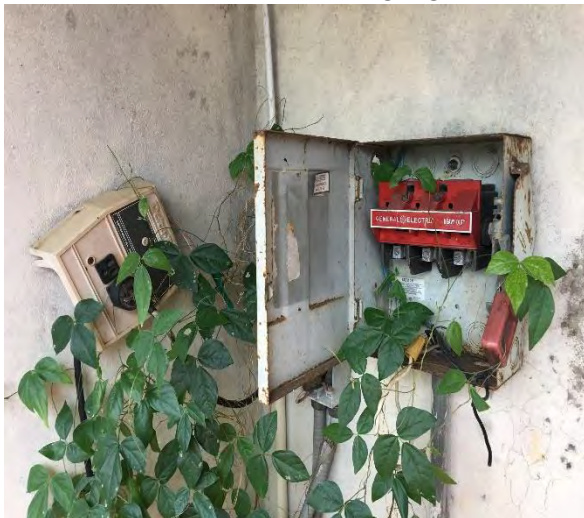
Electrical panel exposed

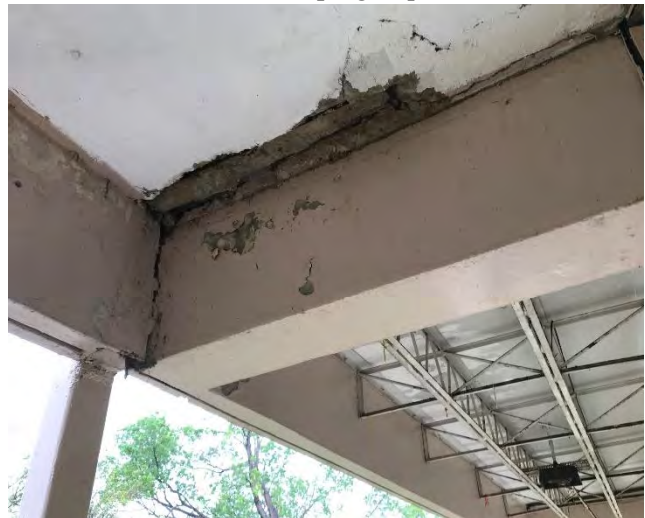
Disintegrating concrete from moisture

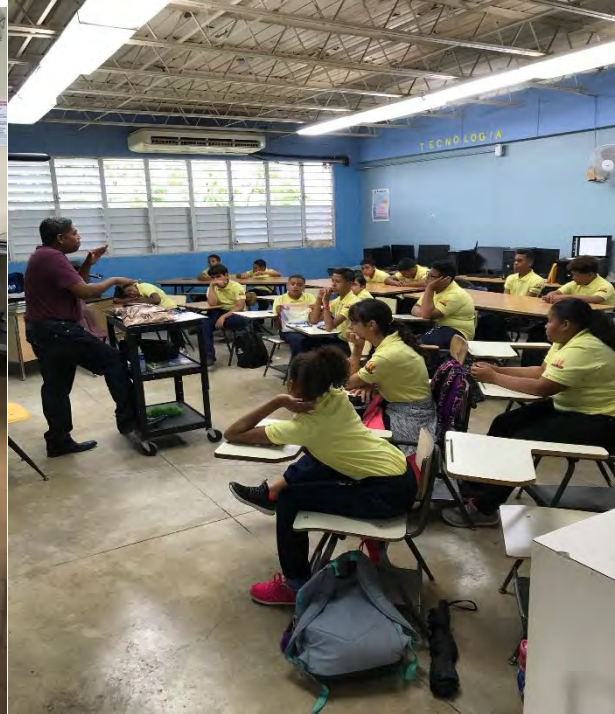
Classes in session—no materials

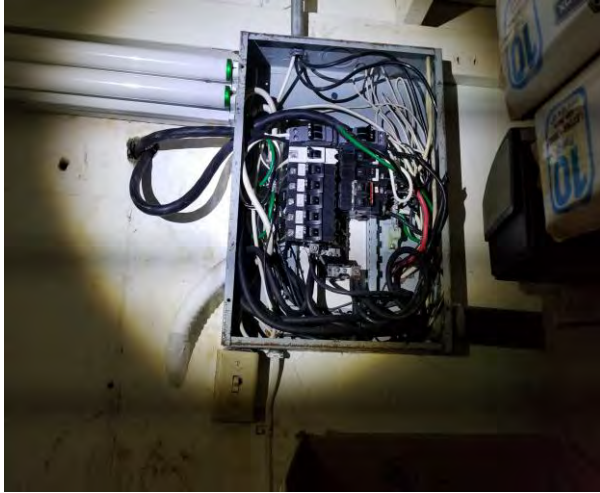
Open electrical panel

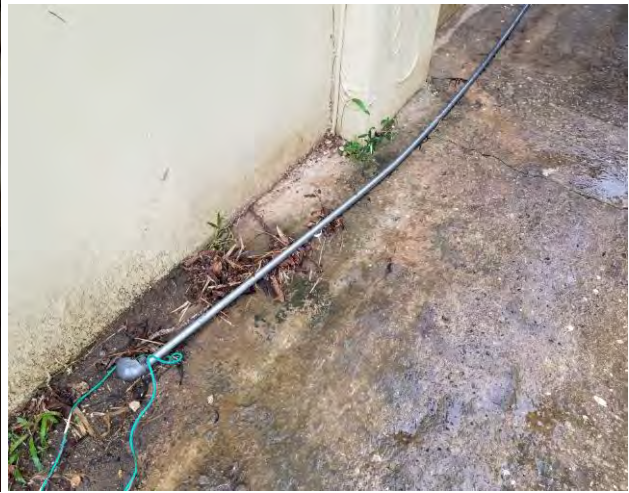
Live power line between buildings

Tie off loose electrical wires

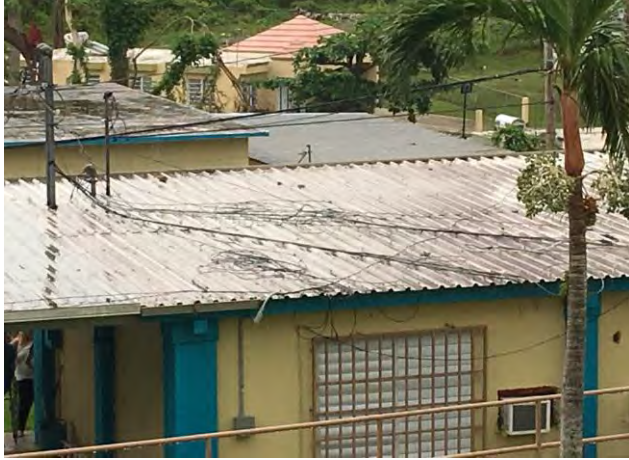
Clear wiring from roof

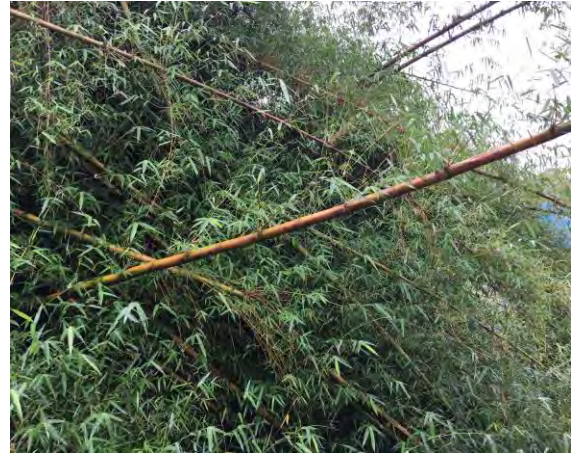
Remove tree limb from building

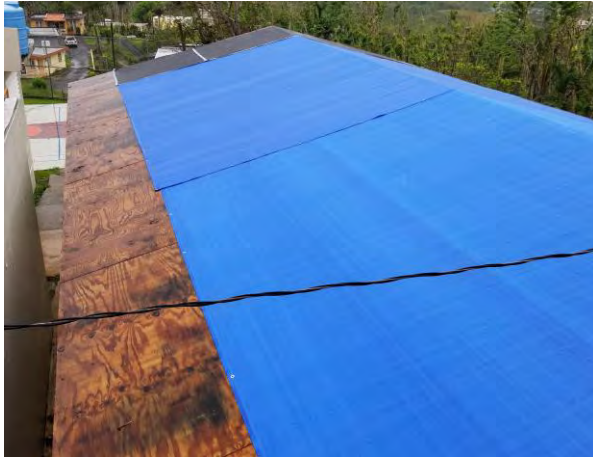
Blue tarps need replacement roofs

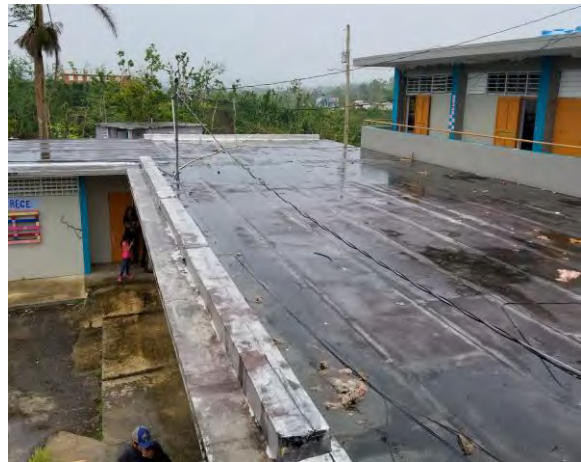
Roofs design/construction causes water to pond, entire roof design will need to be re-evaluated

Standing water on roof

Remove and replace failed roofing system, build up areas so that they have a positive drain to edge of building, cut scuppers in roof top curbs to allow rain water to freely flow

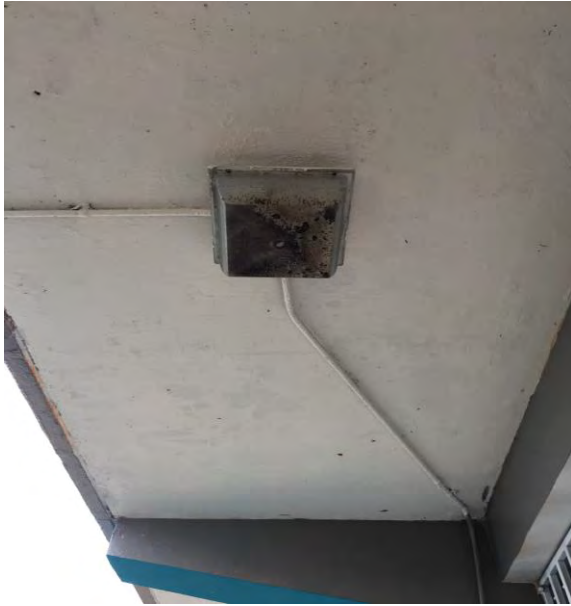
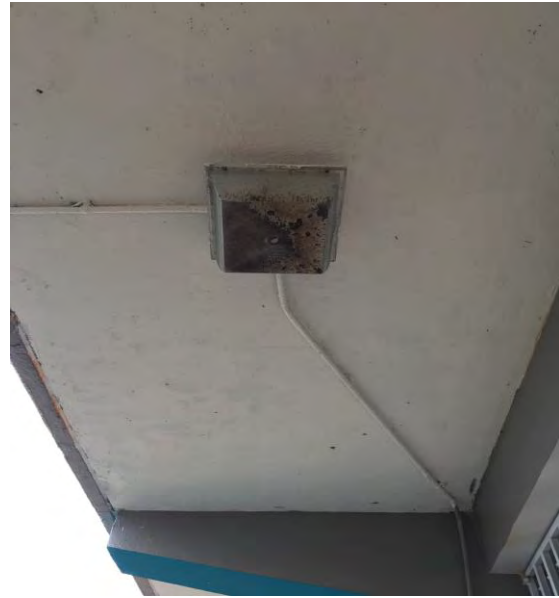
Light fixtures need replacement
