PUERTO RICO SCHOOL FACILITIES ASSESSMENT

COUNCIL OF THE GREAT CITY SCHOOLS

NOVEMBER 11, 2017

Hurricane Maria Damage Assessment of School Facilities in Puerto Rico

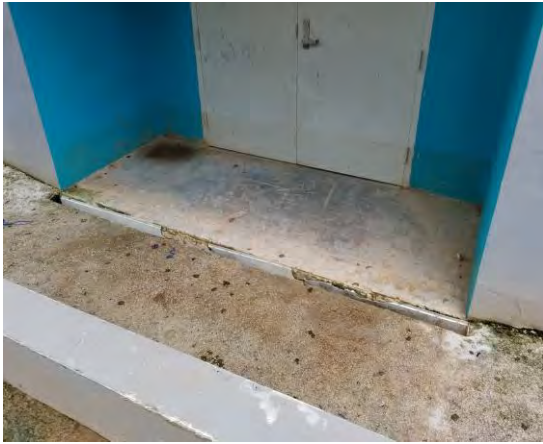
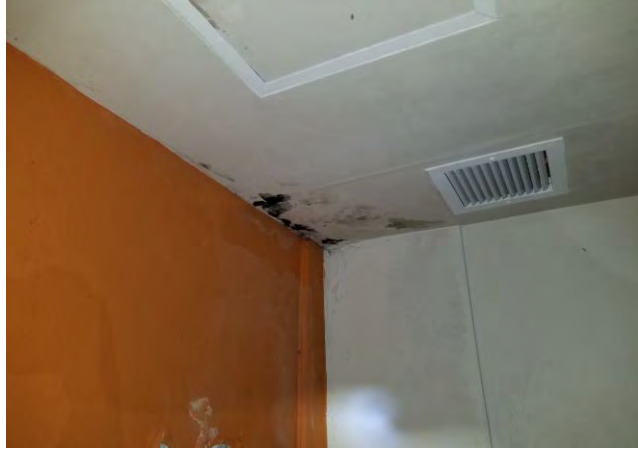
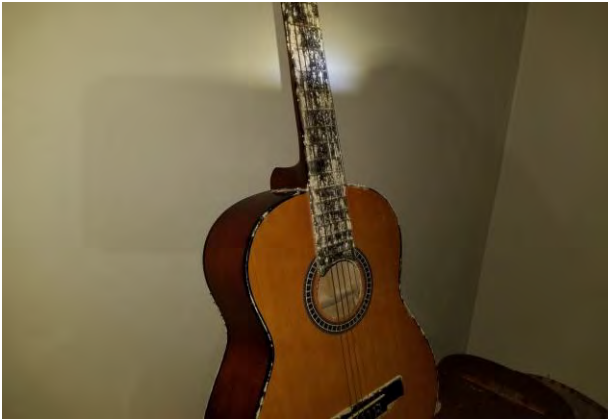
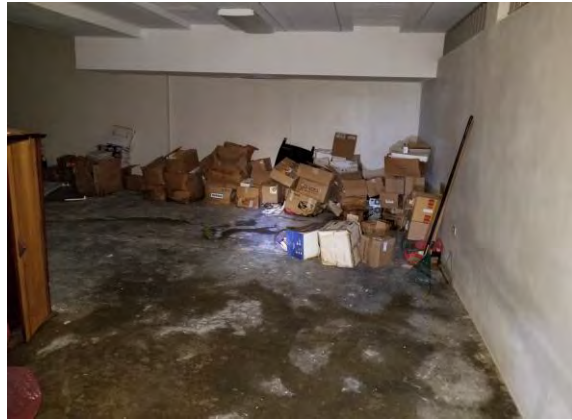
- First or lower level is plagued with mold issues.
- Back side of the building is up against a hillside with an inadequate retaining wall that may be compromised. Wall should have been built higher. Also large tree is probably cracking the retaining wall.

1st floor and basement flooding - mold

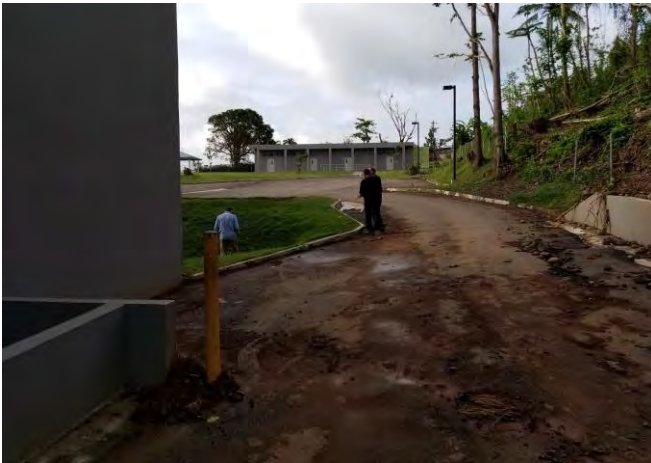
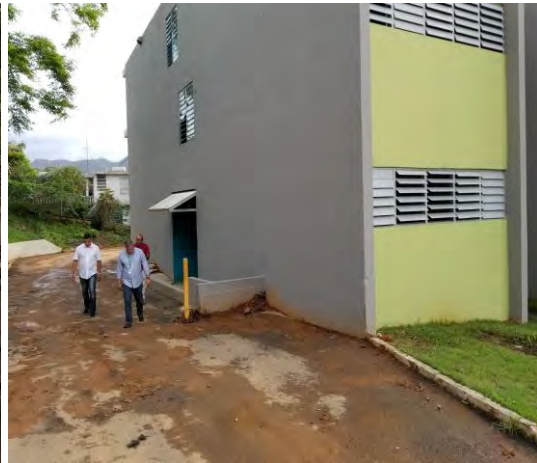
- Outdoor gym has damaged siding and gates need to be re-attached.
- This school is a renovated nightmare. The drainage system in and around the building is a hard to believe. The building was seemingly designed and built to channel water into the building, not away from it. (Have video of water flow.)

Building foundation and architectural design flaw - major drainage issues
Water flows into building due to inadequate drainage

Specific Findings								
Faulty drainage system in place - immediate mold remediation is required throughout the school. Proper drainage must be addressed and resolved and retaining walls built with drainage design and structural-design issues in mind along with access concerns.								
Storm Damage								
Structure	Elements	Specifics	None	Minimal	Moderate	Severe	Replace	Comments
	Foundation			x				
	Walls, exterior					x		
	Roof					x		Theater
		Membrane				x		theater
		Flashing			x

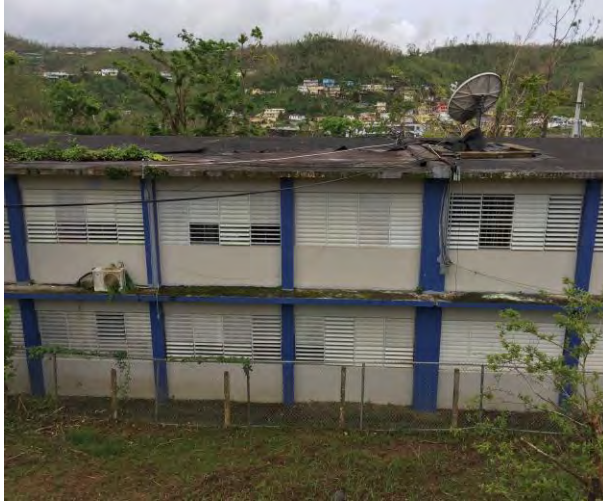
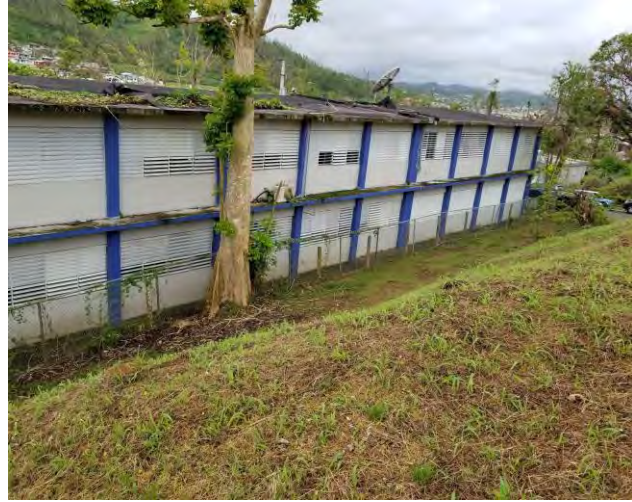
Roof debris needs to be removed

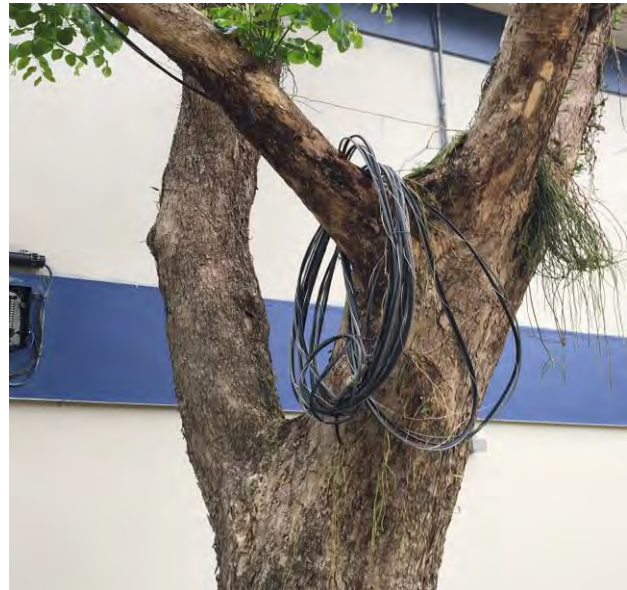
Electrical panel open on side of the building and wires on the trees

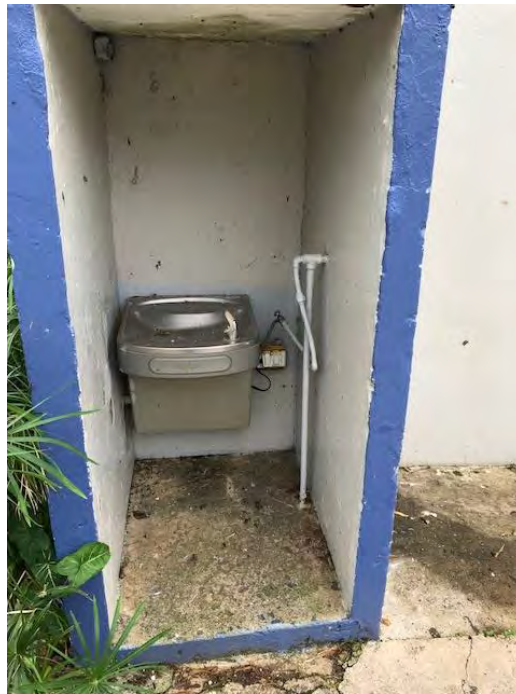
Water fountain out-of-order

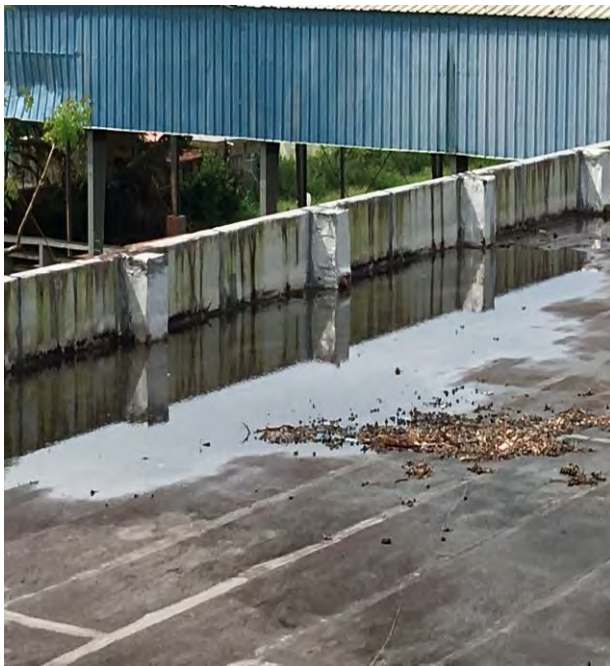
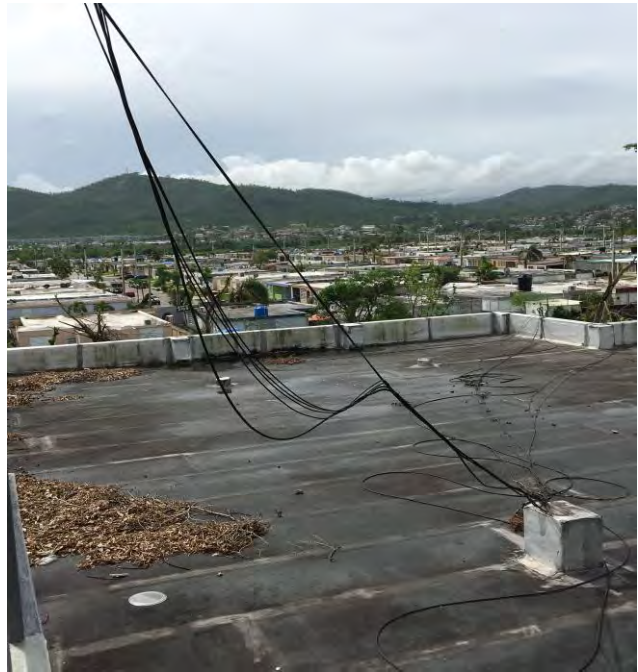
Clean roof and clear drain lines - remove standing water

Clean drains on roof to prevent pooling and leakage

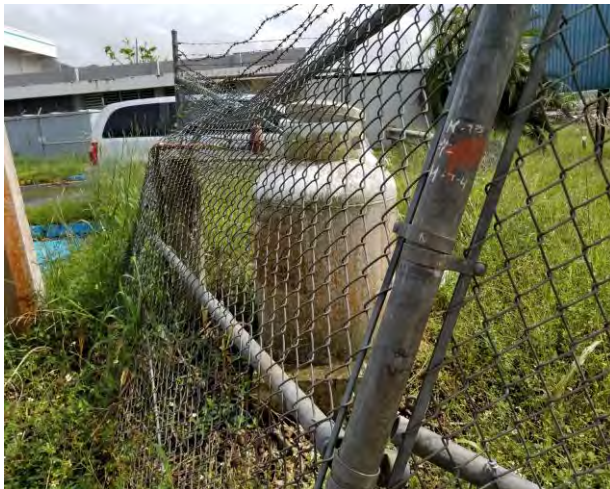
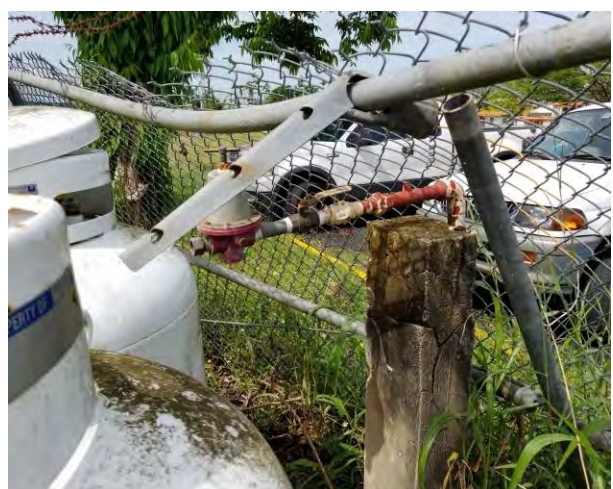
Gas line needs to be replaced - safety issue

Have gas company replace gas pipeline. Fence leaning on the pipe.

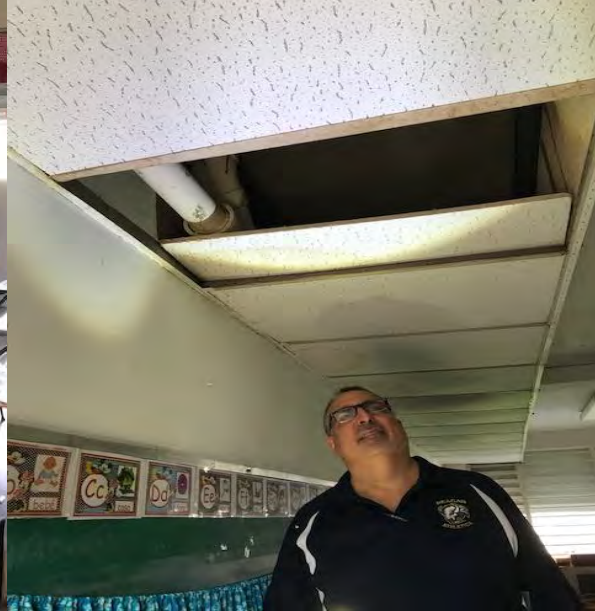
Ceiling staining in SPED room from above bathroom sewage

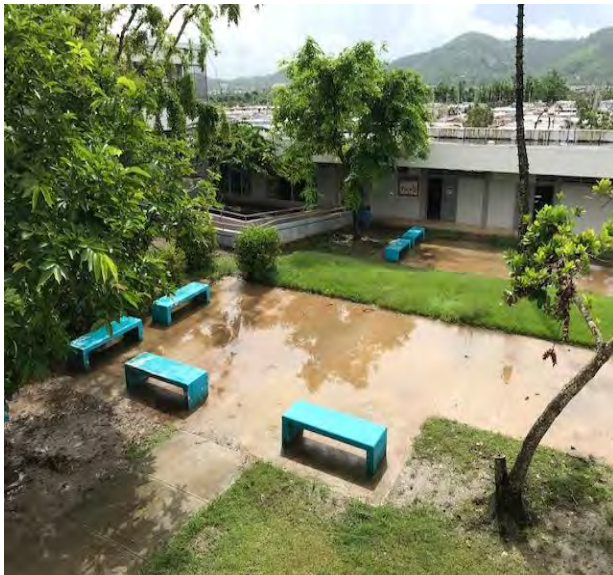
Courtyard and standing water

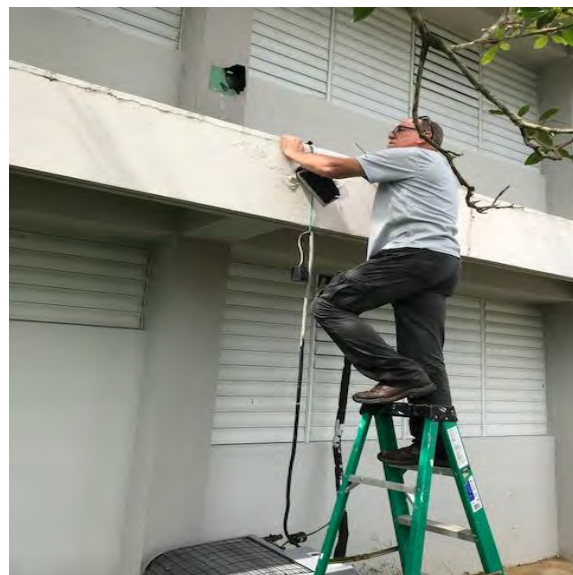
Tying off live wires from downed AC unit

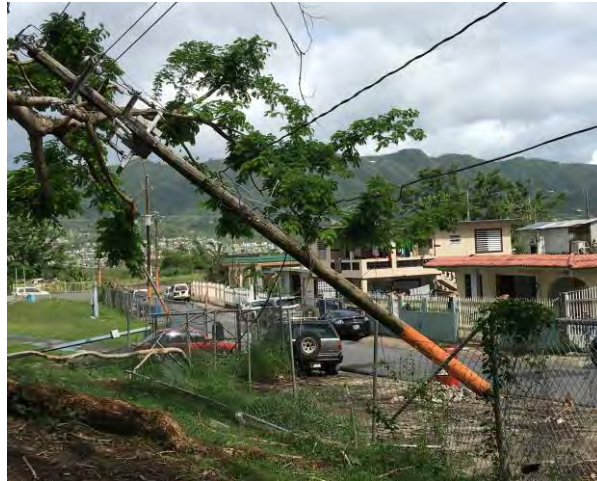
Downed power lines - safety issue

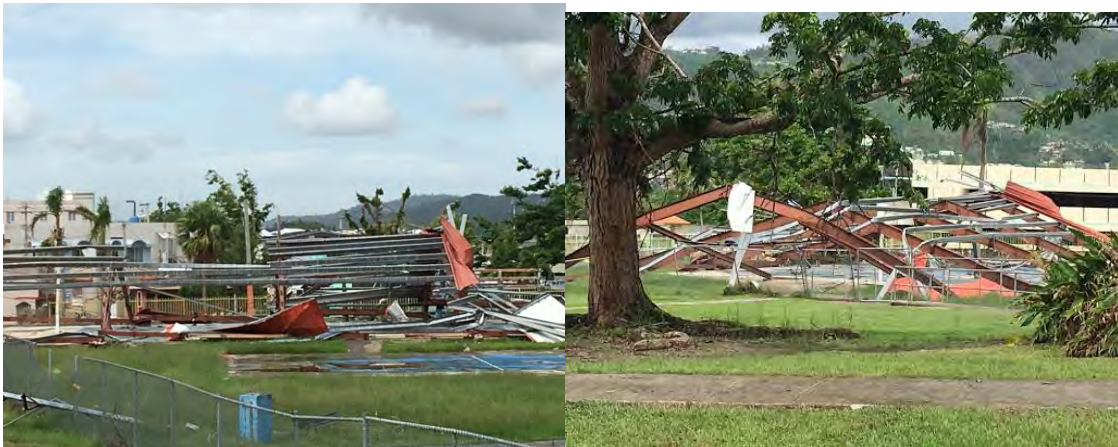
PE shelter lost

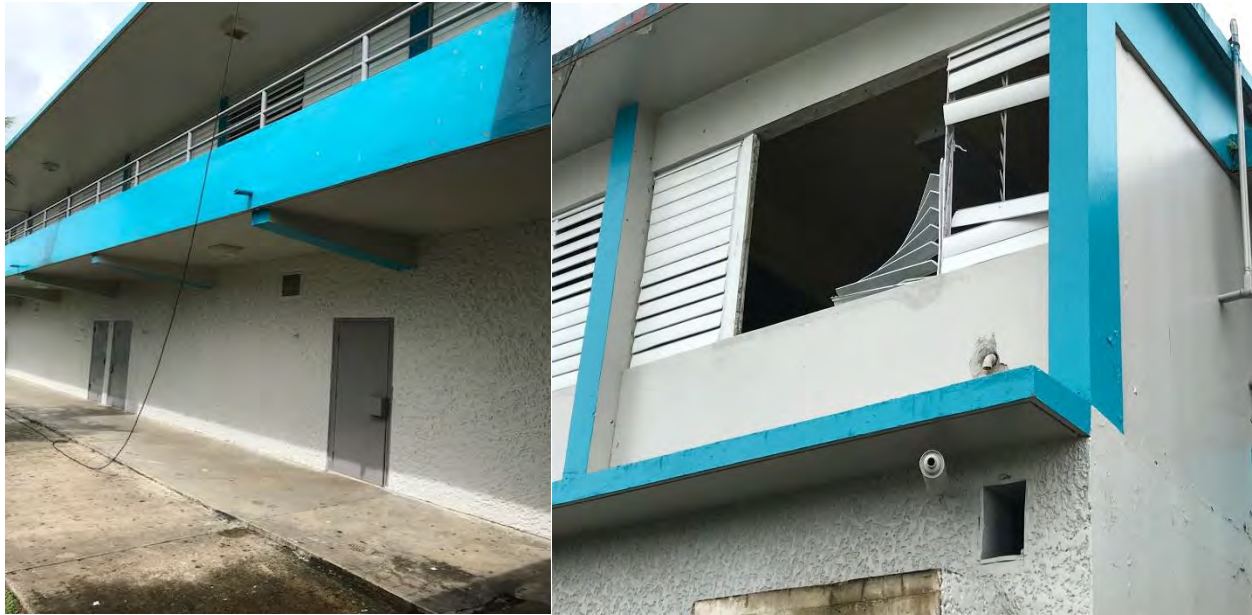
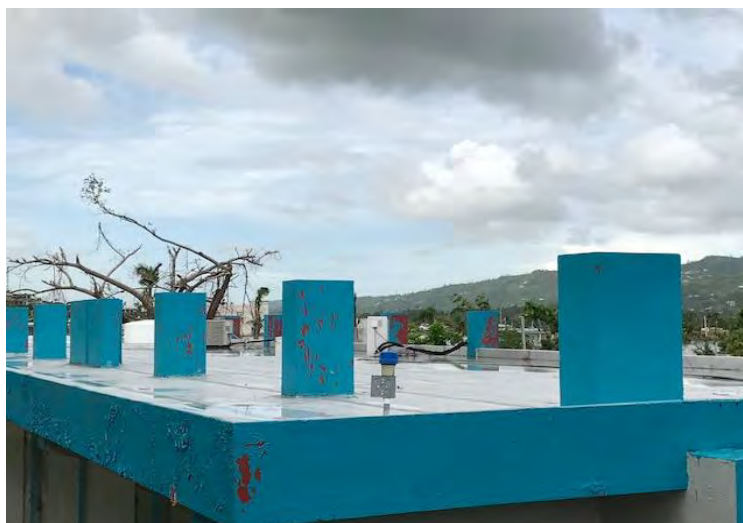
Debris on roof

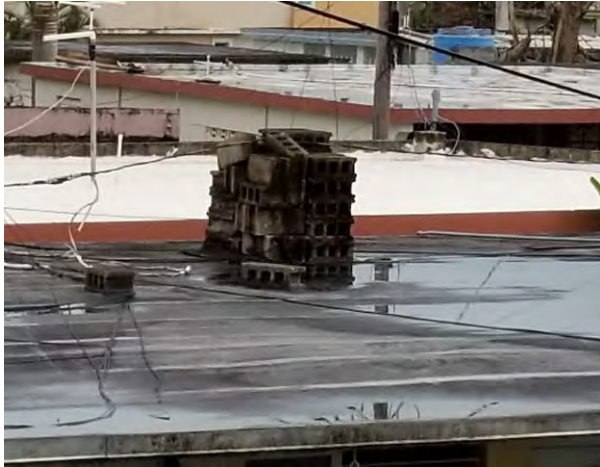
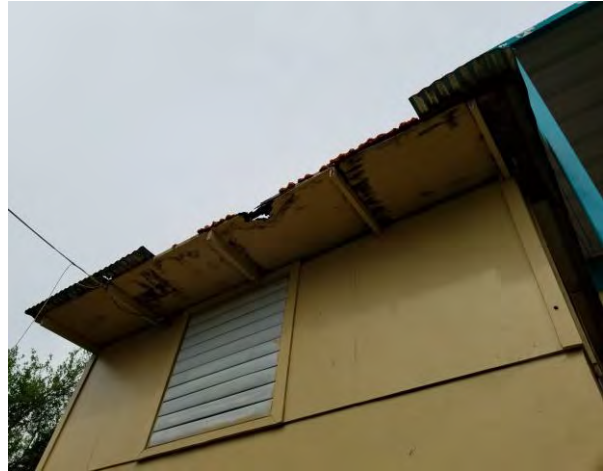
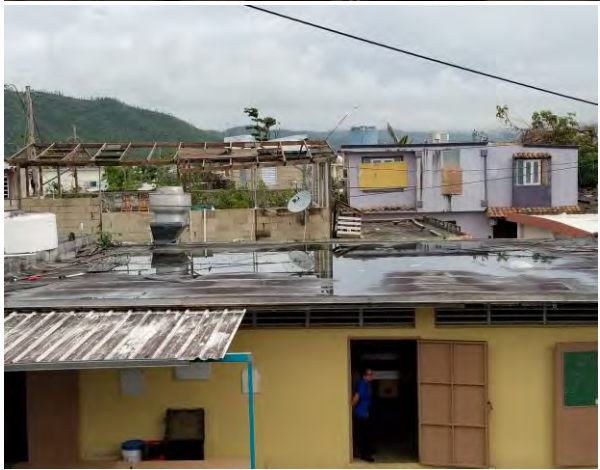
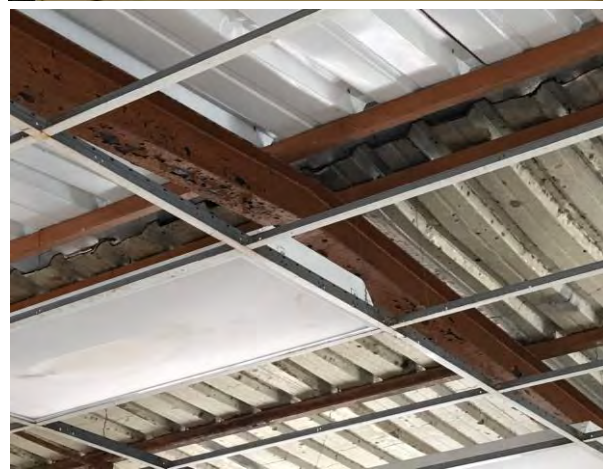
Roofs with minor leaks and standing water

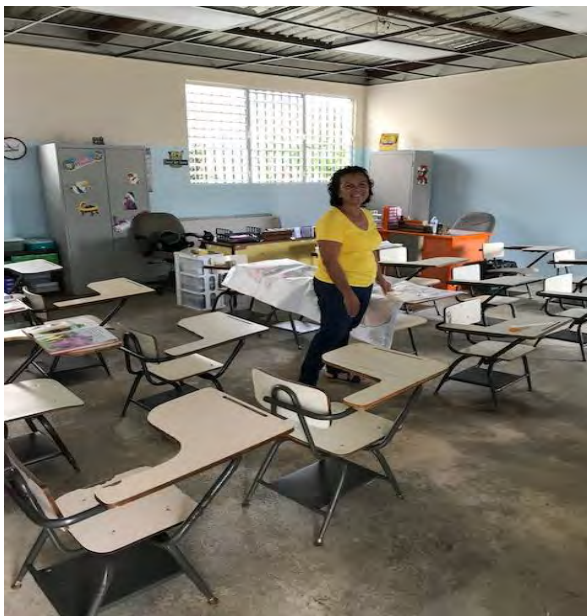
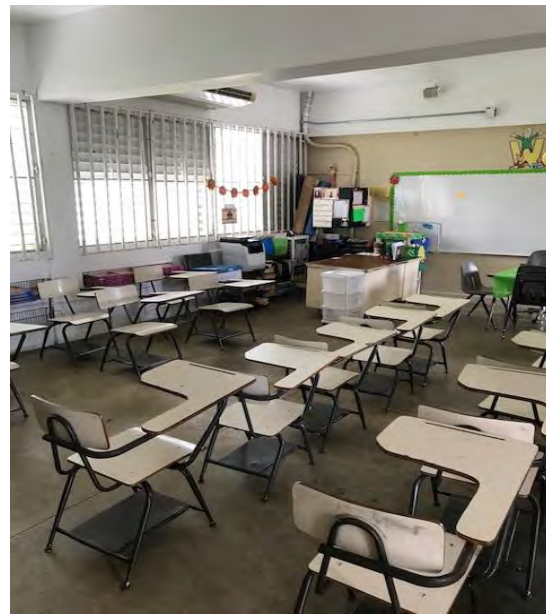
Classrooms ready for instruction

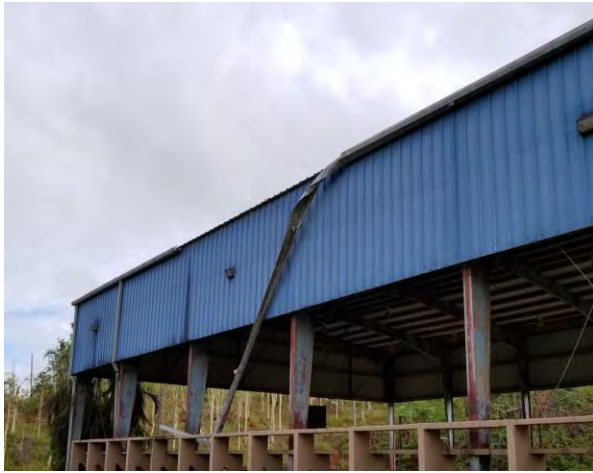
Horizontal gutter should be removed - safety issue

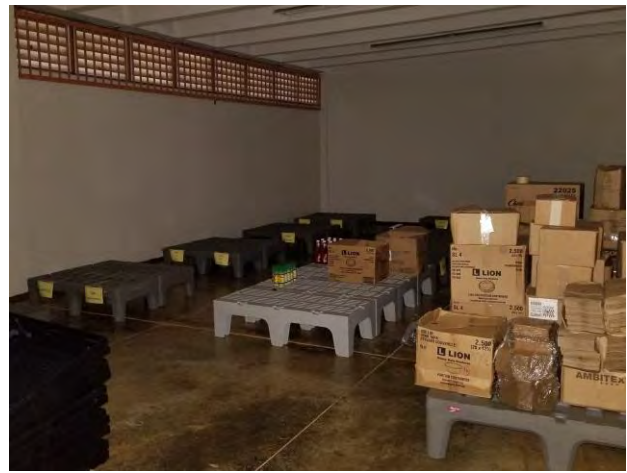
Food pantry supplies very low

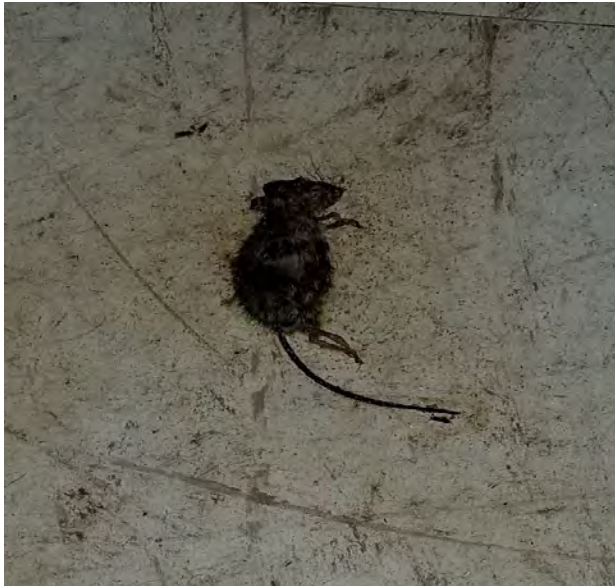
- Kitchen and dining room in excellent condition. Has gas
- No water leaks or integrity issues
- All classrooms in excellent condition, cleaned, and ready to receive students.
- Rodent issue in the file room and offices.

Office area infested with rodents

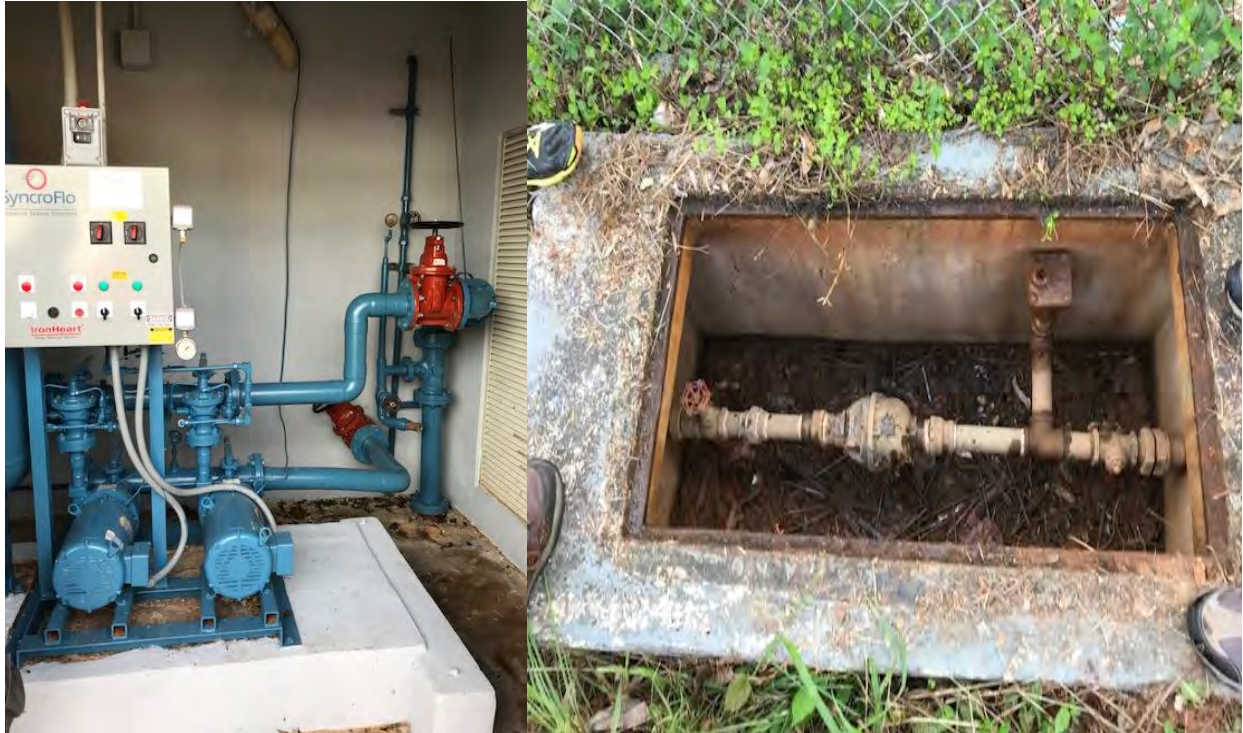
Need 220 generator to power water supply to both Cruz-Garcia and Padin schools

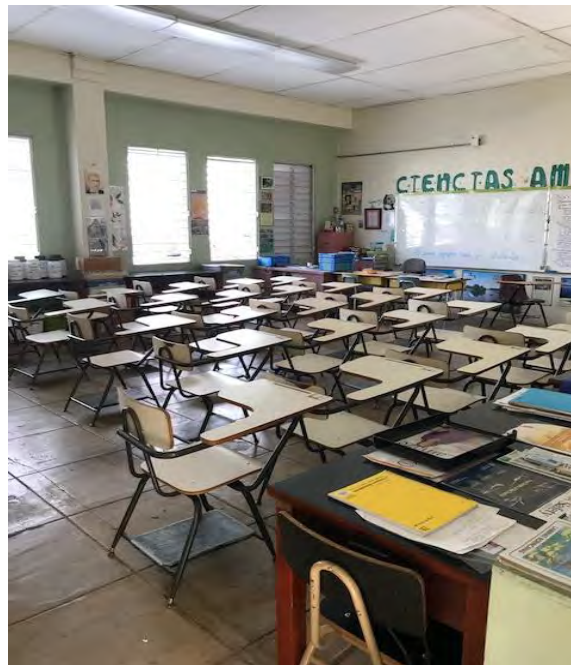
Some classrooms ready for instruction

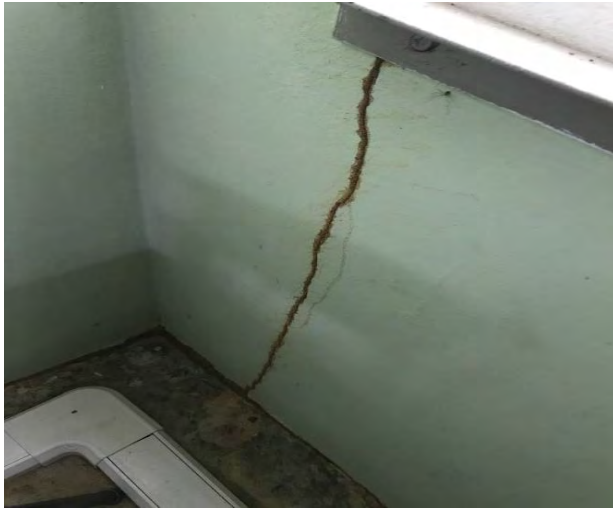
- School is currently without electrical and water utilities
- Water and sewer are not operational without electricity
- Active leaks visible in many areas
- Evidence of termites is present
- Overall classrooms and kitchen/dining are clean, or in the process of being cleaned and prepped for occupancy

Evidence of Termites

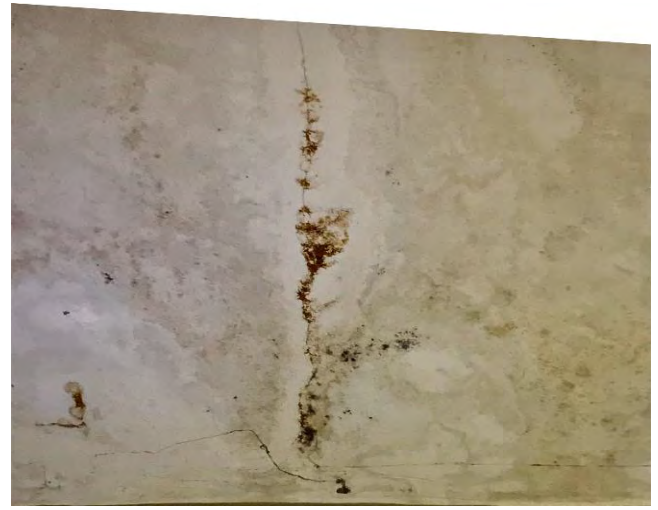
Active water leaks from the ceiling

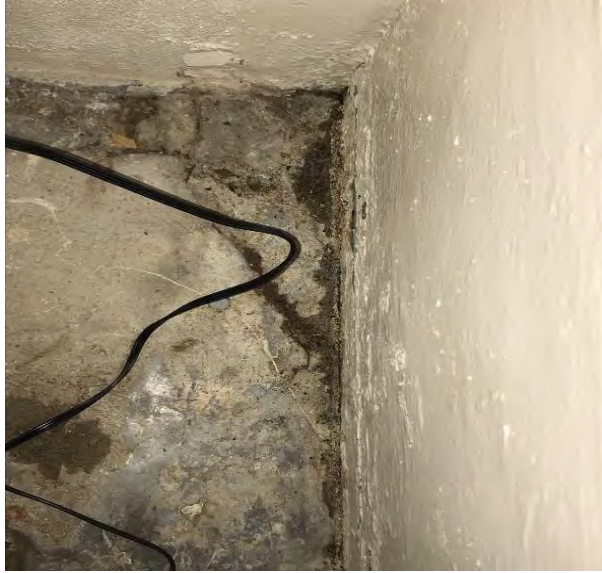
Water infiltration through 1st floor
3rd grade classroom

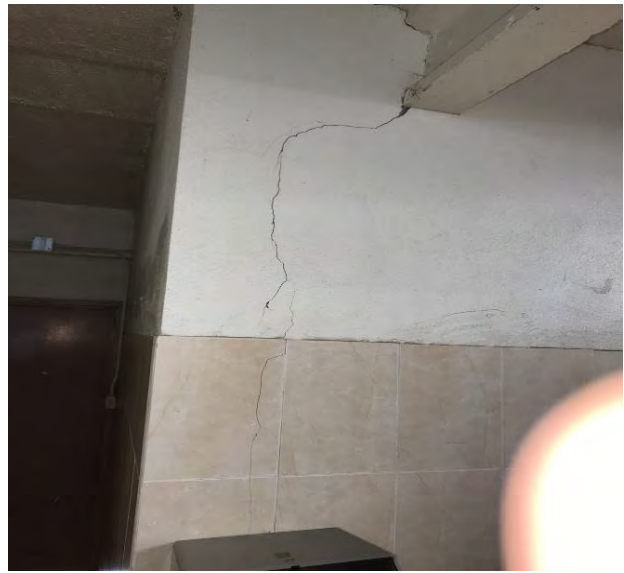
Wall cracks

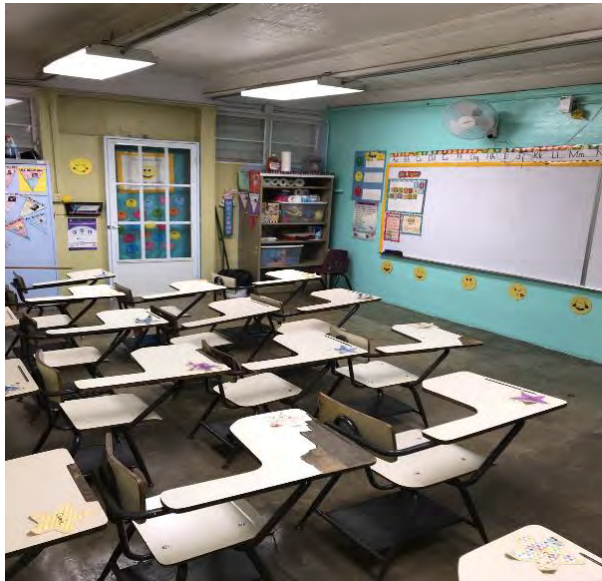
Classroom prepped for instruction. Replace
damaged student desk.

Replace damaged furniture

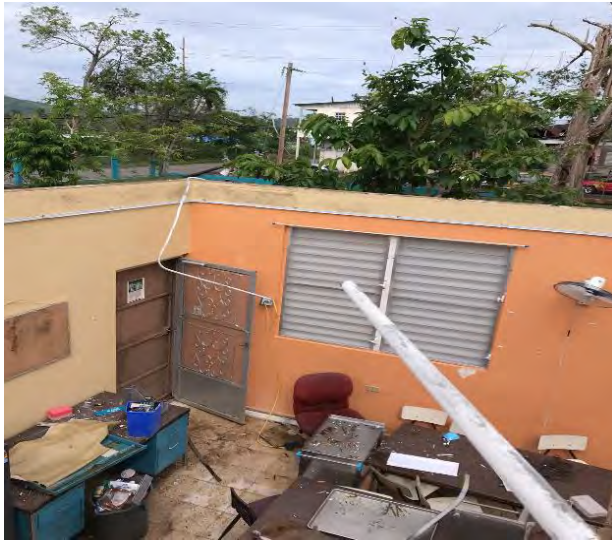
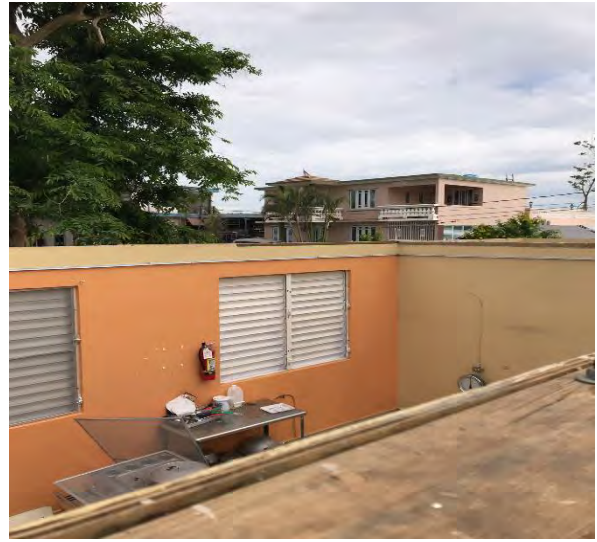
Roof completely blown away from cafeteria/dining building at kindergarten site

Kindergarten campus' cafeteria/dining building roof is completely removed. Recommend an engineer evaluate remains to determine if the building is salvageable.

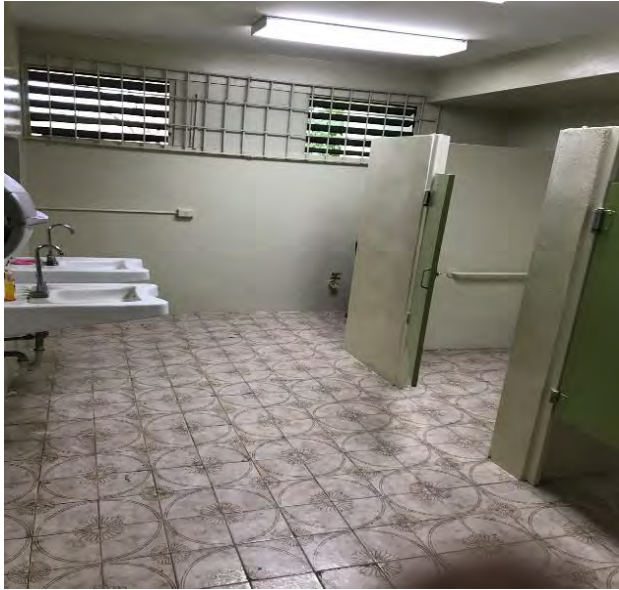
Most bathrooms are operational

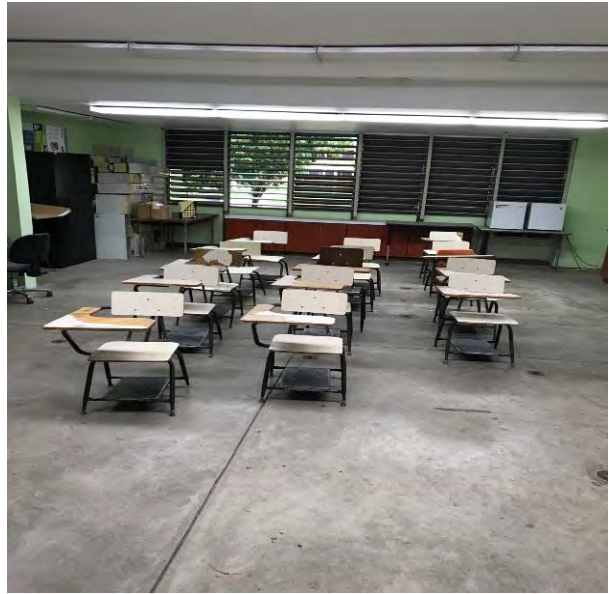
Classrooms prepped for instruction

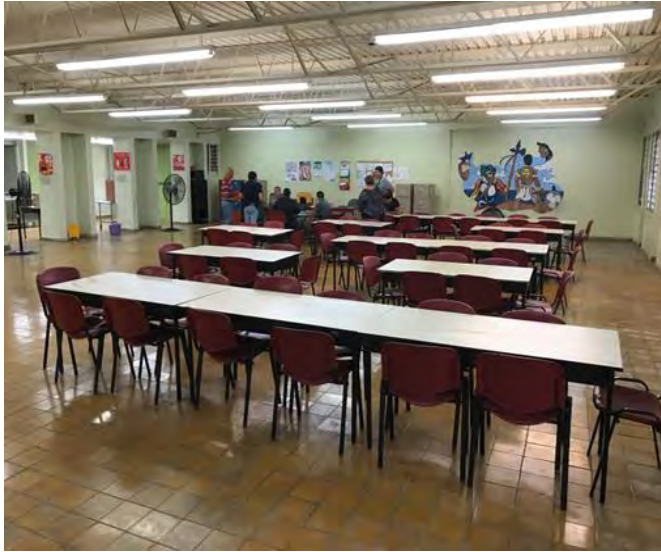
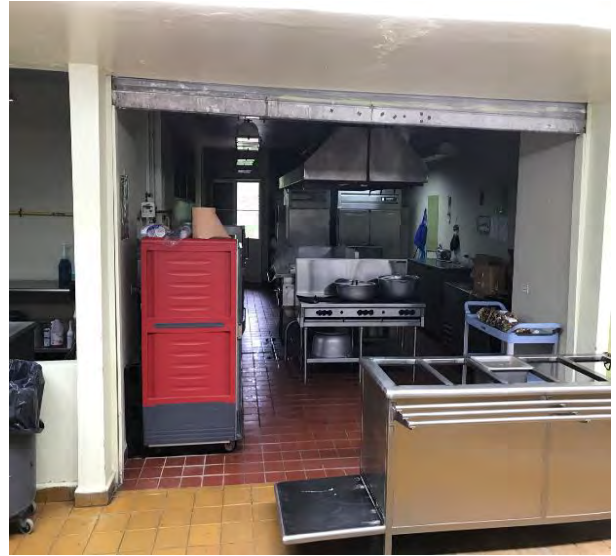
Dining and kitchen area clean and prepped for occupancy

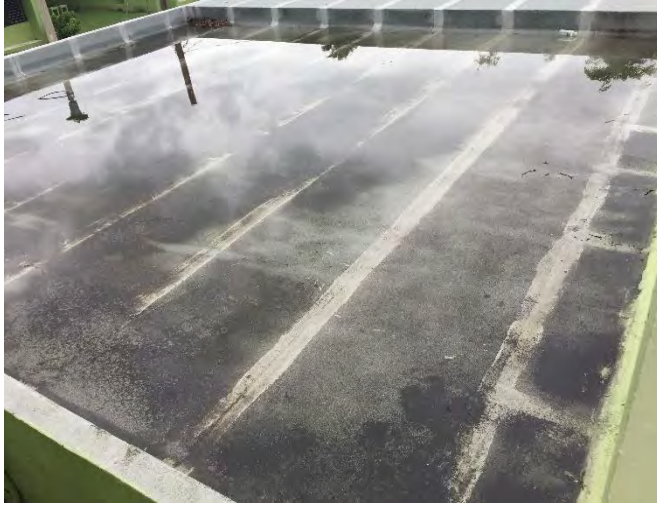
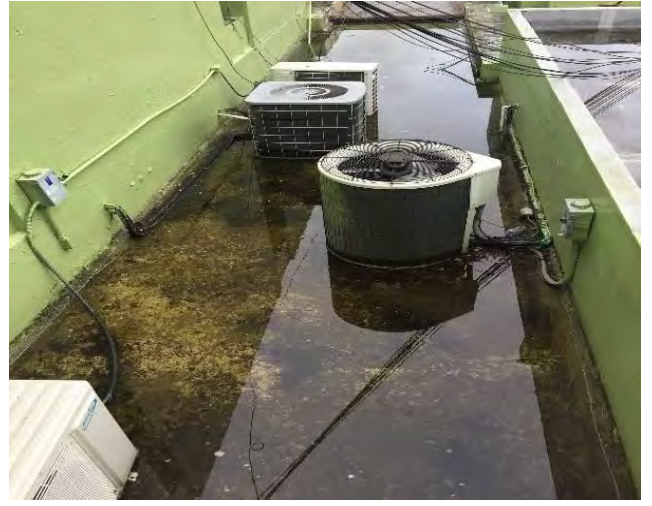
Standing water on roofs

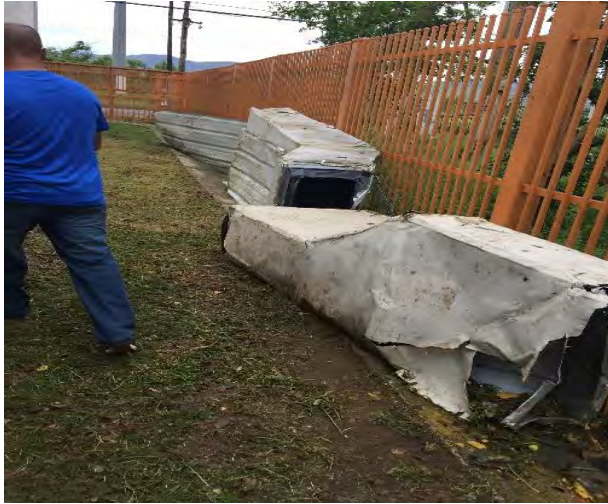
Duct blown from roof

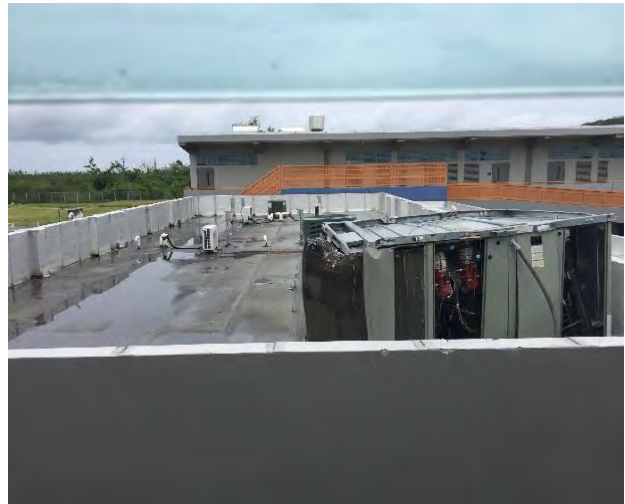
Mechanical unit turned over...water ponding

Replace rooftop mechanical units and properly fasten to roof curb

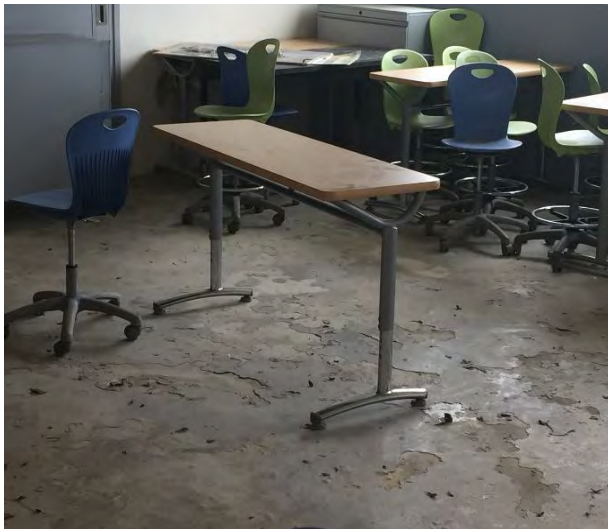
Concrete floors scaling

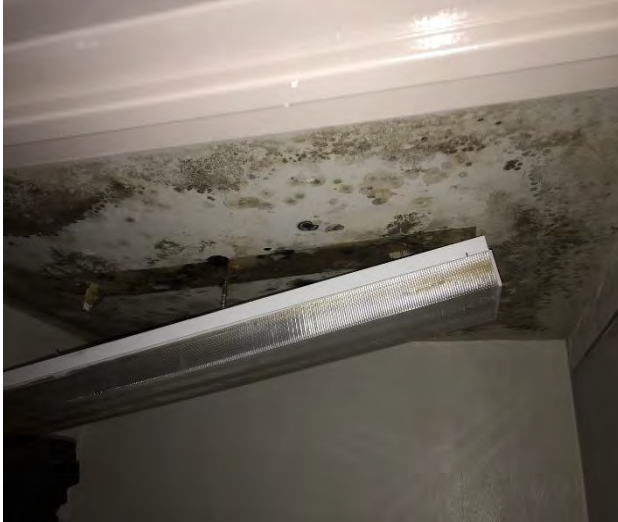
Mold on ceiling and broken light fixture

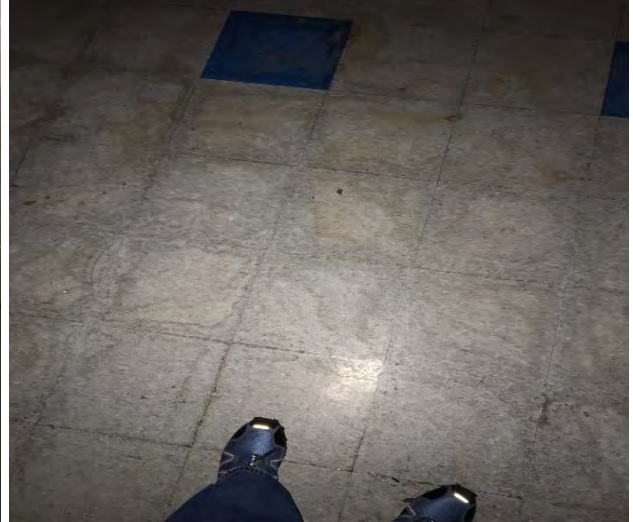
VCT flooring is saturated with water

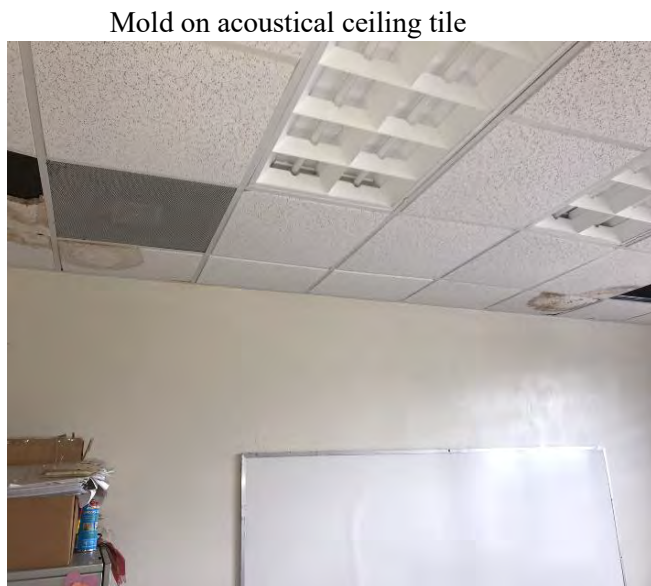
Mold on acoustical ceiling tile

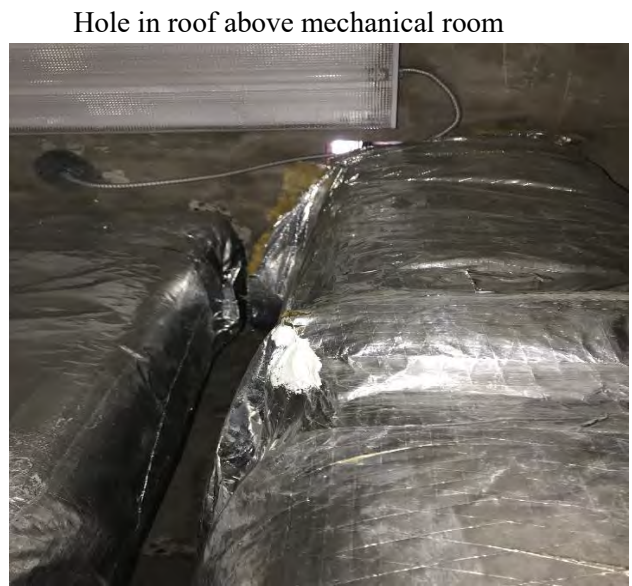
Hole in roof above mechanical room

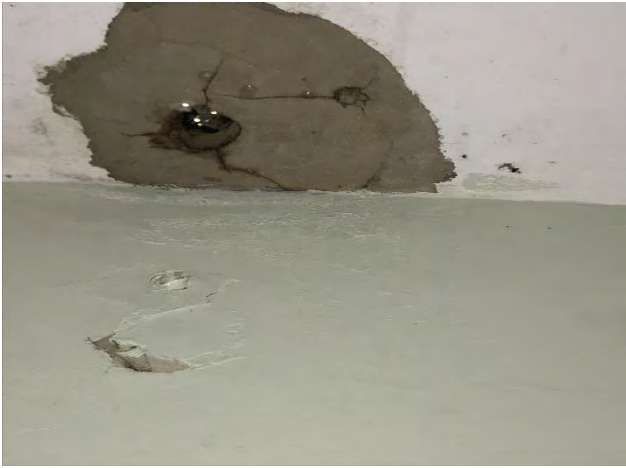
Hole in concrete roof

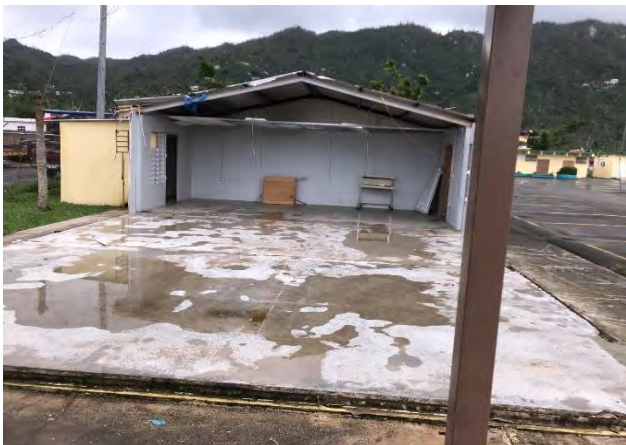
Portion of classroom building blown away

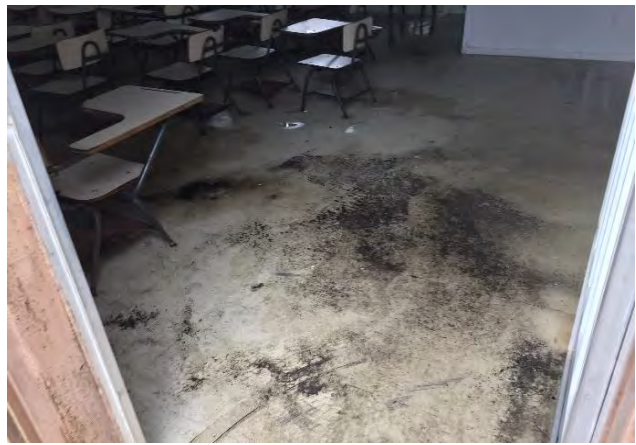
Water and soil on floor in classroom

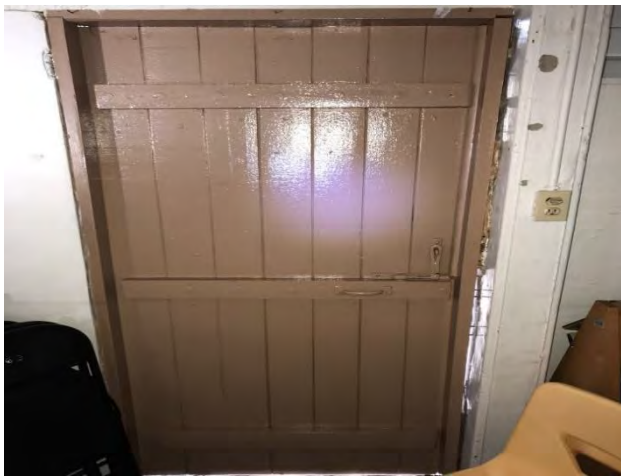
Wooden exterior door and jam

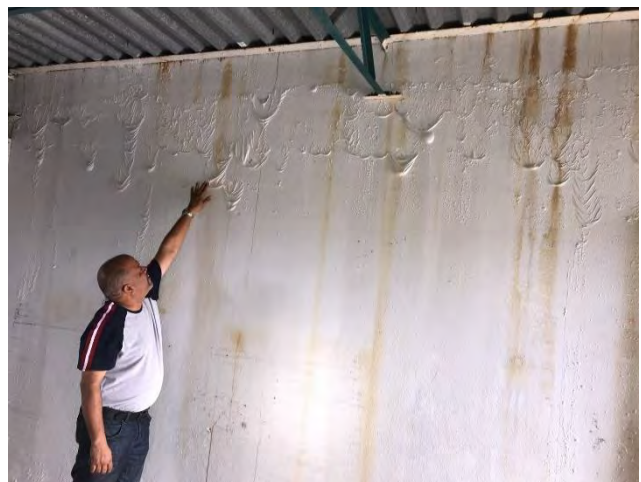
Water pockets on walls from roof leaks

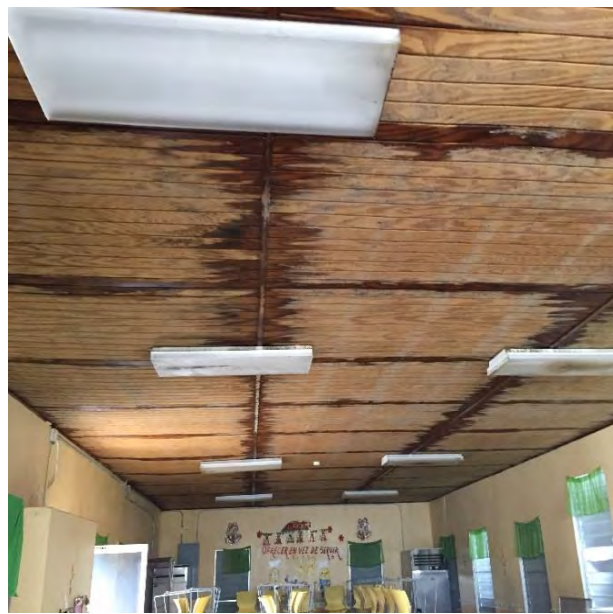
Wood ceiling in cafeteria is wet

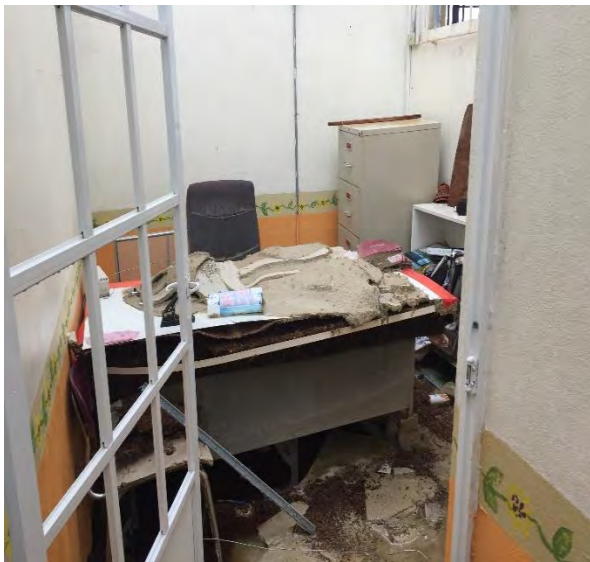
Debris left in office

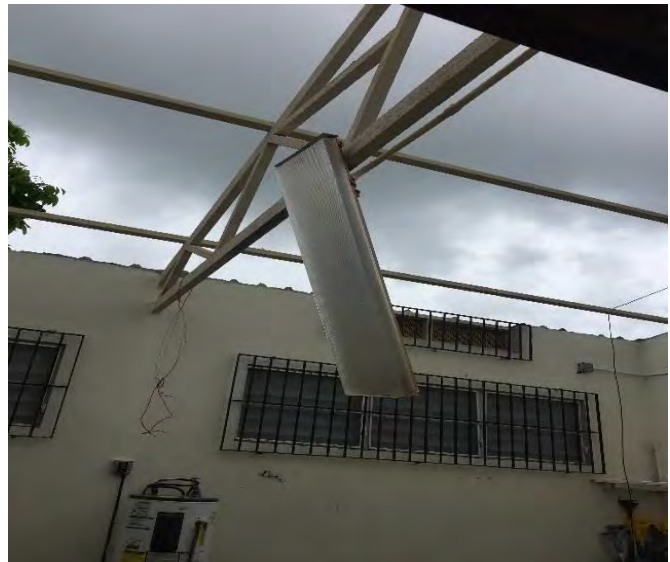
Roof blown off main building

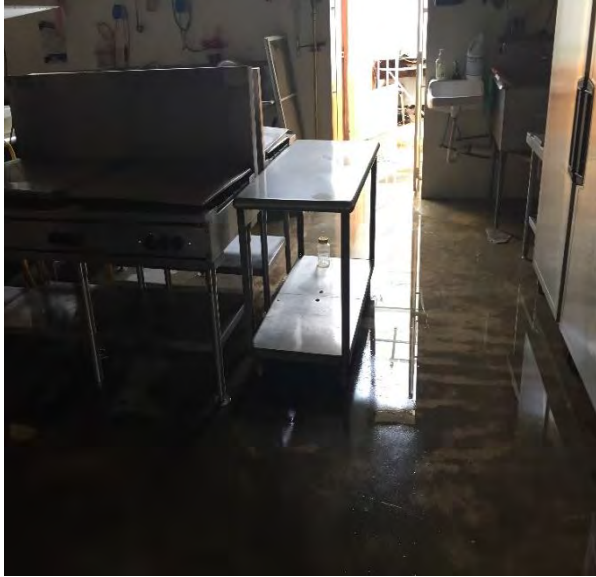
Kitchen flooded

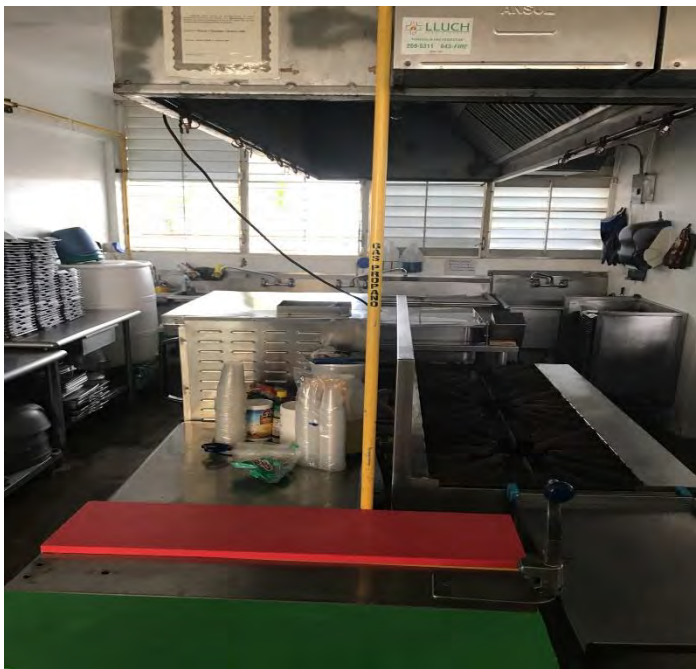
Kitchen is clean

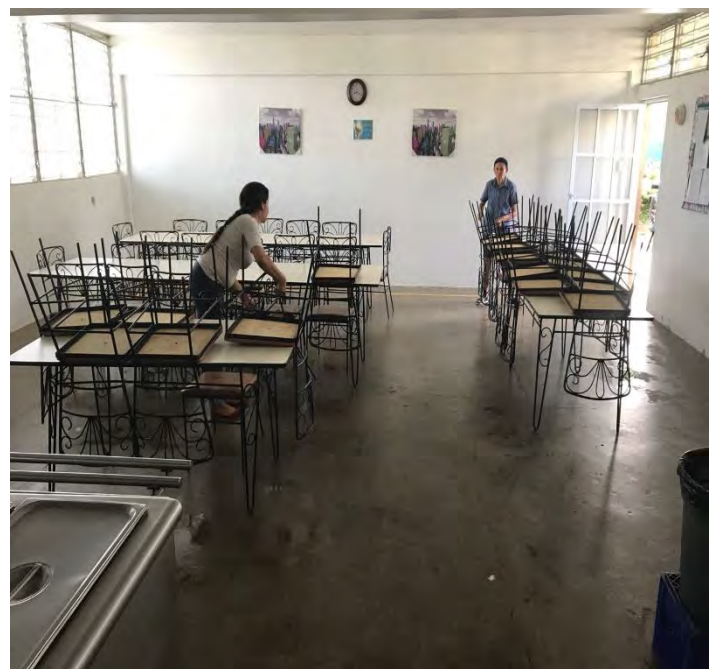
Dining area is clean
