PUERTO RICO SCHOOL FACILITIES ASSESSMENT

COUNCIL OF THE GREAT CITY SCHOOLS

NOVEMBER 11, 2017

Hurricane Maria Damage Assessment of School Facilities in Puerto Rico

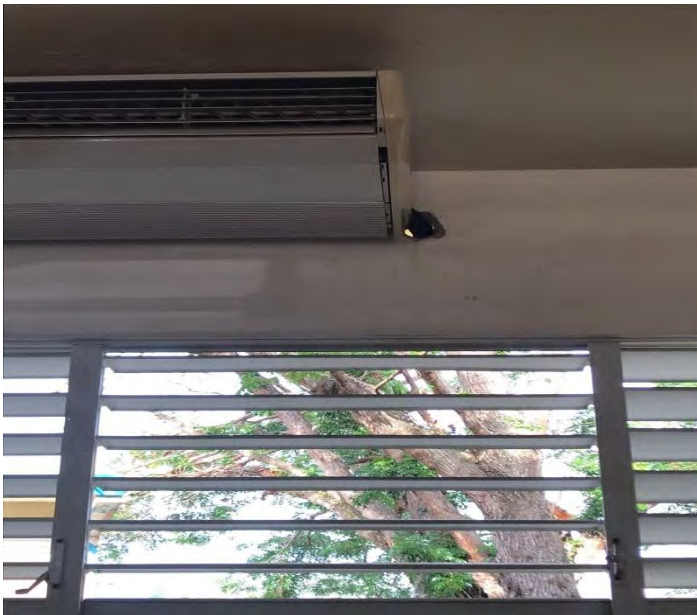
Exposed electrical wiring

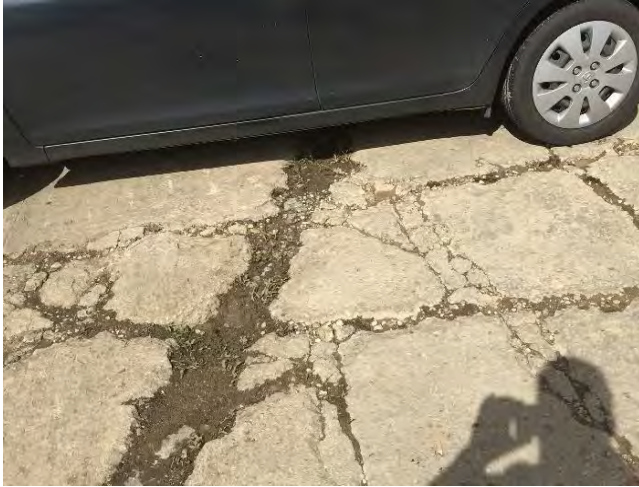
Large cracks throughout front parking lot

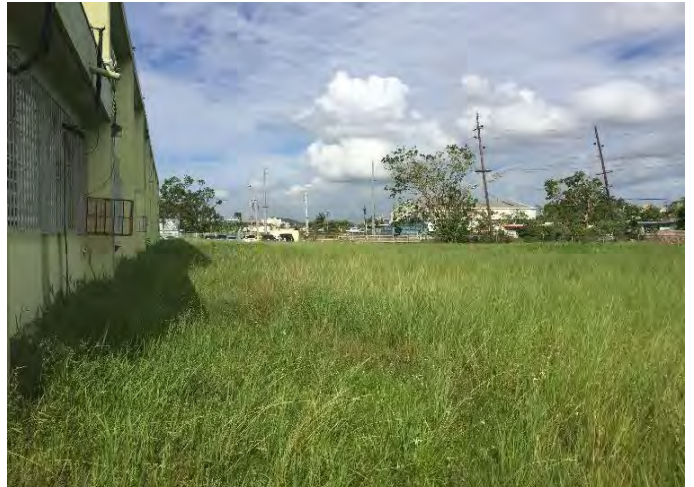
Grounds overgrown

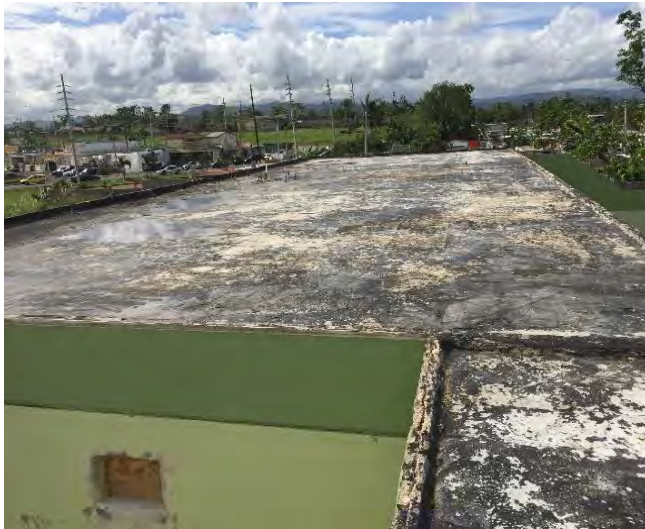
Contractor has removed roof to substrate

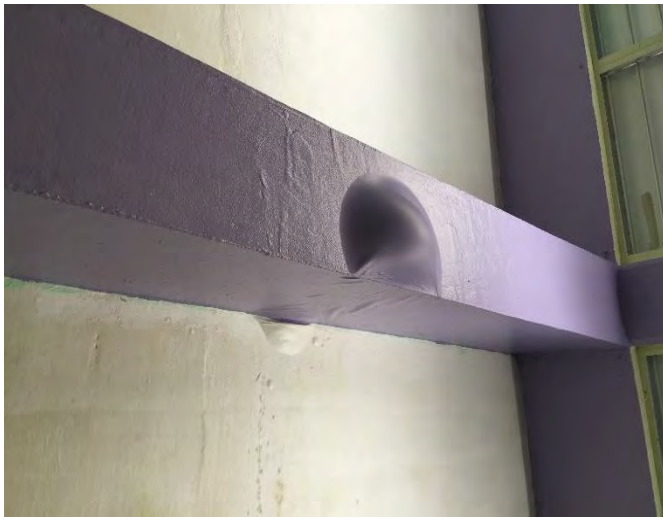
Water pocket from moisture trapped in paint

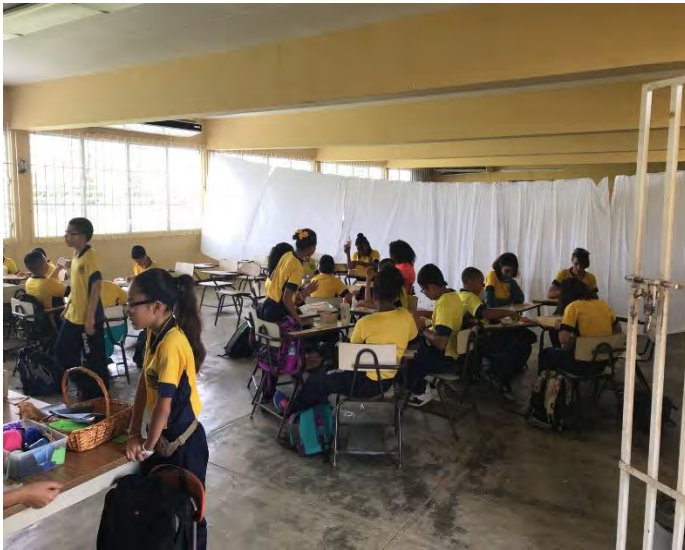
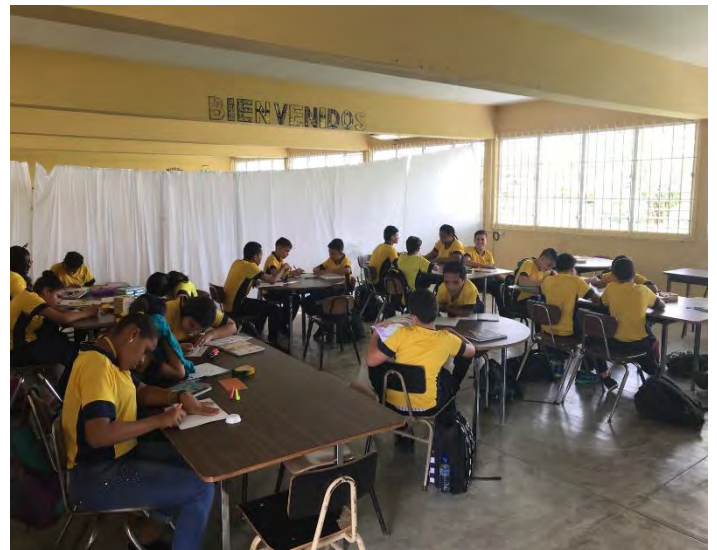
Media center divided into two classrooms

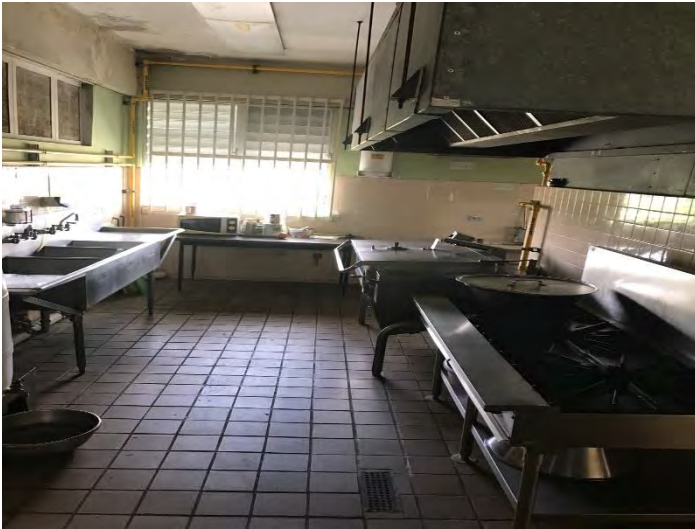
Kitchen cleaned and prepped

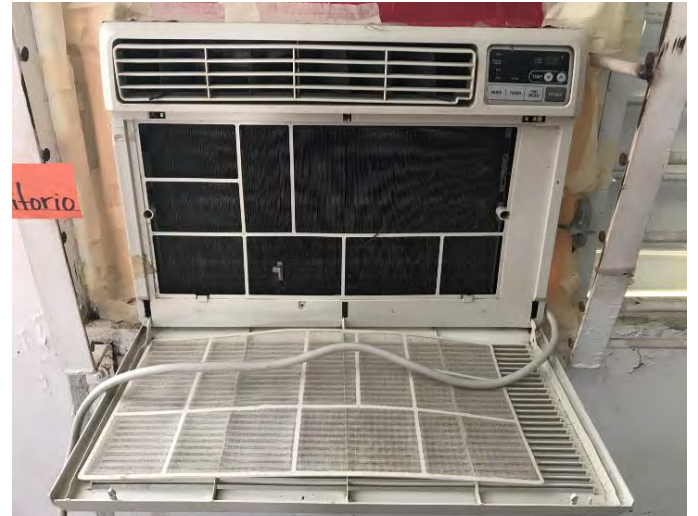
Damaged window unit
